the play inspection company

Annual Inspection

Adderbury Parish Council

Lucy Placket Playing Field

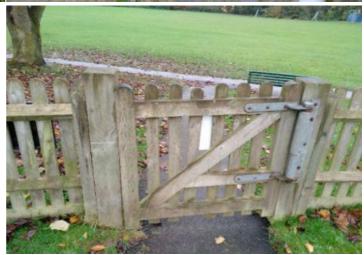
Finding: The configuration of the timbers poses a risk of head and neck entrapment in the framework

Action: Monitor- No remedial work recommended

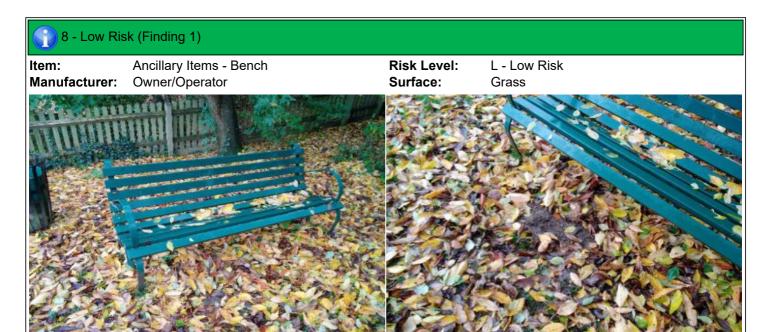
Finding: The area around the item has eroded and may become slippery

Action: Reinstate eroded area

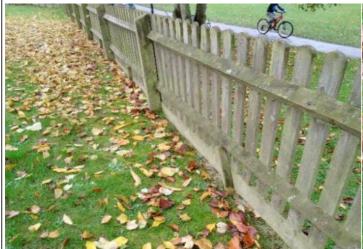
Finding: There is some strimmer / machinery damage apparent on the posts, this can penetrate the preservative applied to the timber and accelerate the rotting process

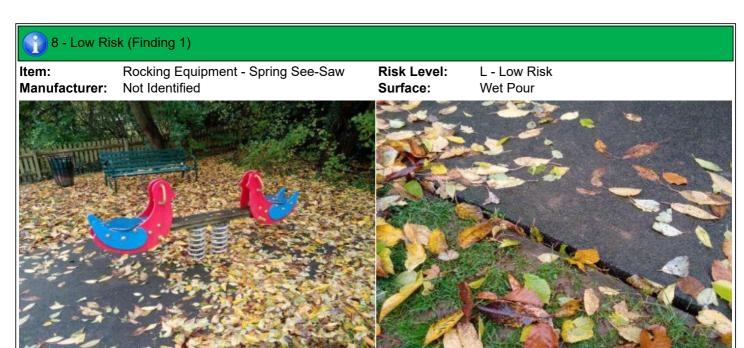
Finding: The surface is lifting at the edges and creating trip **Action:** Repair perimeter of surfacing to remove trip points points

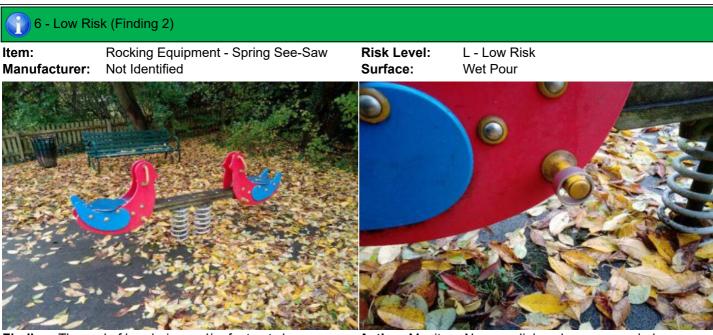
Finding: The end of handgrips and/or footrests have a cross **Action:** Monitor - No remedial work recommended section of less than 15cm2 and fail to meet the requirements of BS EN 1176 Part 6

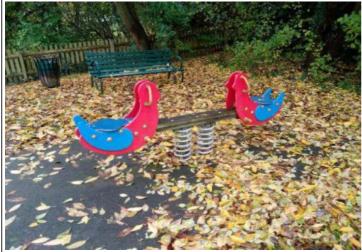
Finding: There is/are bolt cap covers missing or damaged Action: Replace missing or damaged bolt cap covers on the item

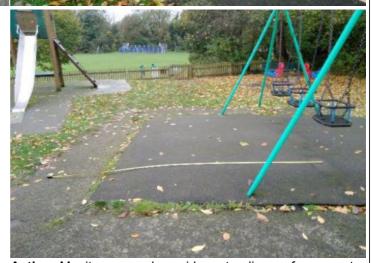
Finding: The surfacing dimensions are significantly short and do not meet with the requirements of the current applicable standard (3163mm required / 2500mm provided)

Action: Monitor use and consider extending surface area to comply

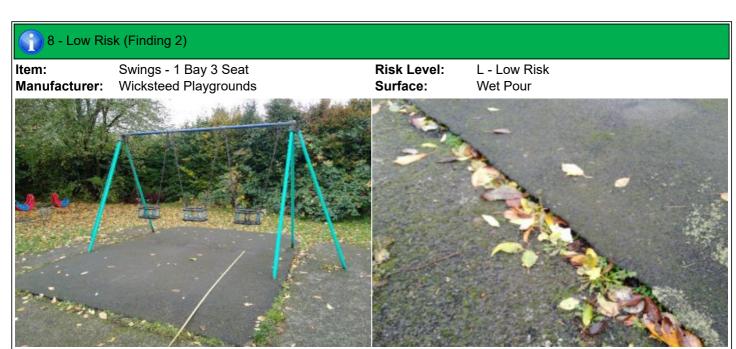
Finding: The surface is lifting at the edges and creating trip **Action:** Repair perimeter of surfacing to remove trip points points

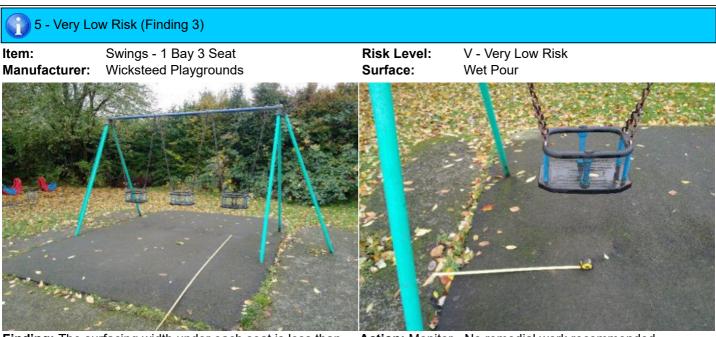
Finding: The surfacing width under each seat is less than **Action:** Monitor - No remedial work recommended 1.75 metres and fails the requirements of BS EN 1176 Part 2

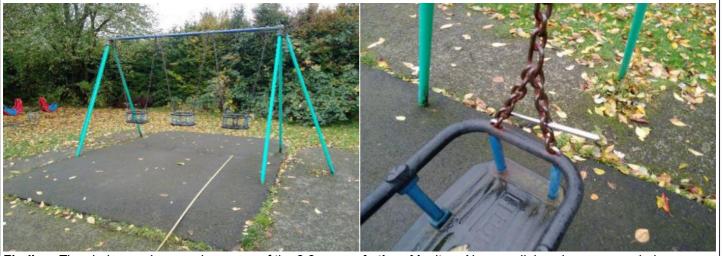
Finding: The chain openings are in excess of the 8.6mm as **Action:** Monitor - No remedial work recommended recommended by BS EN 1176

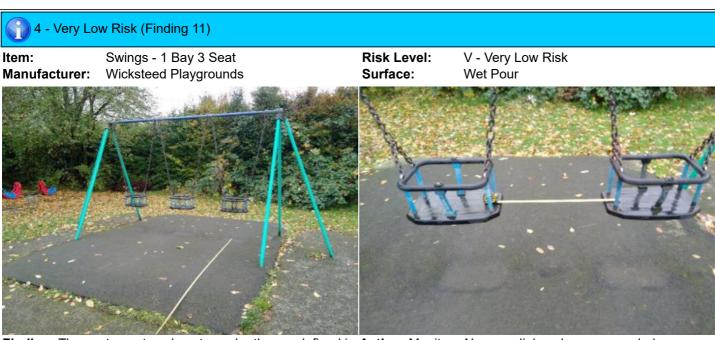
Finding: The seats are too close to each other as defined in **Action:** Monitor - No remedial work recommended BS EN 1176 Part 2; this is a low risk failure and no remedial action is required

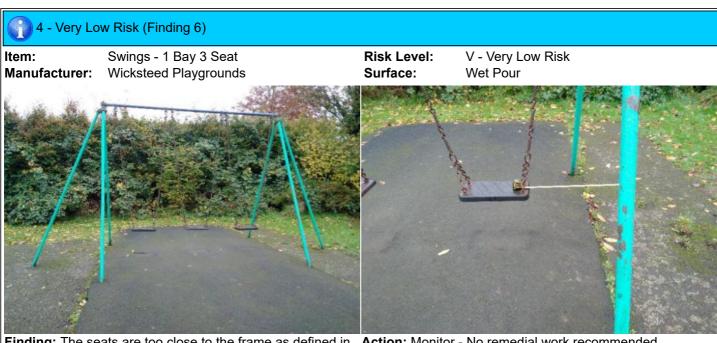
Finding: The seats are too close to the frame as defined in BS EN 1176 Part 2; this is a low risk failure and no remedial action is required

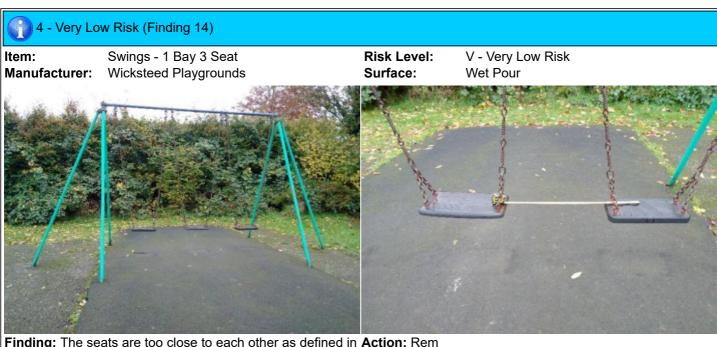
Finding: The seats are too close to each other as defined in **Action:** Rem BS EN 1176 Part 2; this is a low risk failure and no remedial action is required

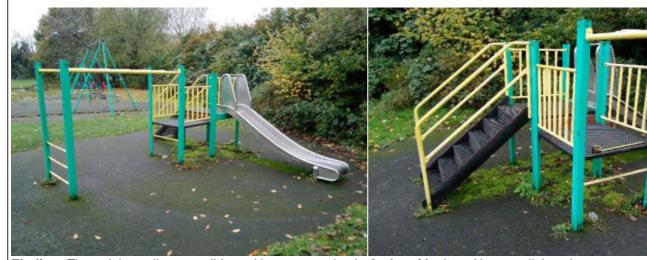
Finding: The unit is easily accessible and has an opening in **Action:** Monitor - No remedial work recommended the barrier to steep play elements in excess of 500mm in contravention of BS EN 1176 Part 1

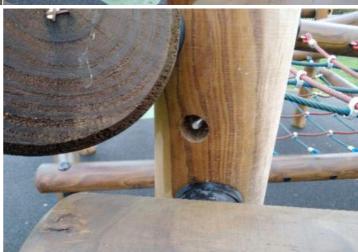
Finding: There is/are several inserts missing

Action: Replace missing inserts

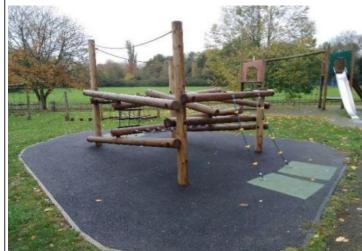
Finding: The connecting links are in excess of 8.6mm and Action: Monitor - No remedial work recommended less than 12mm and fail the requirements of BS EN 1176

Part 1; clause 4.2.13, Chains

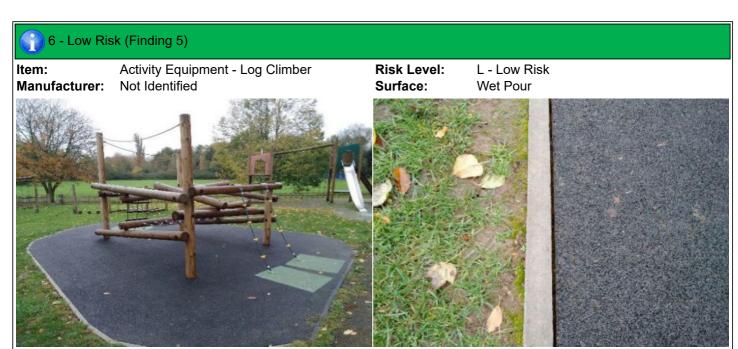
Finding: There are gaps opening between the surfacing and **Action:** Monitor for any further deterioration and repair as the edging surround or between the joints in the surfacing required

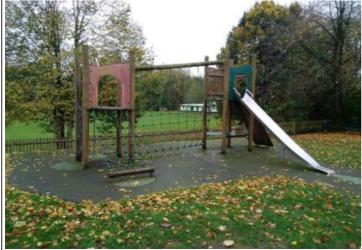
Finding: There are significant gaps (over 30mm) between the surface and the edging or between the joints in the surface; these are large enough for a small foot to enter

Action: Repair surfacing

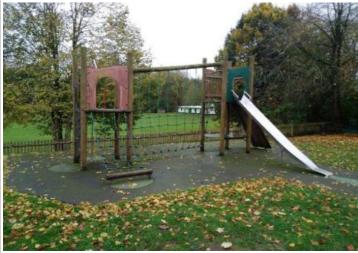
Finding: There is/are finger entrapment/s in the climbing ramp and the item fails to meet the requirements of BS EN 1176 Part 1 4.2.7.6 Entrapment of fingers

Action: Monitor - No remedial work recommended

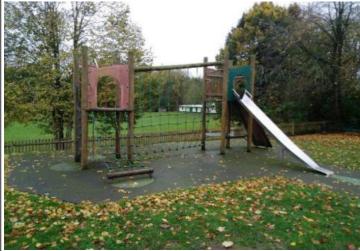
Finding: A number of fixing(s) have worked loose on the climbing treads

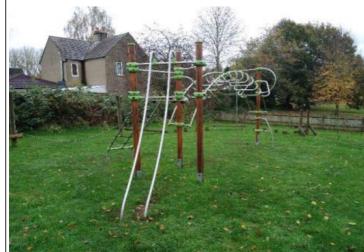
Finding: The item fails to meet the requirements of BS EN Action: Monitor - No remedial work recommended 1176 Part 1 4.2.7.2 for head and neck entrapment in the framework

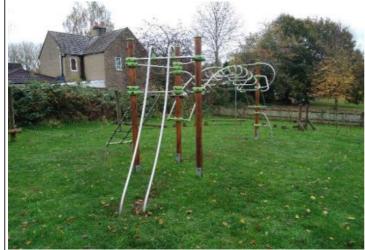
Finding: There are post / end caps missing from the item

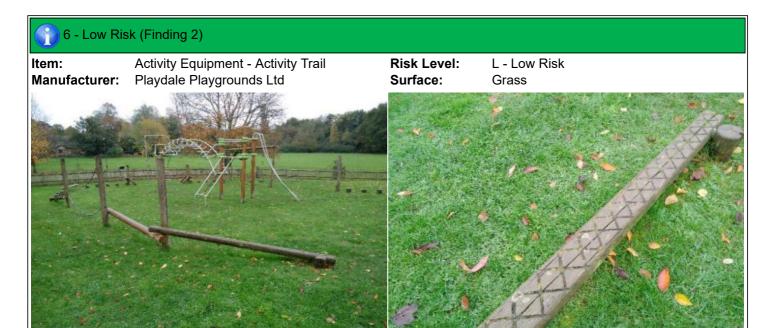
Finding: The timber has a number of splits/shakes or air **Action:** Monitor to ensure the splits do not cross through cracks and this may affect the stability or allow water ingress fixing points of the structure and/or cause any instability which will accelerate the rotting process

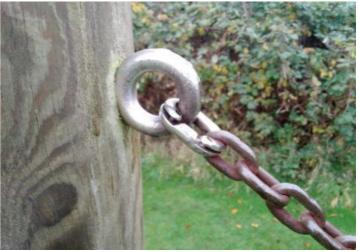
Finding: Fixings are damaged and/or have sharp edges

Action: Repair or replace as required

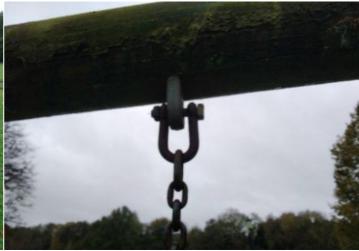
Finding: The shackles are corroding

Action: Monitor for any further deterioration and replace as required

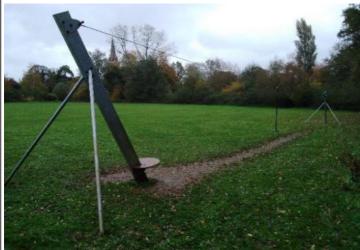
Finding: We have completed a visual inspection of the cable and fixing points from ground level, however it is not possible to fully inspect the cable and fixings without either hiring equipment to gain access or removing the cable and inspecting at ground level. We recommend that the main cable and fixing security is thoroughly inspected at least in accordance with the manufacturers recommendations to check for damage, security or internal rusting, this will help to ensure the continued safe use of the equipment

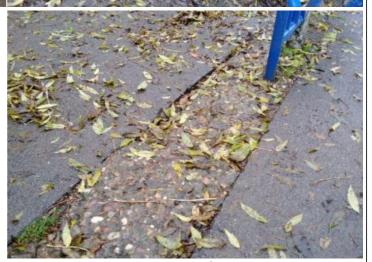
Finding: There are trip hazards present

Action: Reinstate surrounding surfaces to level to remove the trip points

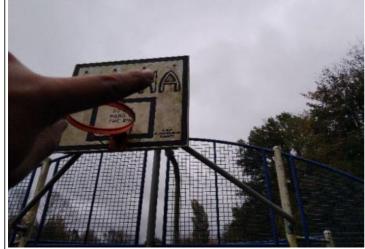
Finding: There is or are fixings missing on the backboard

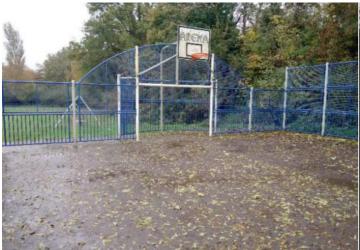
Finding: A clearly visible facility sign should be provided in Action: Provide signage to BS EN 15312 a prominent position with the wording as detailed BS EN 15312- the equipment is not intended for children less than 3 years old- the warning - Do not climb on the framework or nets- the warning - Do not hang on the ring (if provided)- the warning - Do not wear rings or other jewellery- name and telephone number of the administrator- number to call in case of accident

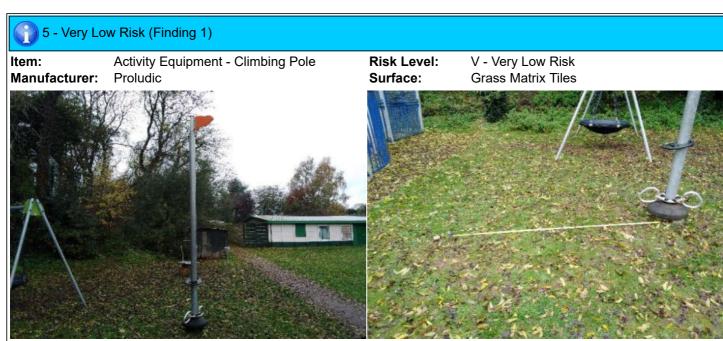
Finding: The surfacing dimensions are short and do not meet with the requirements of the current applicable standard

Action: Monitor - no remedial action recommended
