the play inspection company

Annual Inspection

Adderbury Parish Council

The Rise

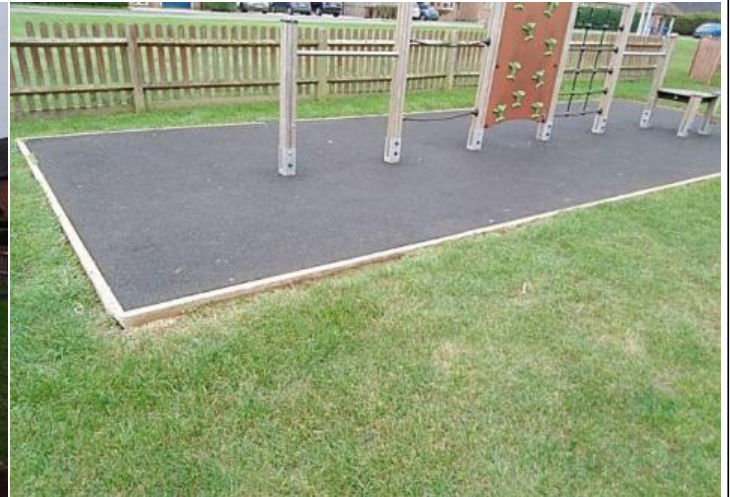
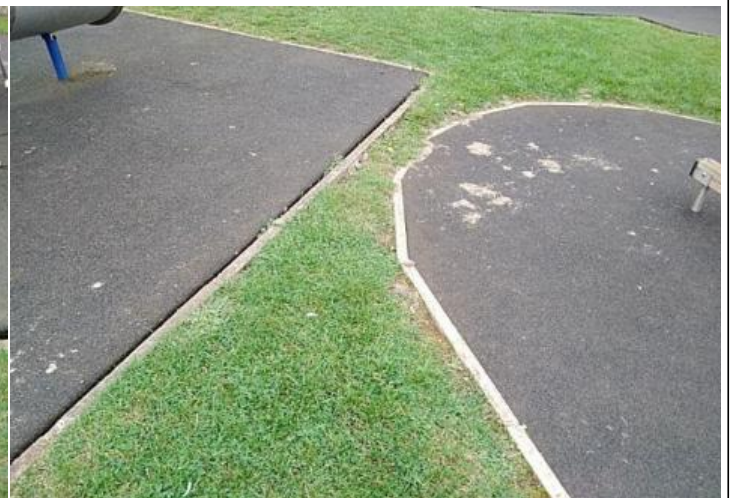
Finding: There are trip hazards at the edges of the surface **Action:** Reinstate surrounding surface levels to remove the trip points

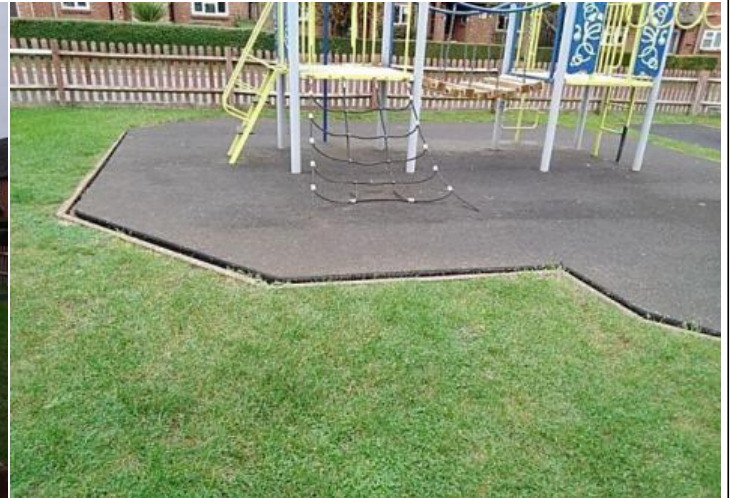
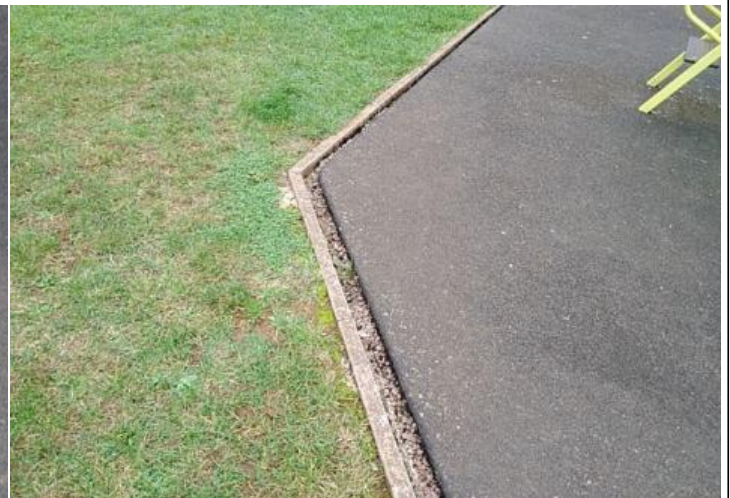
Finding: There are significant gaps (over 30mm) between the surface and the edging or between the joints in the surface; these are large enough for a small foot to enter

Action: Repair surfacing

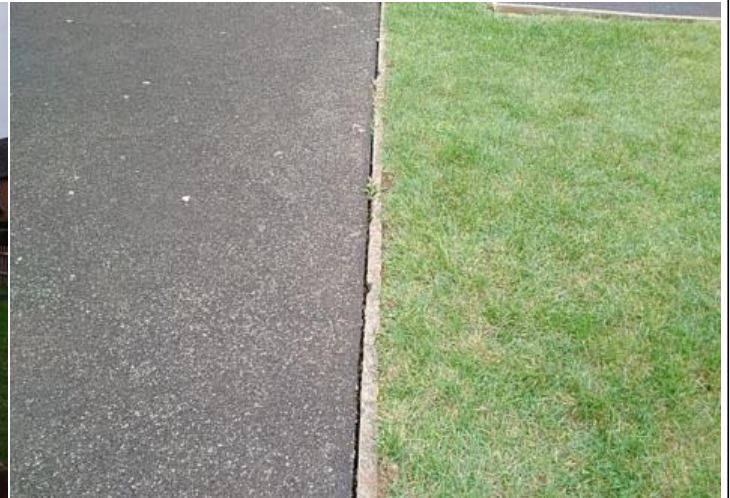
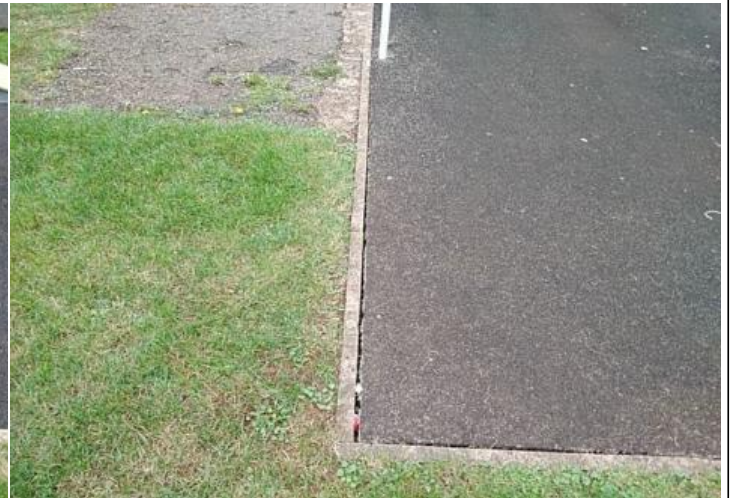
Finding: There are gaps opening between the surfacing and the edging surround or between the joints in the surfacing **Action:** Monitor for any further deterioration and repair as required

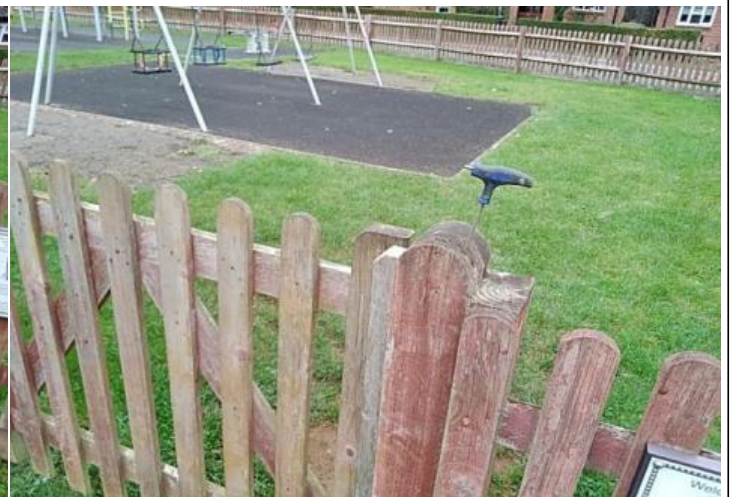
Finding: There is some evidence of rot in the timber

Action: Monitor for any further deterioration and replace as required

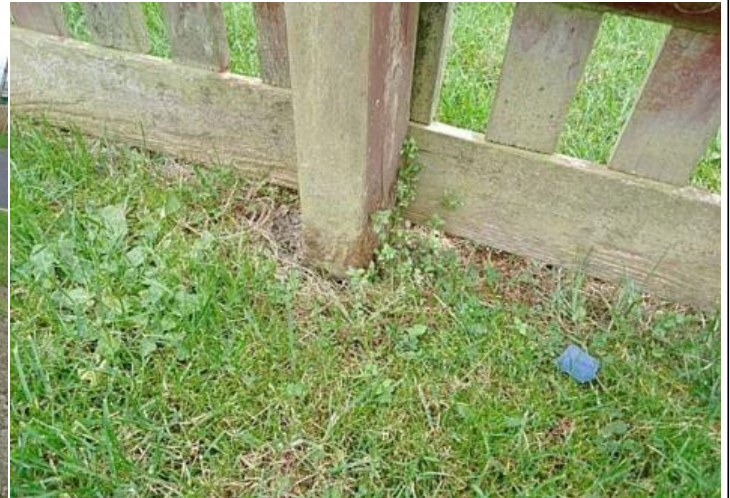
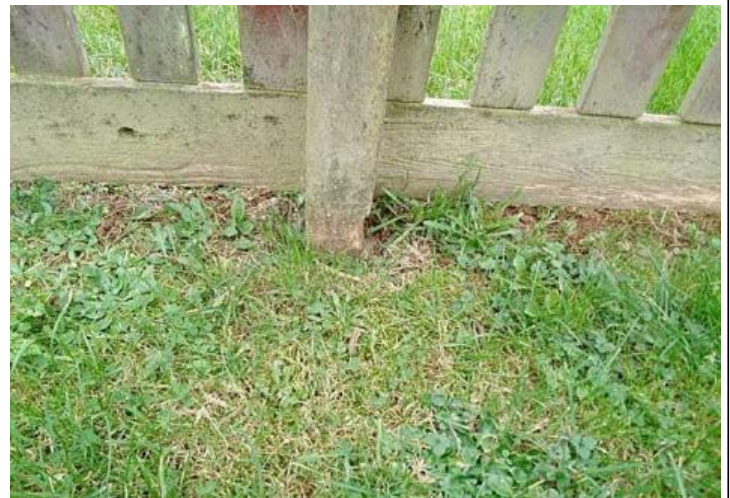
Finding: There is some strimmer / machinery damage apparent on the posts, this can penetrate the preservative applied to the timber and accelerate the rotting process

Action: Monitor for any deterioration (rot) and replace as required

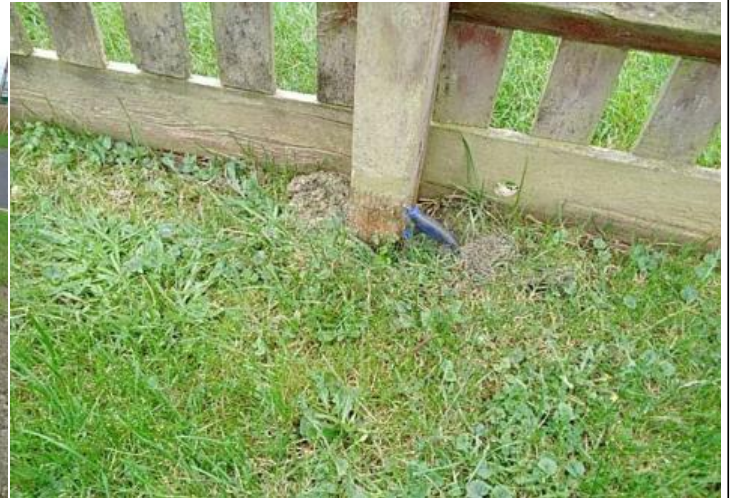
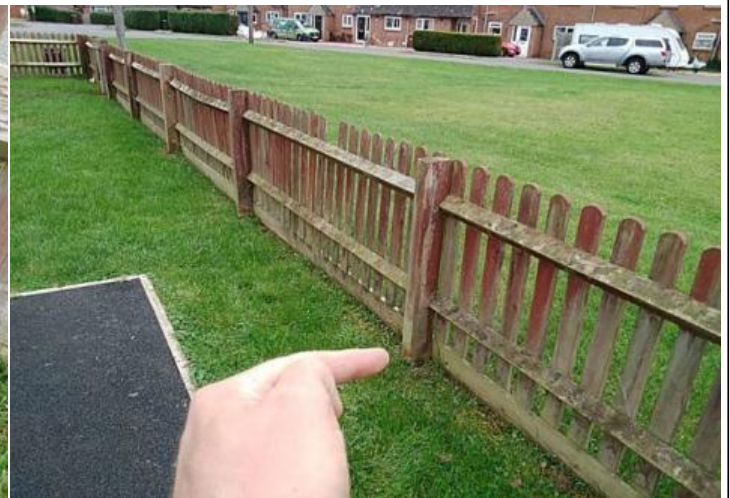
Finding: There are areas or parts of the timber on the structure that have rotted

Action: Replace all affected timbers

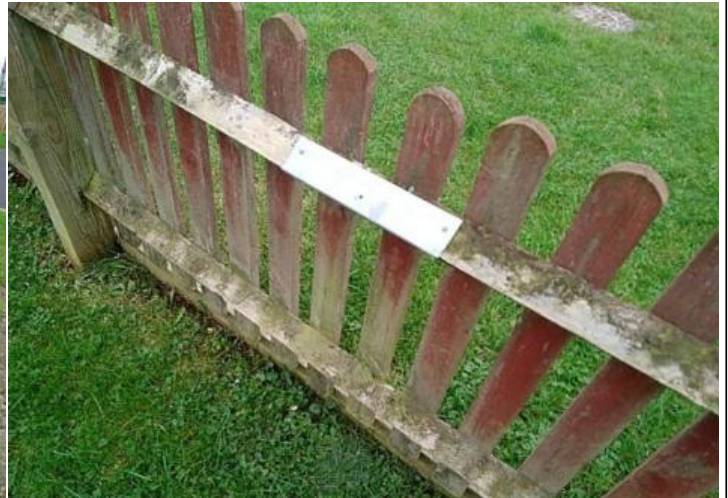
Finding: There is or are fixings missing on the item

Action: Replace all missing fixings

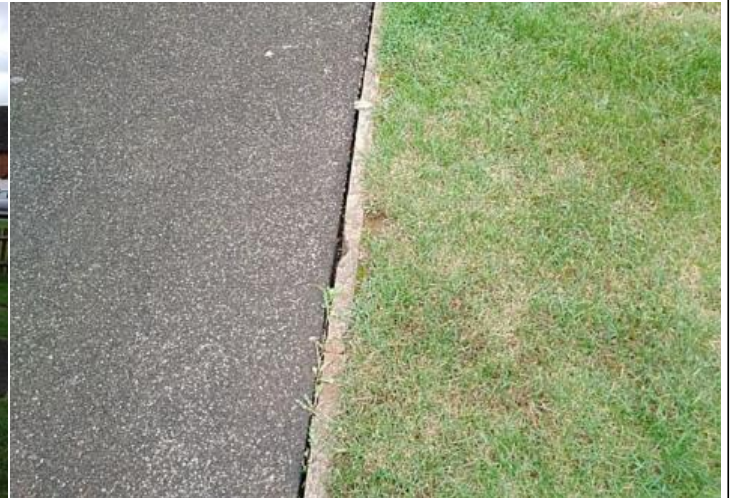
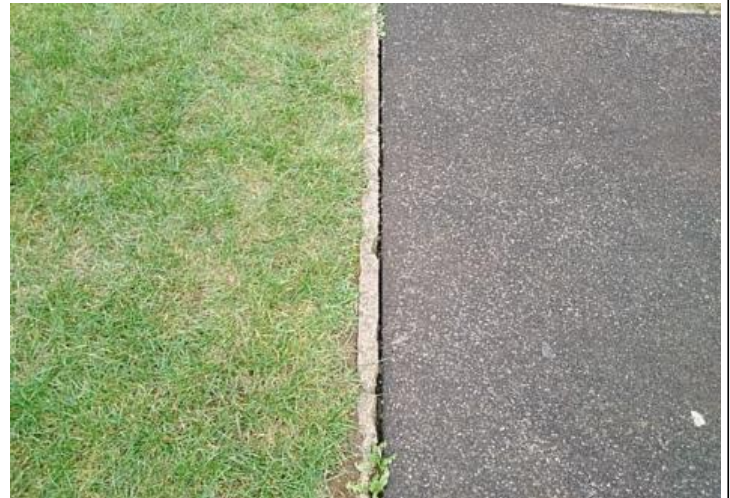
Finding: There is some damage to the concrete edging

Action: Monitor for any further deterioration and repair as required

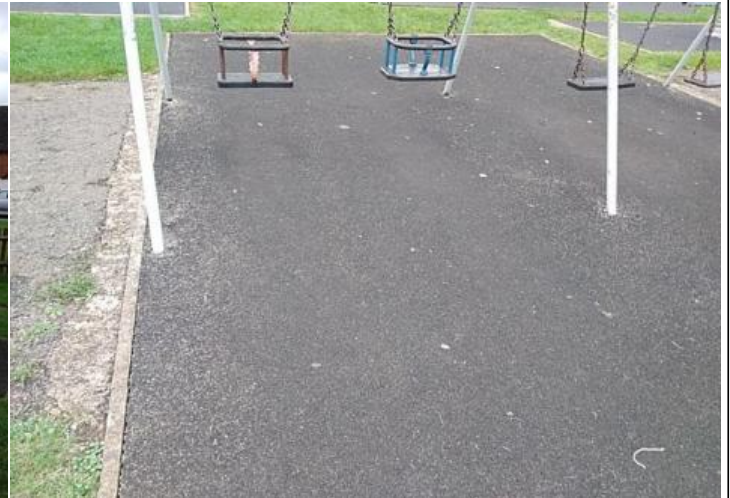
Finding: There is algae or moss growth on the surface resulting in slippery conditions

Action: Clean and treat appropriately

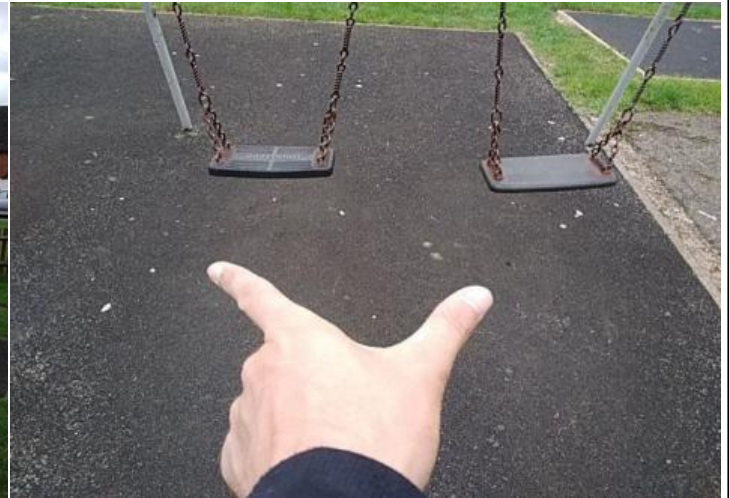
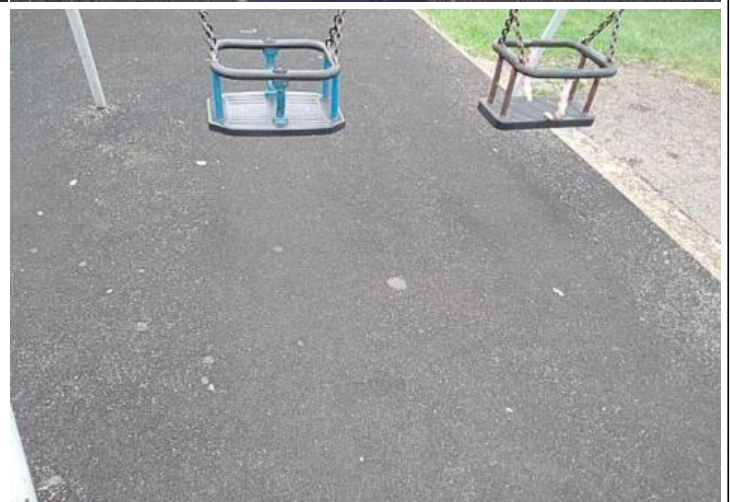
Finding: The safety surface around the area is beginning to wear
Action: Monitor for any further deterioration and repair as required

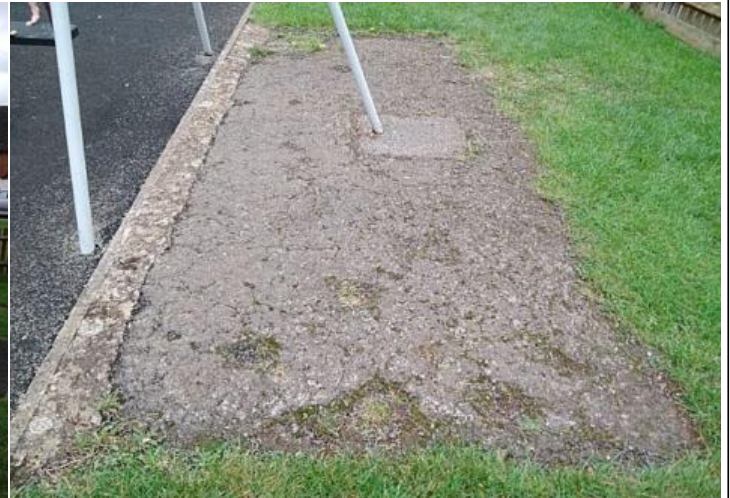
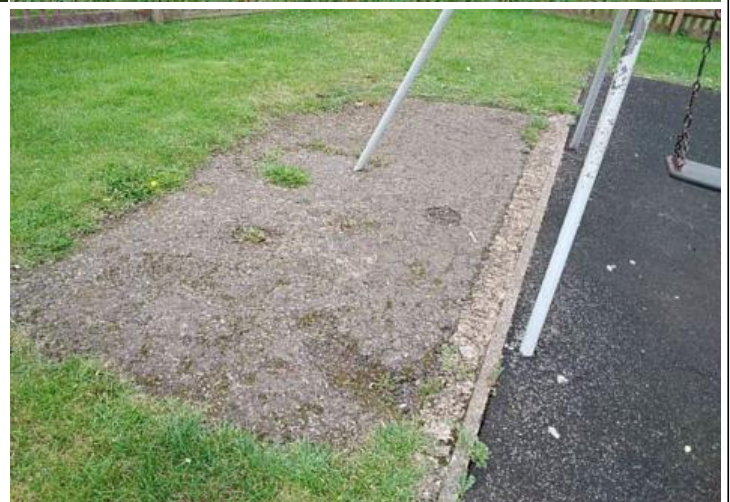
Finding: There is moderate damage to the surface

Action: Repair the damaged areas of surfacing

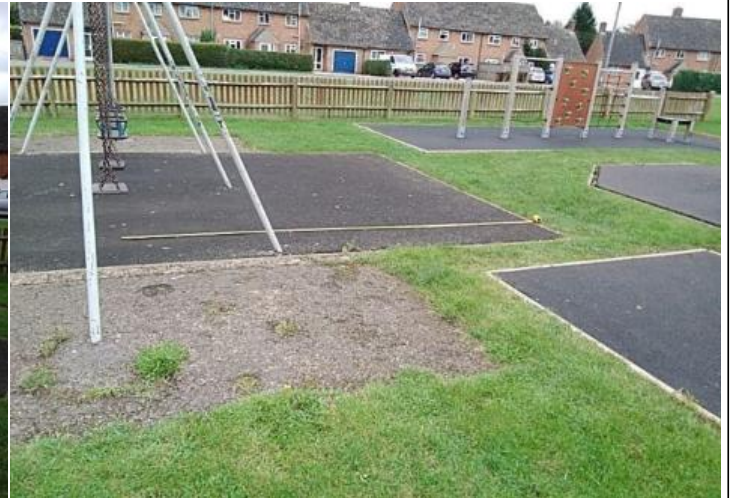
Finding: The concrete edging forms a hard object within the impact area of the equipment in contravention of the requirements of BS EN 1176 Part 1
Action: Monitor - No remedial work recommended

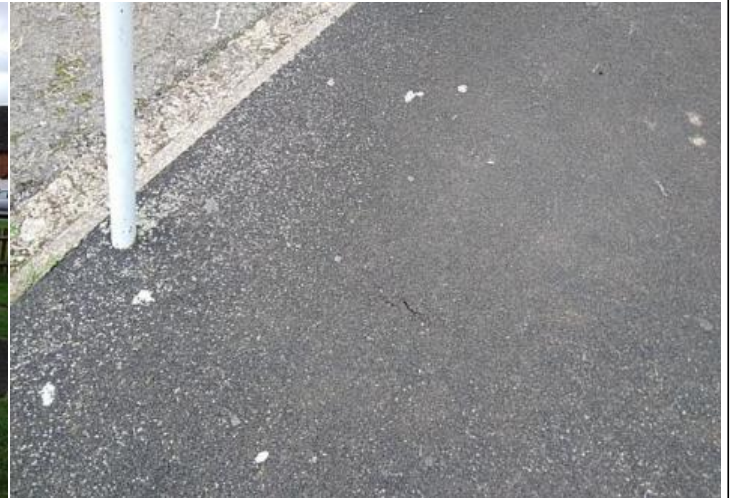
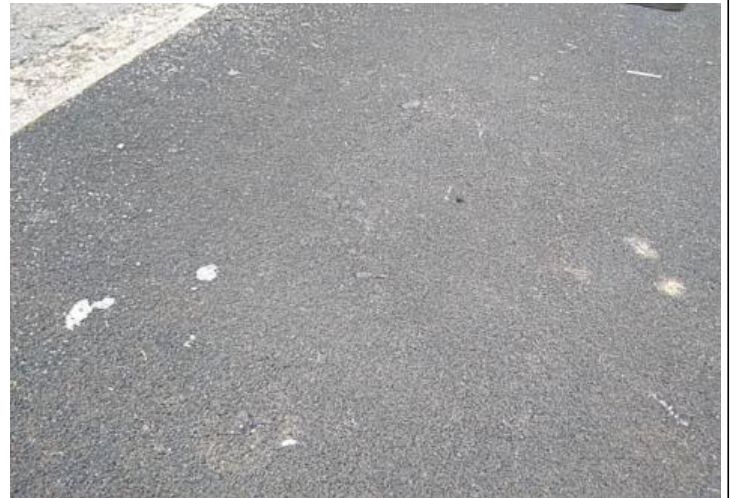
Finding: There is some minor damage to the surface

Action: Monitor for any further deterioration and repair as required

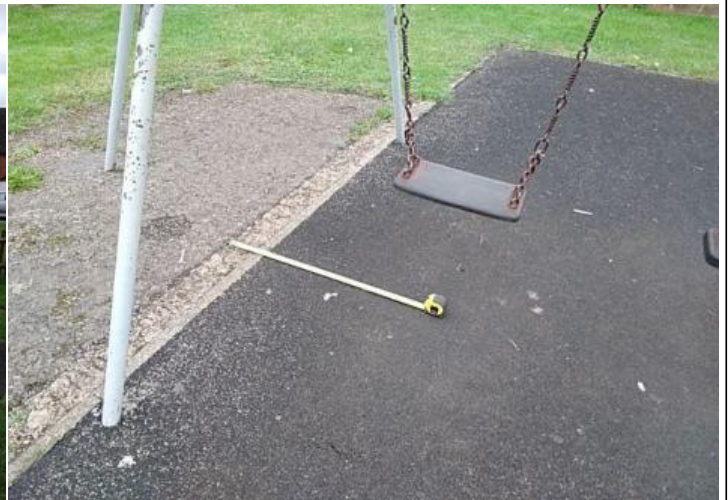
Finding: The surfacing width under each seat is less than 1.75 metres and fails the requirements of BS EN 1176 Part 2

Action: Monitor - No remedial work recommended

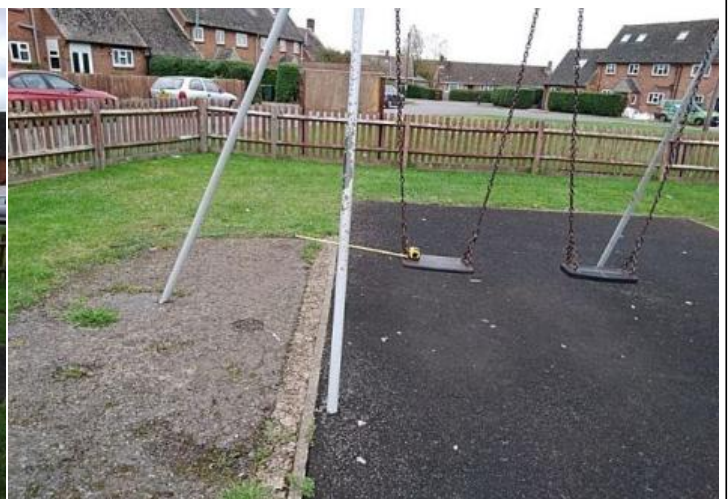
Finding: The seats are too close to the frame as defined in BS EN 1176 Part 2; this is a low risk failure and no remedial action is required

Action: Monitor - No remedial work recommended

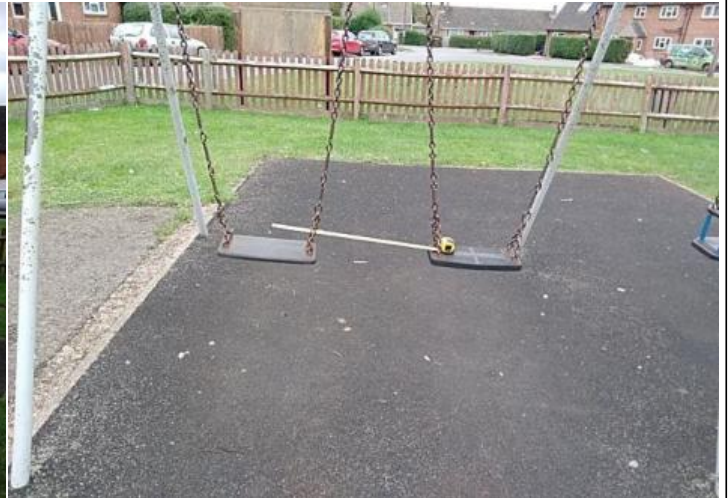
Finding: The seats are too close to each other as defined in BS EN 1176 Part 2; this is a low risk failure and no remedial action is required
Action: Monitor - No remedial work recommended

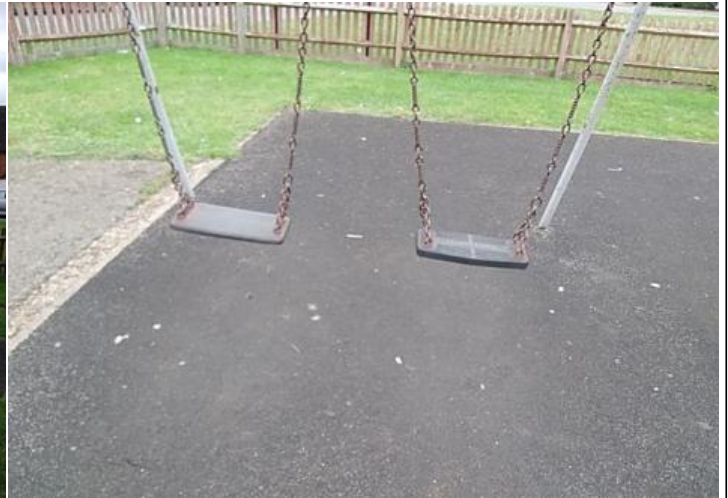
Finding: The swing seat connectors are loose

Action: Tighten to secure

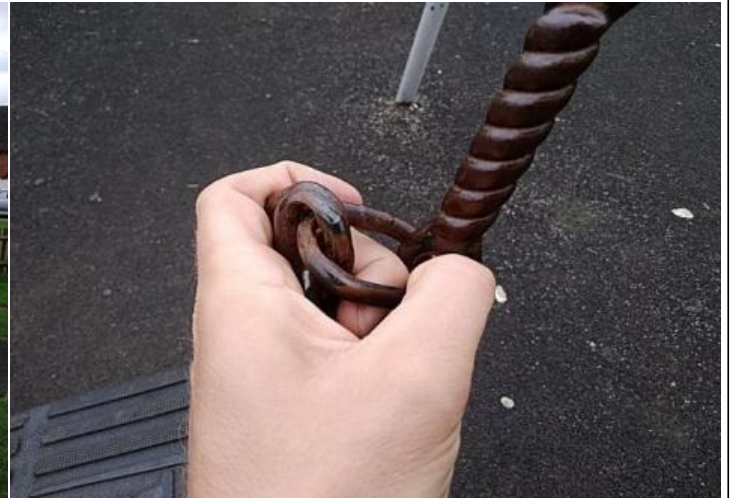
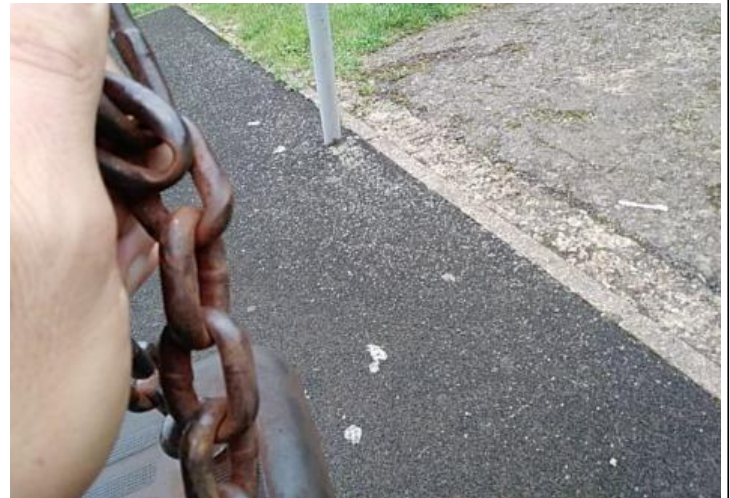
Finding: The chain links are worn in excess of 60% and require renewing

Action: Replace worn chains

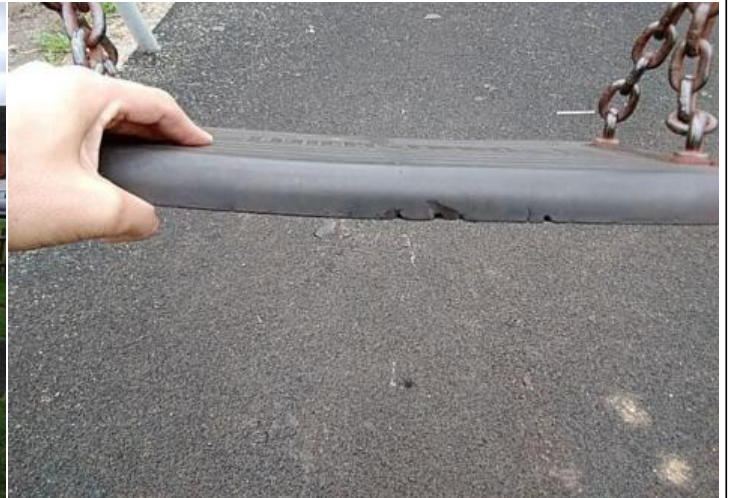
Finding: The seat has minor damage or wear

Action: Monitor for any further deterioration and replace as required

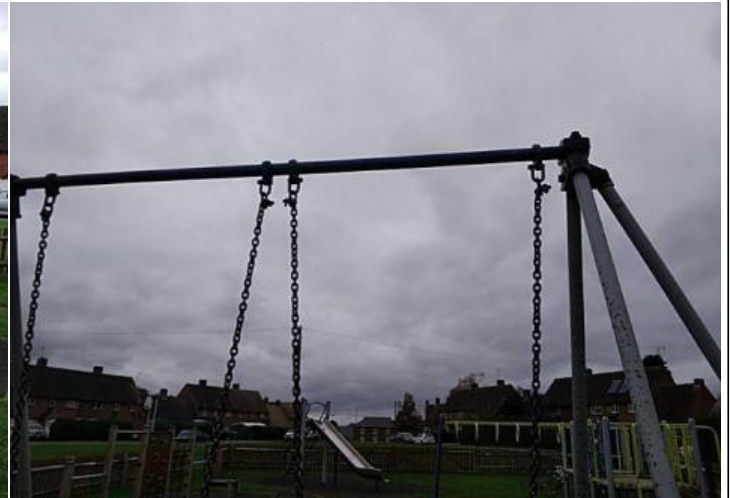
Finding: There is some wear to the shackles

Action: Monitor for any further deterioration and replace when 40% worn

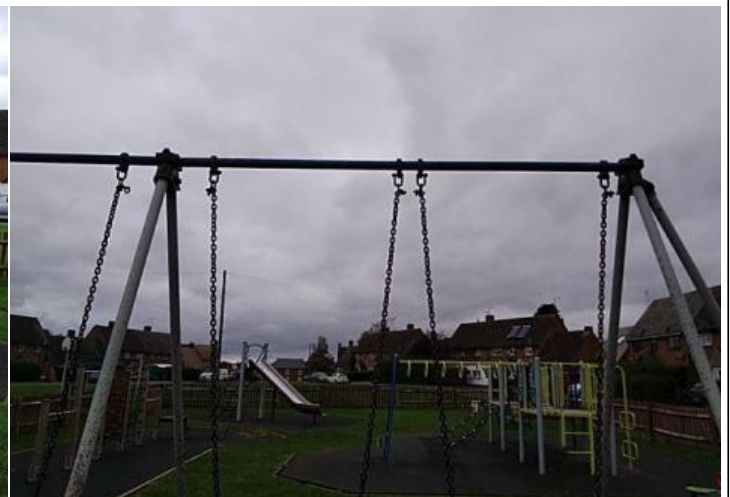
Finding: The bushes are showing signs of wear

Action: Monitor for any further deterioration and replace as required

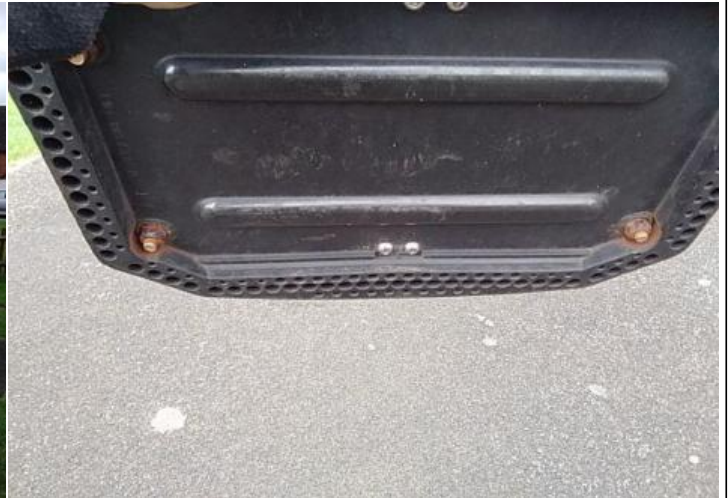
Finding: There is surface corrosion present on the fixings

Action: Replace all corroded fixings

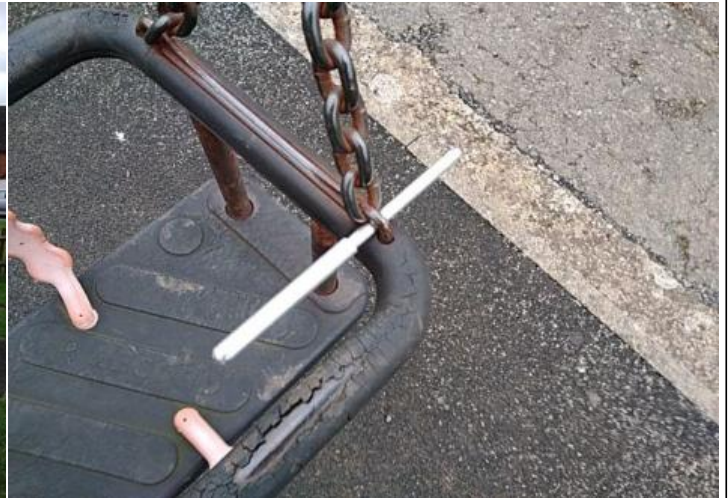
Finding: The connecting links are in excess of 8.6mm and less than 12mm and fail the requirements of BS EN 1176 Part 1; clause 4.2.13, Chains

Action: Monitor use and replace with compliant links at the next maintenance cycle

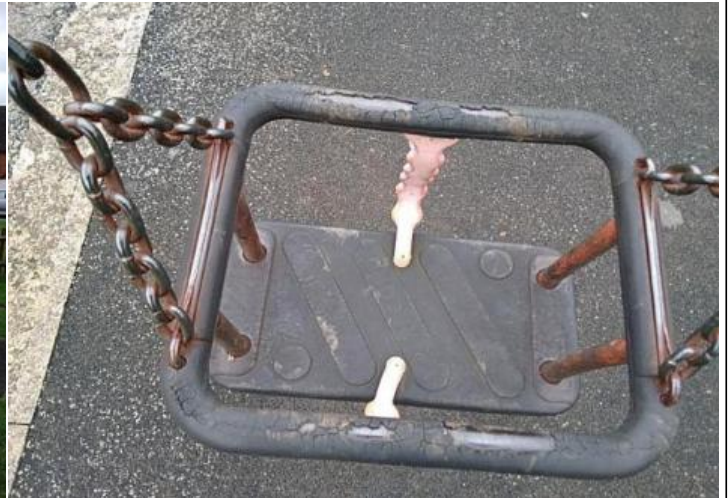
Finding: The seat is severely damaged and requires replacing

Action: Replace damaged seat

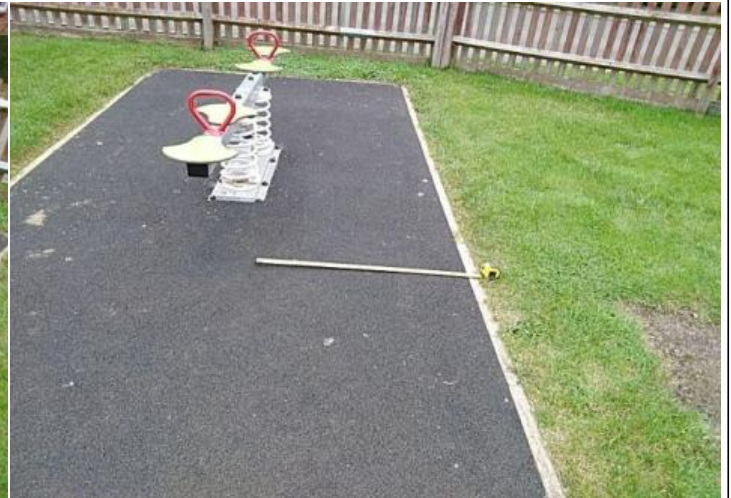
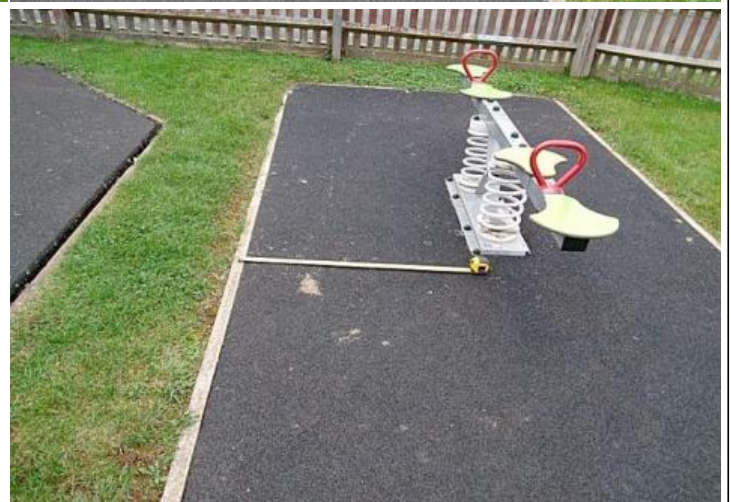
Finding: The concrete edging forms a hard object within the impact area of the equipment in contravention of the requirements of BS EN 1176 Part 1
Action: Monitor - No remedial work recommended

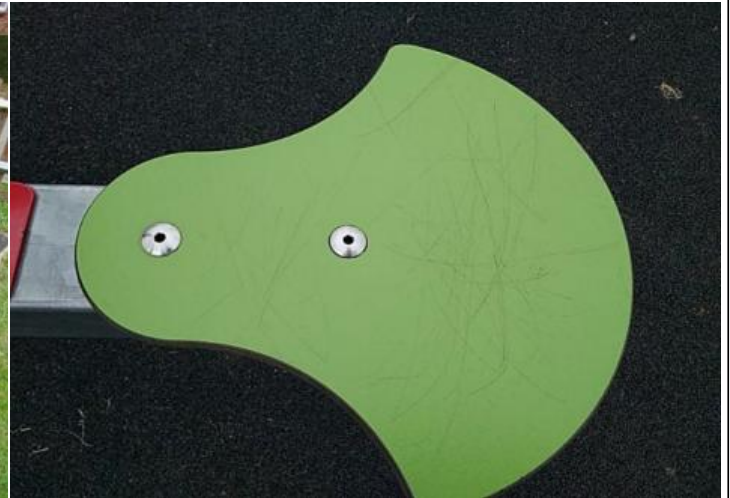
Finding: There is some damage to the item

Action: Monitor for any further deterioration and repair as required

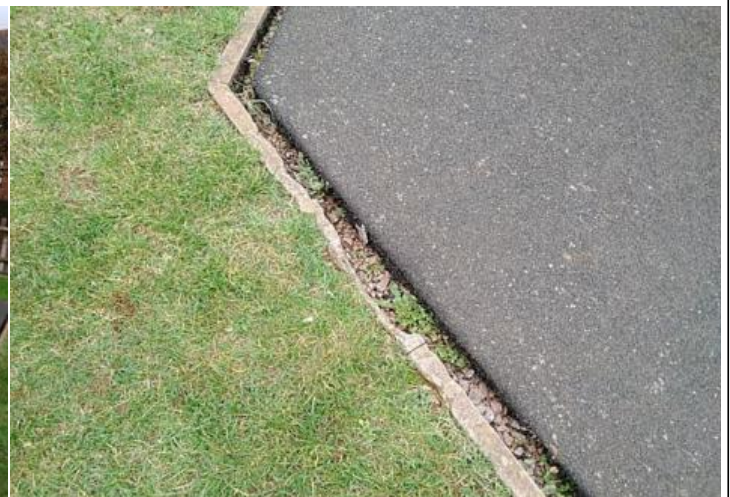
Finding: There is some damage to the concrete edging

Action: Replace all affected areas

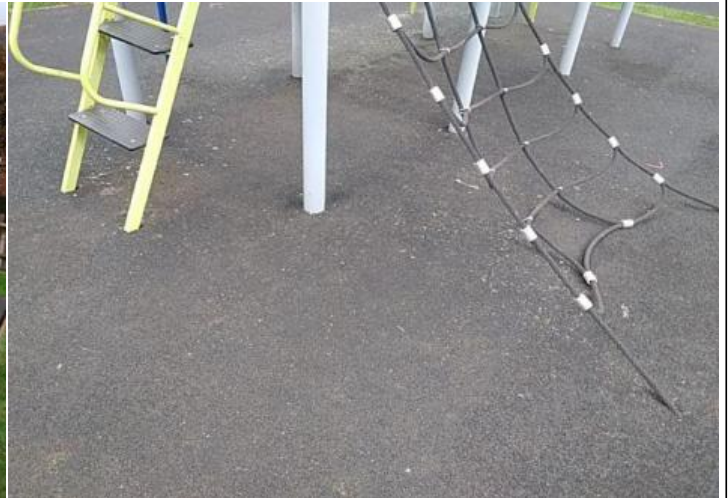
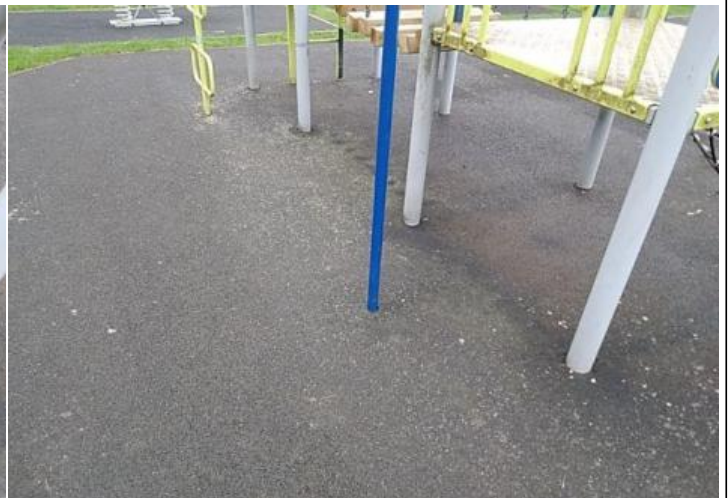
Finding: There is algae or moss growth on the surface resulting in slippery conditions

Action: Clean and treat appropriately

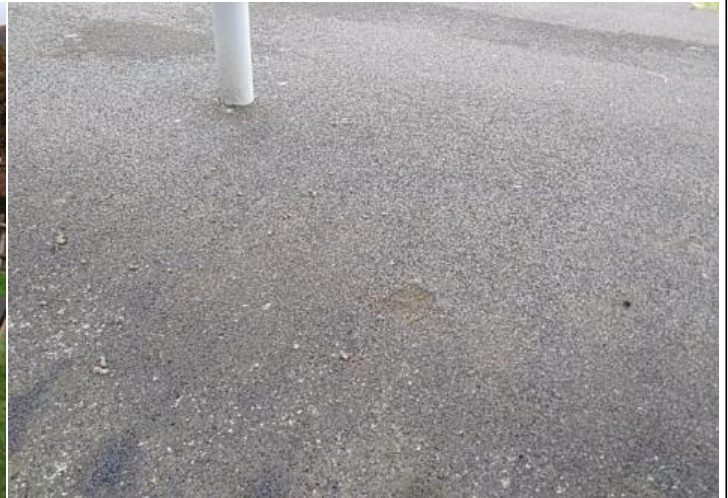
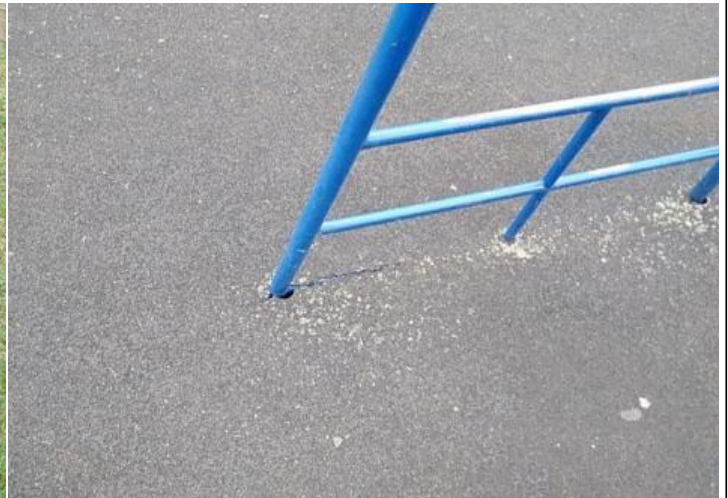
Finding: There is some minor damage to the surface

Action: Monitor for any further deterioration and repair as required

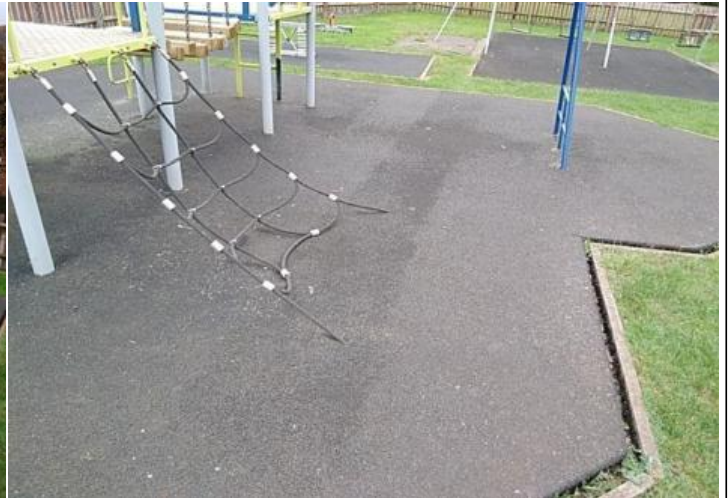
Finding: The safety surface around the area is beginning to wear
Action: Monitor for any further deterioration and repair as required

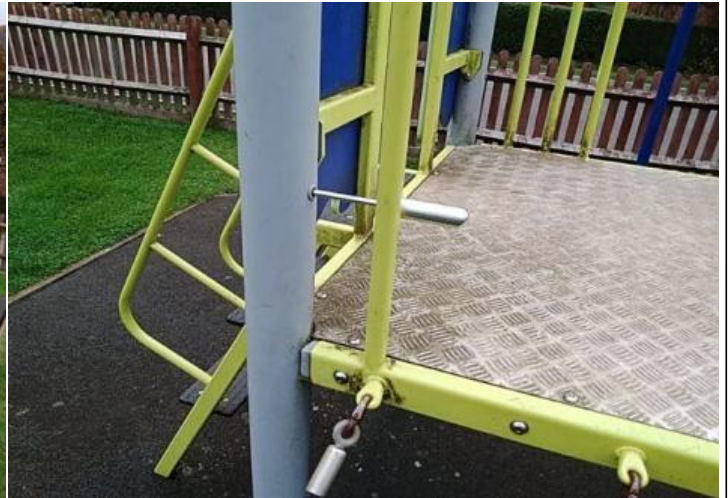
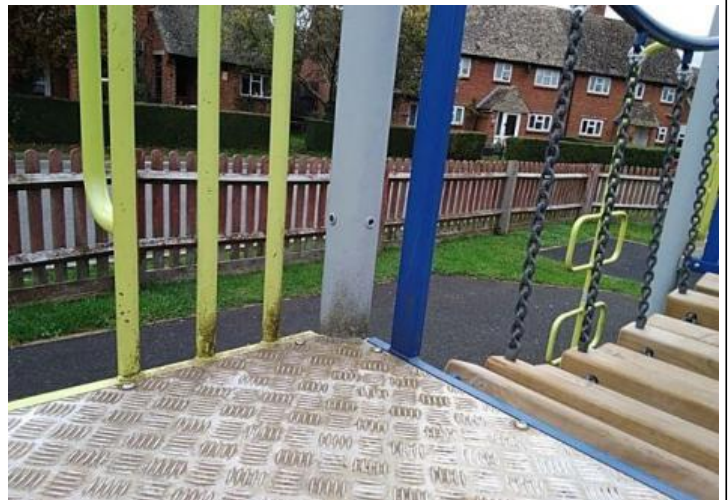
Finding: There is/are finger entrapment/s in the posts due to missing inserts and the item fails to meet the requirements of BS EN 1176 Part 1 4.2.7.6 Entrapment of fingers

Action: Provide inserts to remove the entrapment

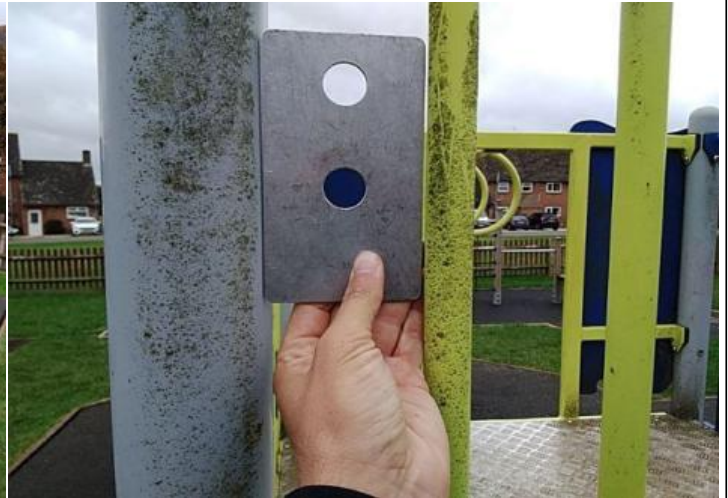
Finding: The item fails to meet the requirements of BS EN 1176 Part 1 4.2.7.2 head and neck entrapment in the barriers and/or steps

Action: Monitor - No remedial work recommended

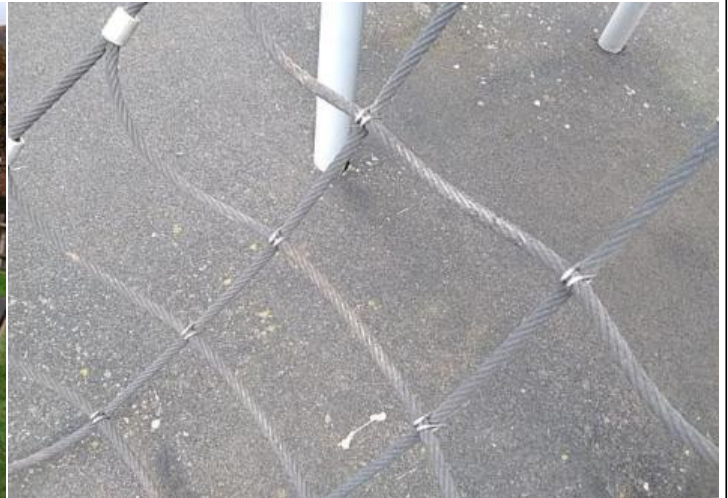
Finding: The ropes/nets are worn/damaged in places

Action: Monitor for any further deterioration and repair or replace as required

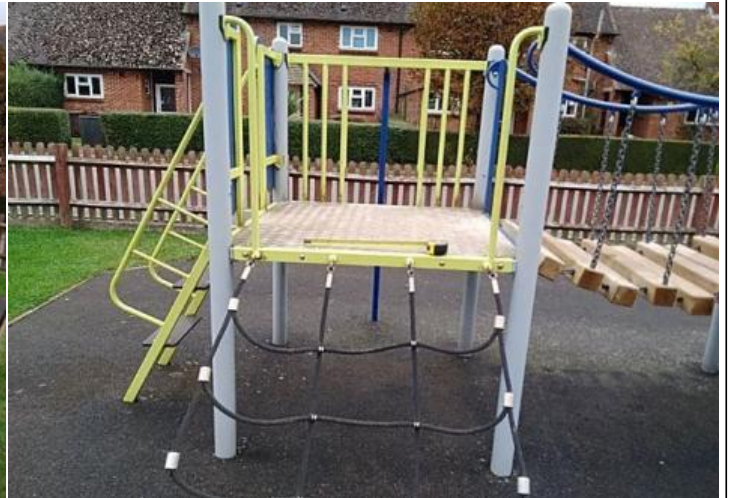
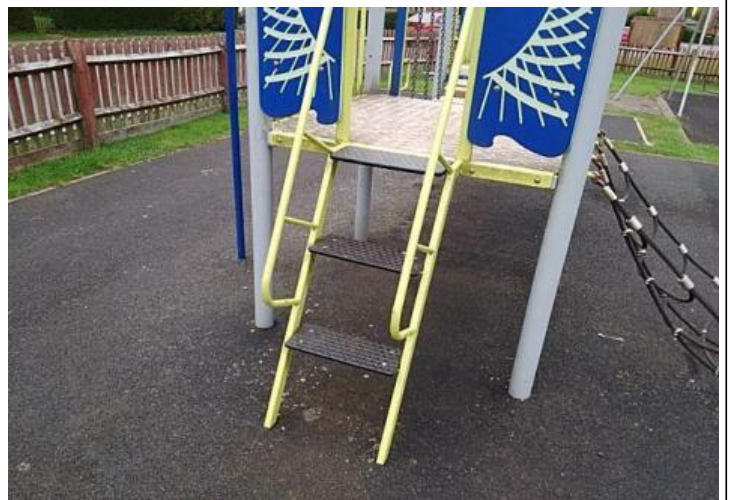
Finding: The unit is easily accessible and has an opening in the barrier to steep play elements in excess of 500mm in contravention of BS EN 1176 Part 1
Action: Monitor - No remedial work recommended

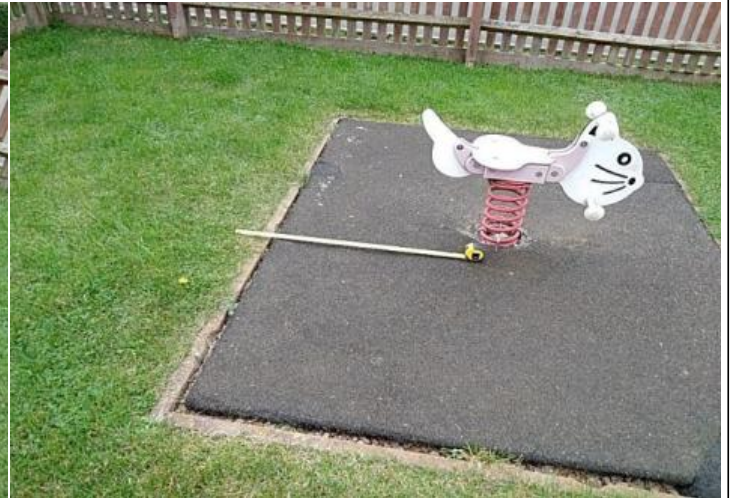
Finding: The concrete edging forms a hard object within the impact area of the equipment in contravention of the requirements of BS EN 1176 Part 1
Action: Monitor - No remedial work recommended

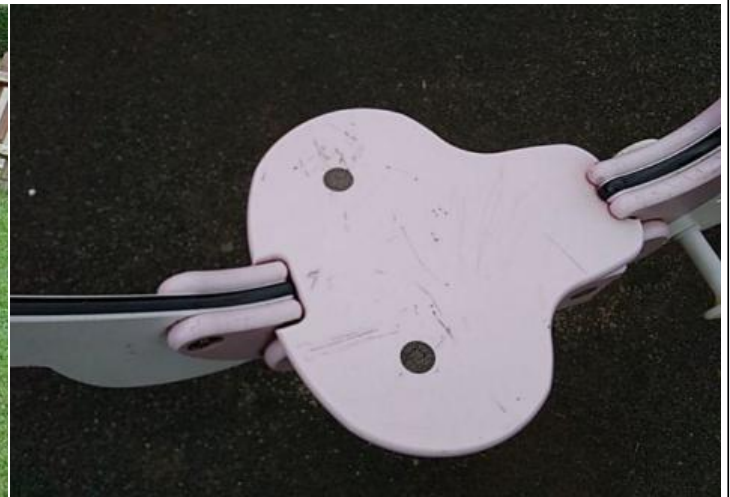
Finding: There is some damage to the seat

Action: Monitor for any further deterioration and repair as required

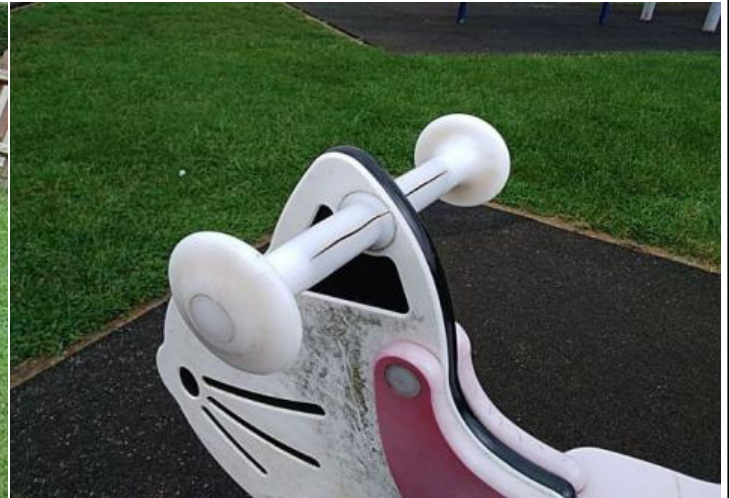
Finding: There is some damage to the handlebars

Action: Monitor for any further deterioration and repair as required

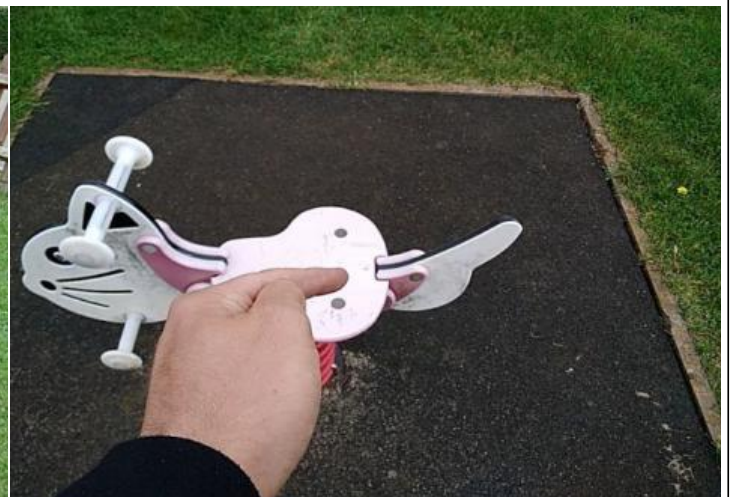
Finding: A number of fixing(s) have worked loose

Action: Secure all loose fixings

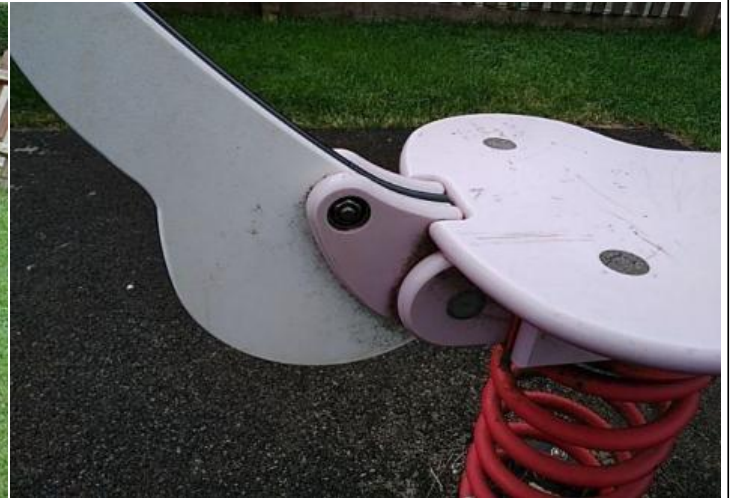
Finding: There is/are bolt cap covers missing or damaged on the item

Action: Replace missing or damaged bolt cap covers

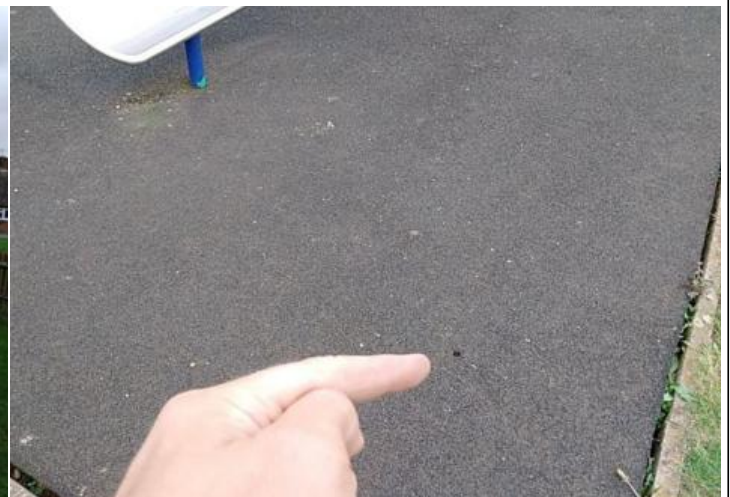
Finding: There is some minor damage to the surface

Action: Monitor for any further deterioration and repair as required

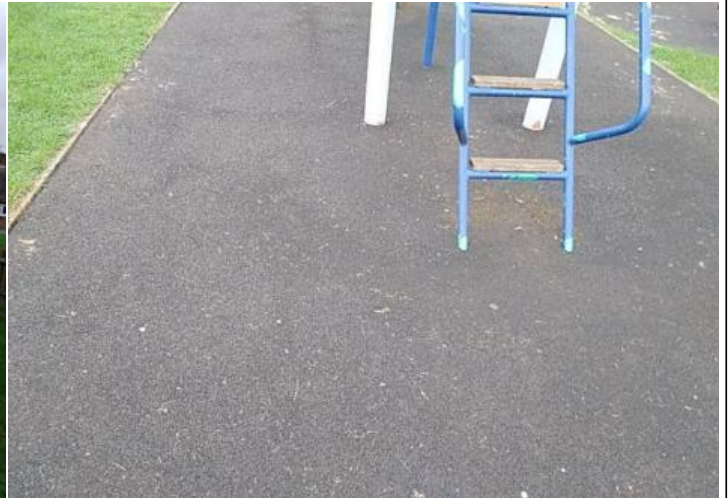
Finding: The safety surface around the area is beginning to wear
Action: Monitor for any further deterioration and repair as required

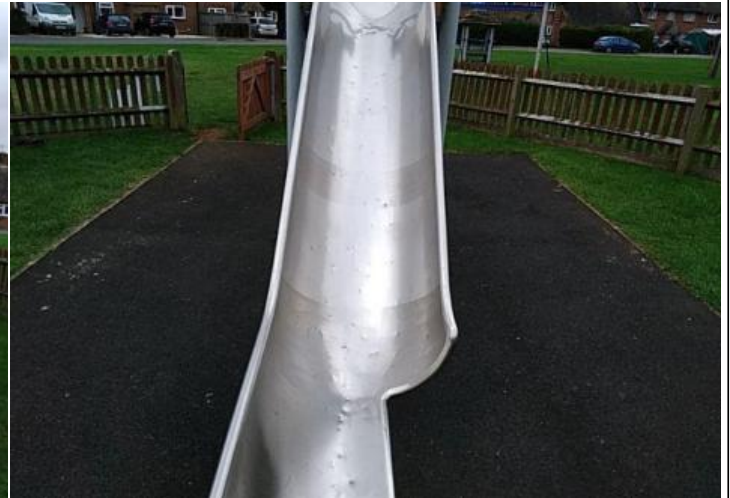
Finding: There are a number of dents in the slide surface

Action: Monitor for any further deterioration and repair as required

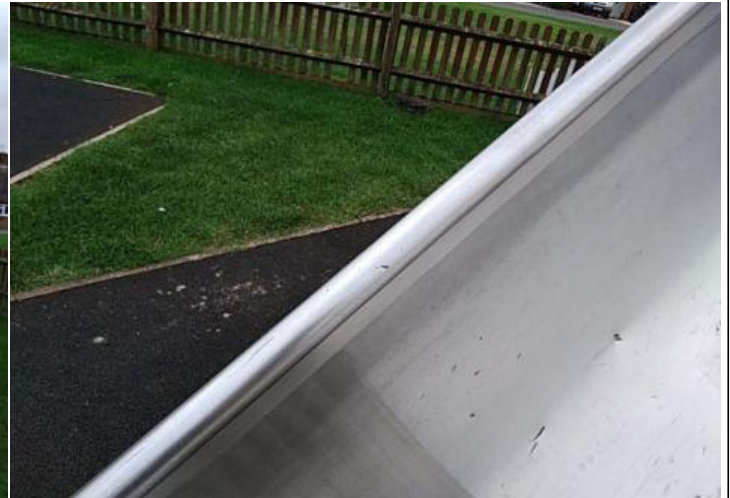
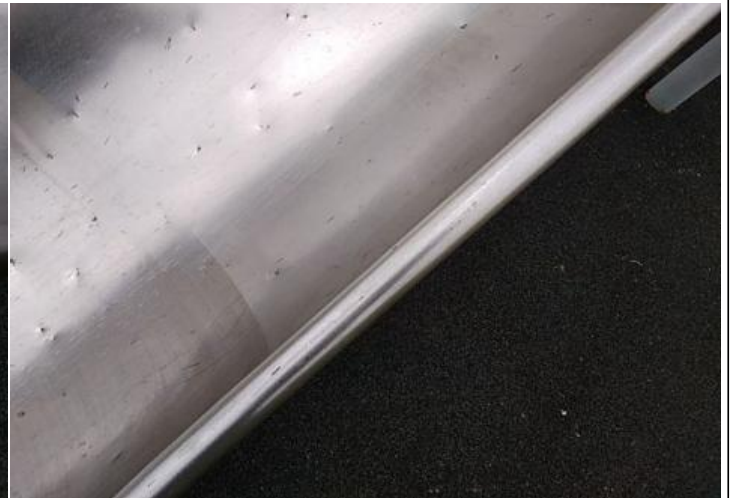
Finding: The side of the slide is damaged

Action: Monitor for any further deterioration and repair as required
