the play inspection company

Annual Inspection

Adderbury Parish Council

The Rise

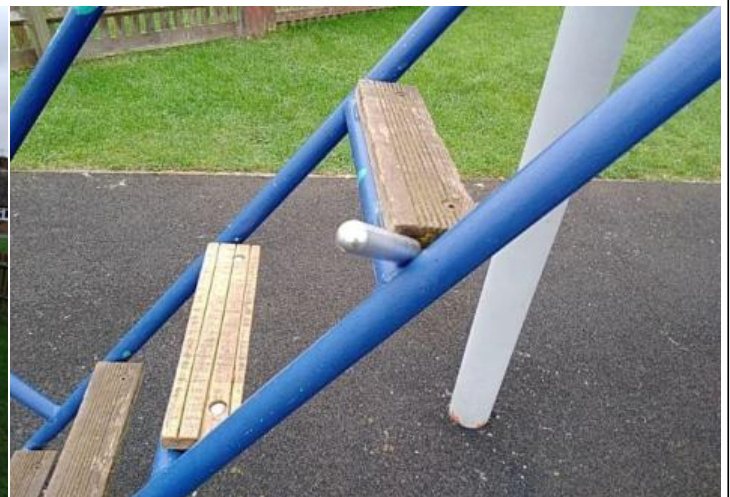
Finding: There is/are finger entrapment/s in the steps and the item fails to meet the requirements of BS EN 1176 Part 1 4.2.7.6 Entrapment of fingers

Action: Monitor - No remedial work recommended

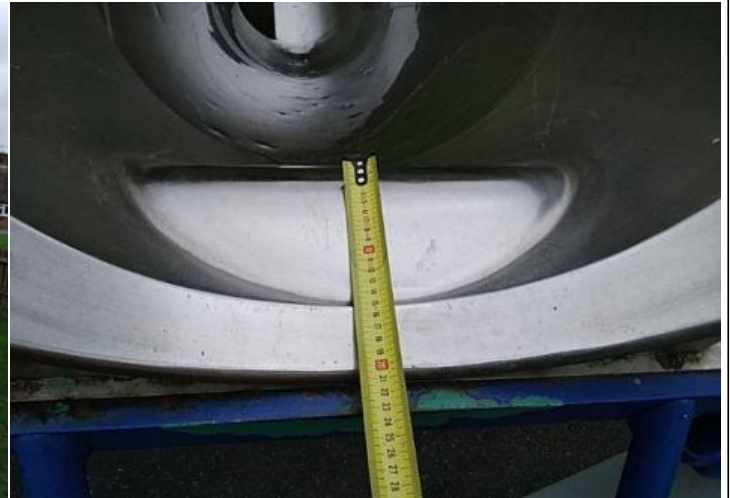
Finding: The slide start section is less than 350mm long and fails the requirements of BS EN 1176 Part 3

Action: Monitor - No remedial work recommended

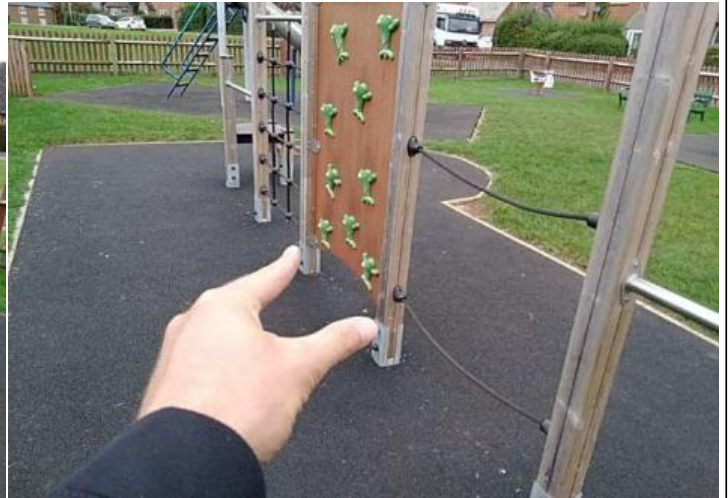
Finding: The item is slightly loose in its foundations

Action: Monitor for any further deterioration and repair as required

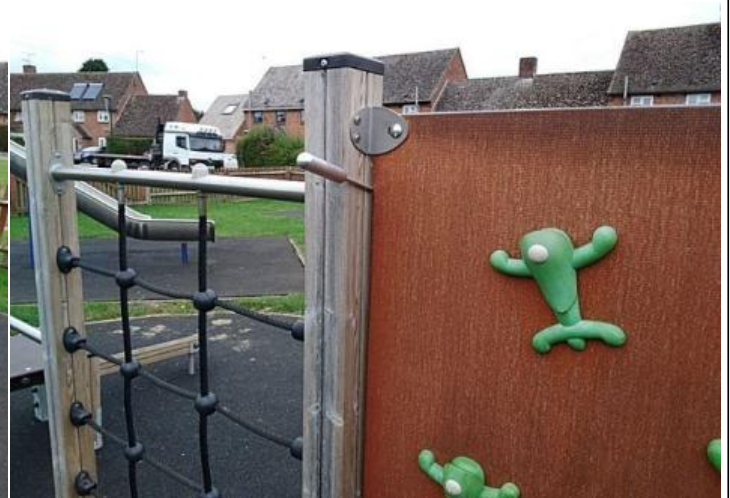
Finding: There is/are finger entrapment/s in the climbing wall and the item fails to meet the requirements of BS EN 1176 Part 1 4.2.7.6 Entrapment of fingers

Action: Monitor - No remedial work recommended

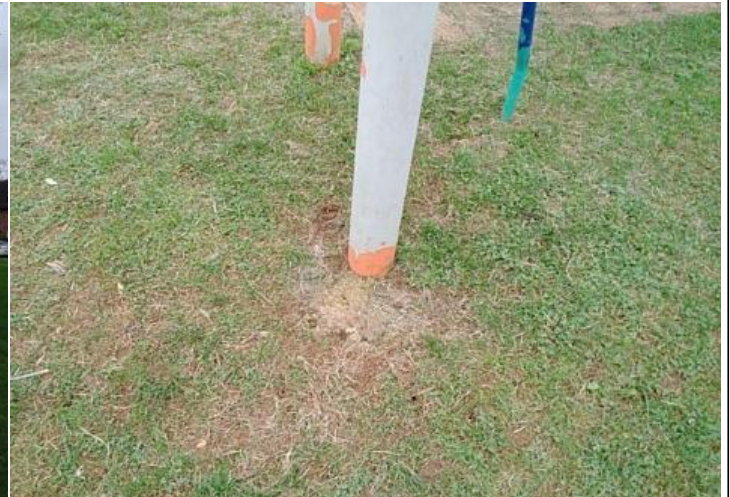
Finding: The surface has eroded and the foundations are exposed

Action: Reinstate the surrounding surfaces

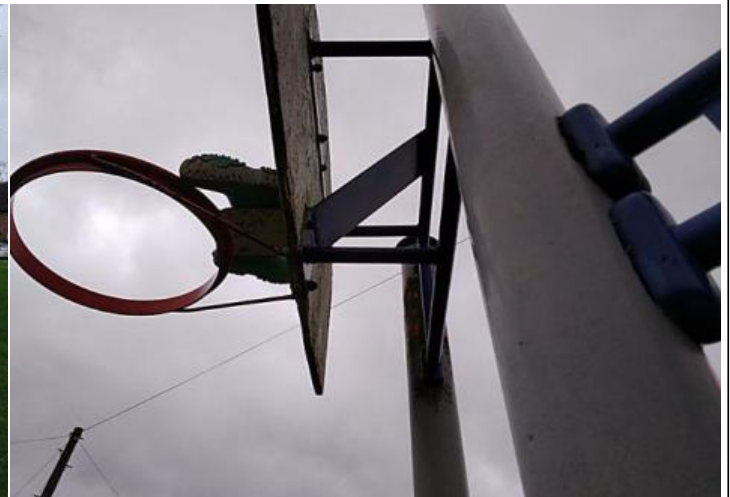
Finding: The free space between the backboard and the framework is less than 600mm and fails the requirements of BS EN15312:2007 +A1 2010

Action: Monitor - No remedial work recommended

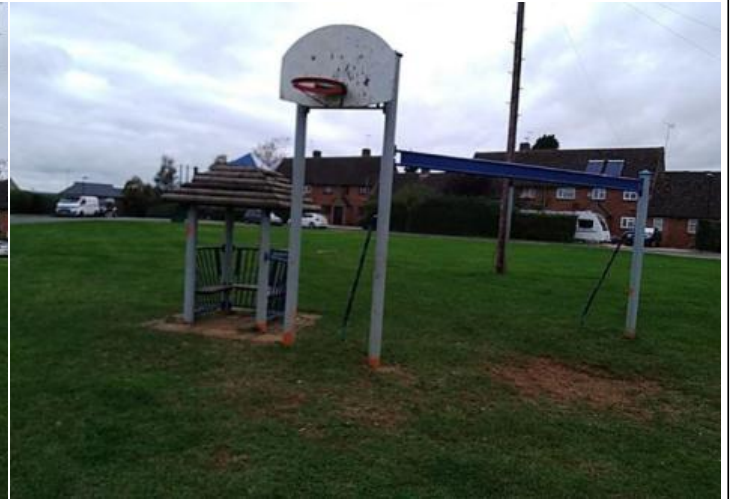
Finding: The proximity of the basketball structure to the shelter may cause conflict between users

Action: Monitor use

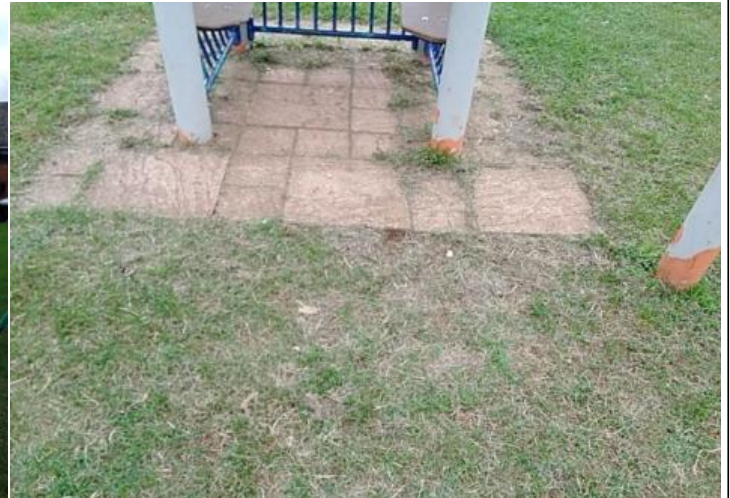
Finding: There are trip hazards at the edges of the surface

Action: Reinstate surrounding surface levels to remove the trip points

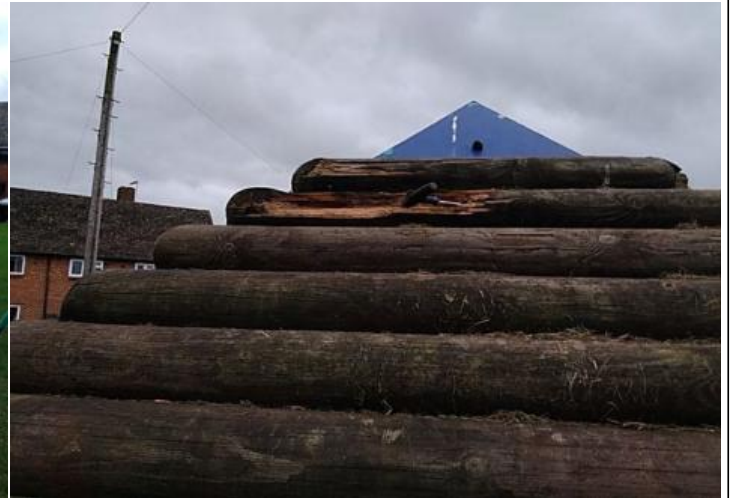
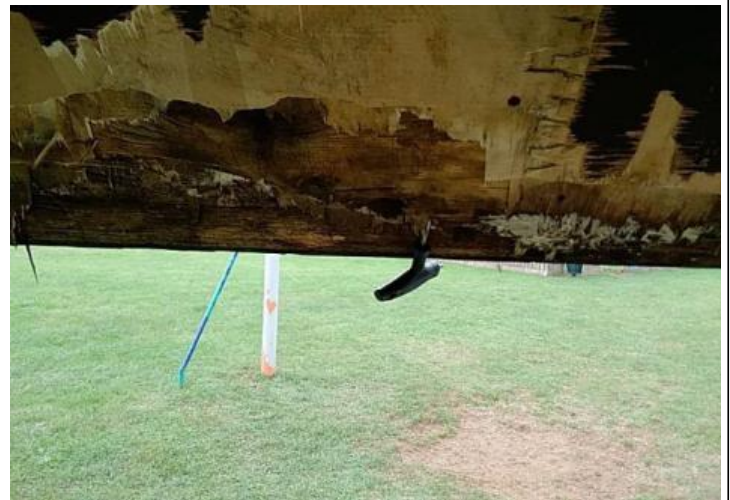
Finding: There are areas or parts of the timber roof have rotted

Action: Replace all affected timbers

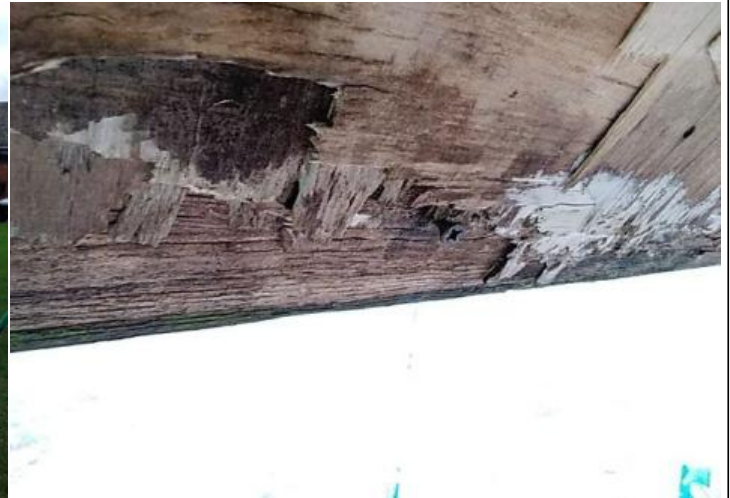
Finding: There are projecting screw ends present

Action: Replace rotting timber and provide more appropriate fixings if required
