ADDERBURY – BENCHES RECORD

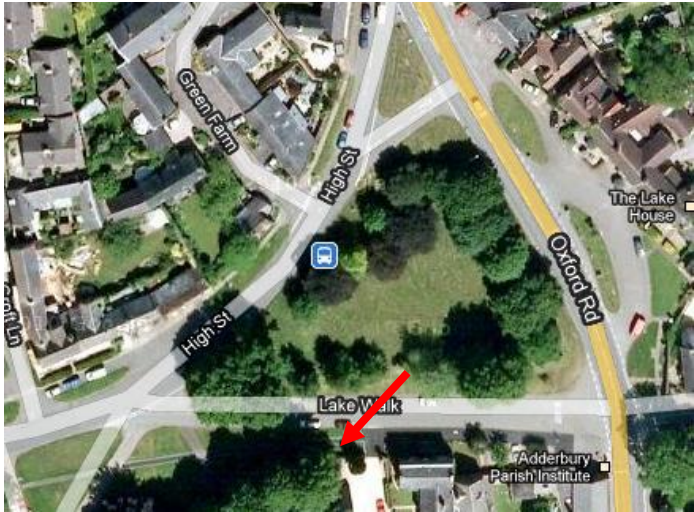
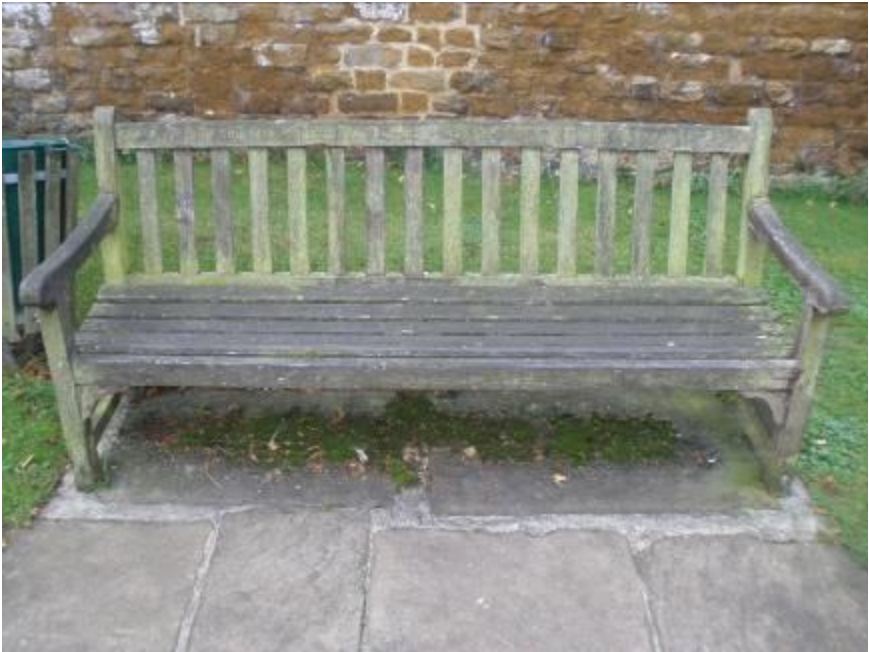
SERIAL NO:	ADD/01
LOCATION: Southern side of The Green.

DATE ERECTED:	1977	
FRAME CONSTRUCTION:	Four legged wooden frame	
FRAME FINISH:	Oiled	
SEAT CONSTRUCTION:	Wooden seat slats with vertical wooden slat back rest	
SEAT FINISH:	Oiled	
ANY INSCRIPTIONS?	Engraving – SEE FROM THIS SEAT THREE OAKS NEW SEAT FOR THE QUEEN IN THE JUBILEE YEAR 1977	
COMMENTS ON CONDITION:	Structure is sound. Wood has become greyed with age and with minor greening.	
DATE PICTURE TAKEN AND INSPECTION MADE: 12 October 2010 MAINTENANCE RECOMMENDATION: Sand down and re-oil if deemed necessary.

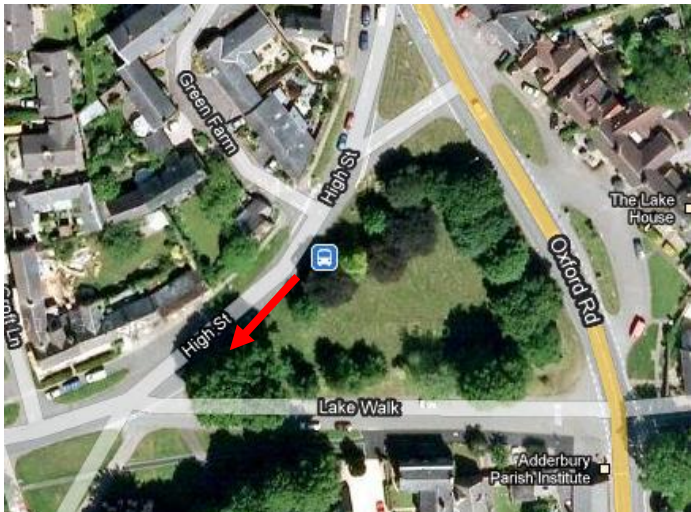
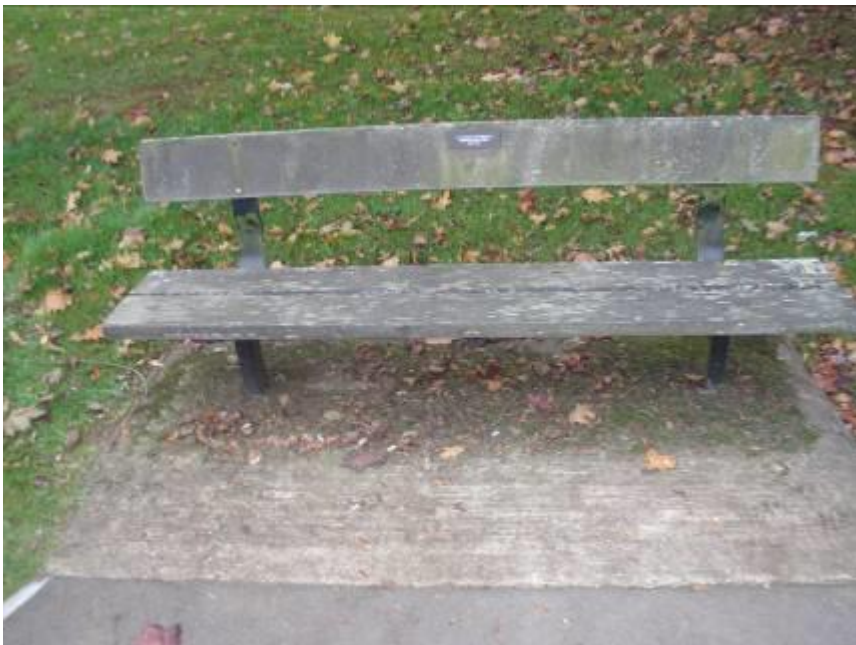
SERIAL NO:	ADD/03
LOCATION: On the Green by the bus stop on the High Street opposite The Coach & Horses.

DATE ERECTED:	1994	
FRAME CONSTRUCTION:	Two legged metal frame	
FRAME FINISH:	Powder coated dark grey	
SEAT CONSTRUCTION:	Two wooden slats / single horizontal wooden slat back rest	
SEAT FINISH:	Oiled	
ANY INSCRIPTIONS?	Plaque: To commemorate the Centenary of ADDERBURY PARISH COUNCIL 1894 - 1994	
COMMENTS ON CONDITION:	Structure is sound. Wood has become greened with age with some lichen growth.	
DATE PICTURE TAKEN AND INSPECTION MADE: 12 October 2010 MAINTENANCE RECOMMENDATION: Sand down and re-oil if deemed necessary.

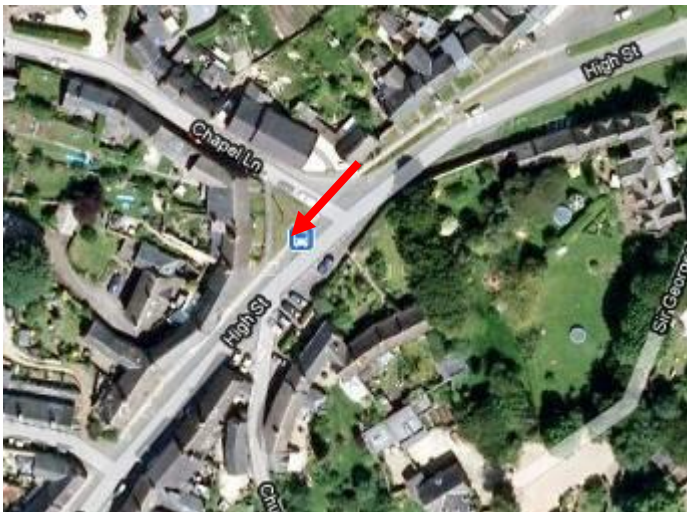
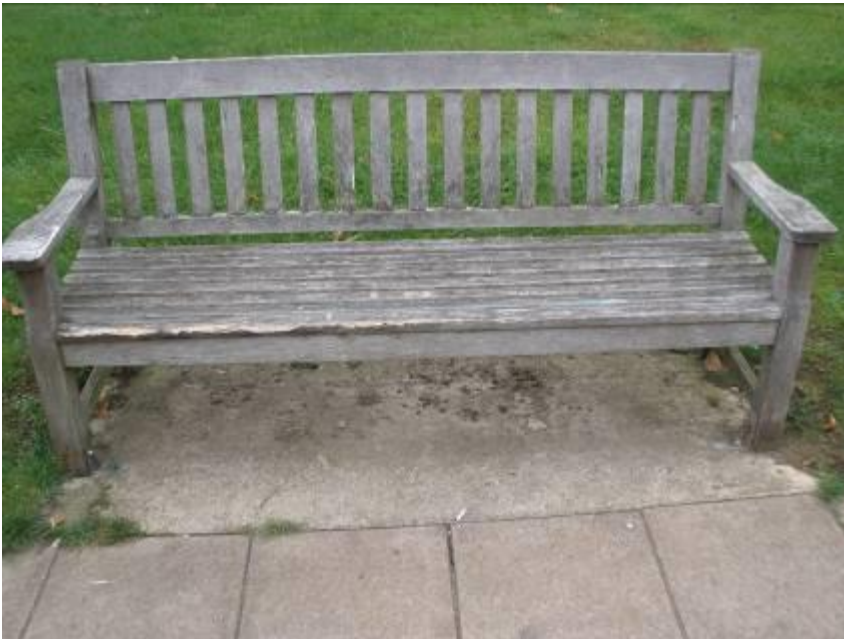
SERIAL NO:	ADD/04
LOCATION: At the bus stop on the corner of High Street and Chapel Lane.

DATE ERECTED:	Unknown	
FRAME CONSTRUCTION:	Four legged wooden frame	
FRAME FINISH:	Oiled	
SEAT CONSTRUCTION:	Wooden seat slats with vertical wooden slat back rest	
SEAT FINISH:	Oiled	
ANY INSCRIPTIONS?	No	
COMMENTS ON CONDITION:	Structure is sound. Wood has greyed with little/no lichen growth.	
DATE PICTURE TAKEN AND INSPECTION MADE: 12 October 2010 MAINTENANCE RECOMMENDATION: Sand down and re-oil if deemed necessary.

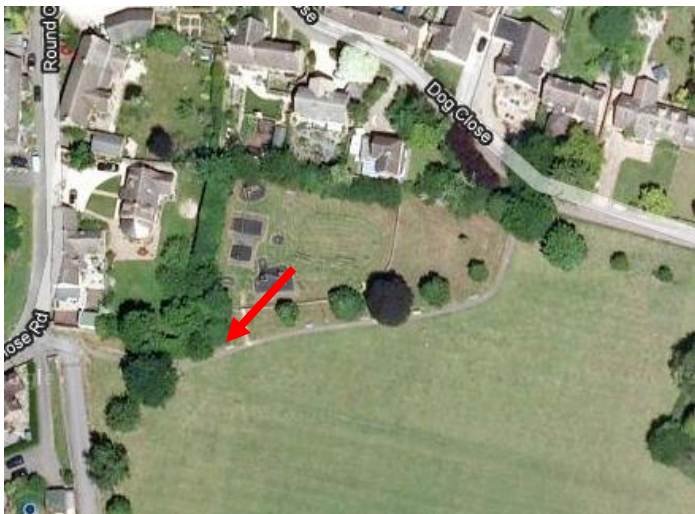
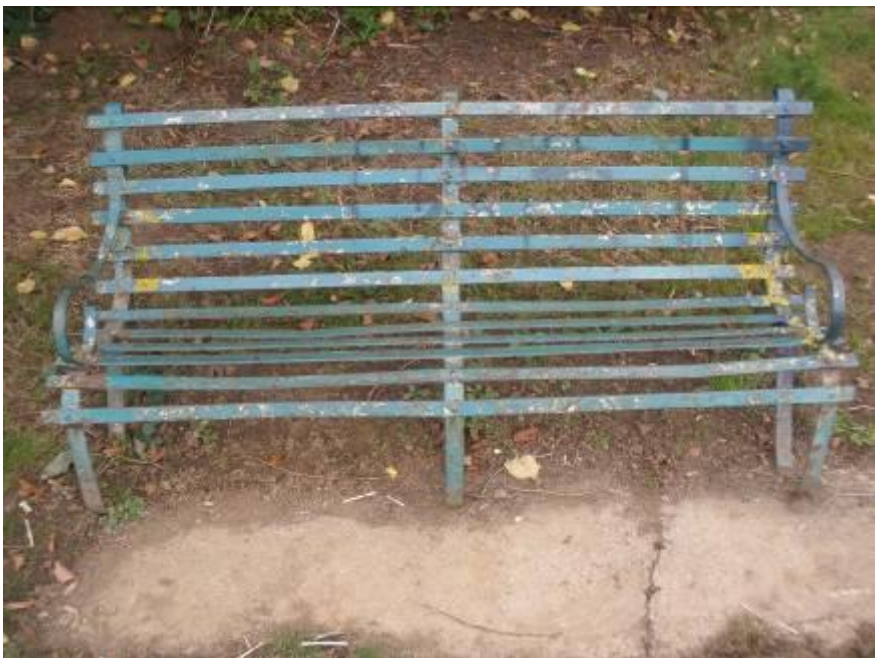
SERIAL NO:	ADD/05
LOCATION: Along the main path through the Lucy Placket playing field.

DATE ERECTED:	Unknown	
FRAME CONSTRUCTION:	Six legged metal frame	
FRAME FINISH:	Painted blue/green	
SEAT CONSTRUCTION:	Horizontal metal slats for seat and back rest	
SEAT FINISH:	Painted blue/green	
ANY INSCRIPTIONS?	No	
COMMENTS ON CONDITION:	Structure is generally sound but some seat slats are bent. Some rust patches and lichen growth.	
DATE PICTURE TAKEN AND INSPECTION MADE: 12 October 2010 MAINTENANCE RECOMMENDATION: Straighten bent seat slats. Sand blast old paint and rust and then prime and repaint. OR REPLACE.

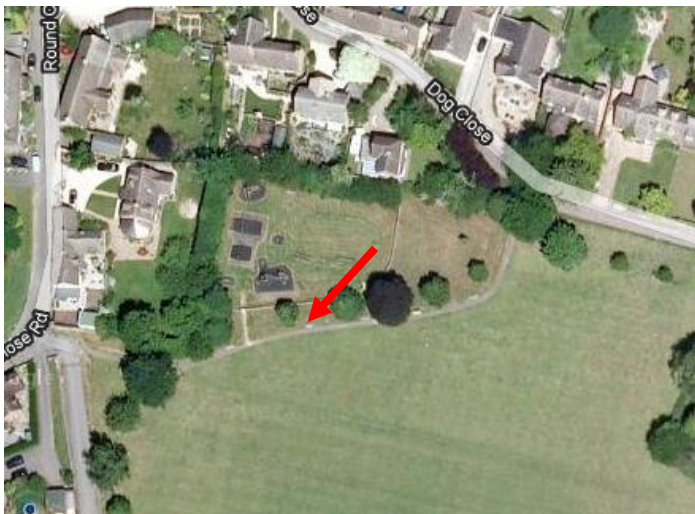
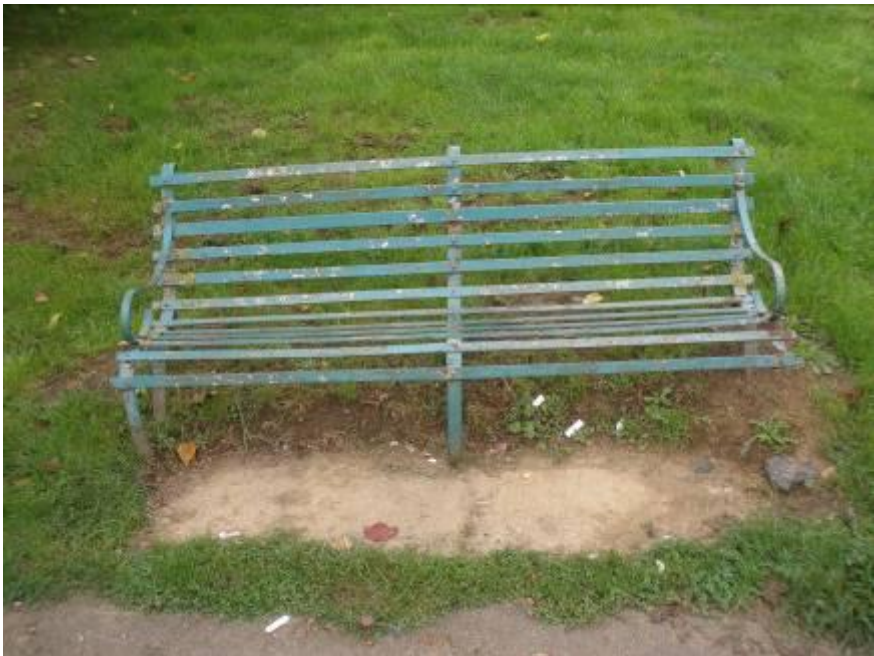
SERIAL NO:	ADD/06
LOCATION: Along the main path through the Lucy Placket playing field.

DATE ERECTED:	Unknown	
FRAME CONSTRUCTION:	Six legged metal frame	
FRAME FINISH:	Painted blue/green	
SEAT CONSTRUCTION:	Horizontal metal slats for seat and back rest	
SEAT FINISH:	Painted blue/green	
ANY INSCRIPTIONS?	No	
COMMENTS ON CONDITION:	The front right leg of the bench has broken off. Some rust patches and lichen growth.	
DATE PICTURE TAKEN AND INSPECTION MADE: 12 October 2010 MAINTENANCE RECOMMENDATION: Weld on new metal leg. Sand blast old paint and rust and then prime and repaint. OR REPLACE.

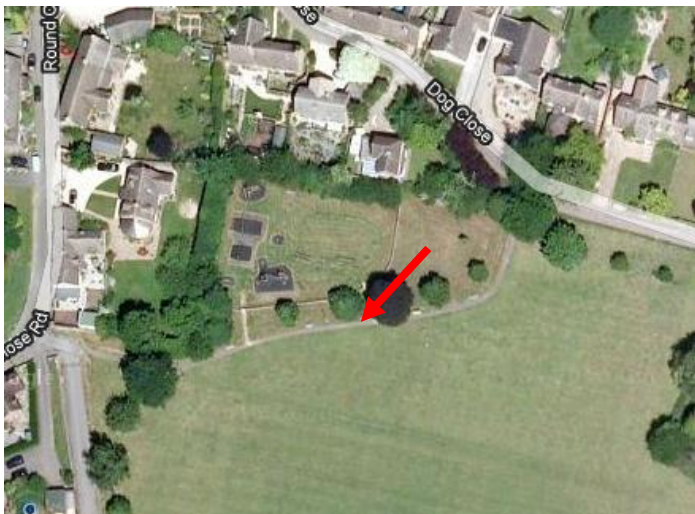
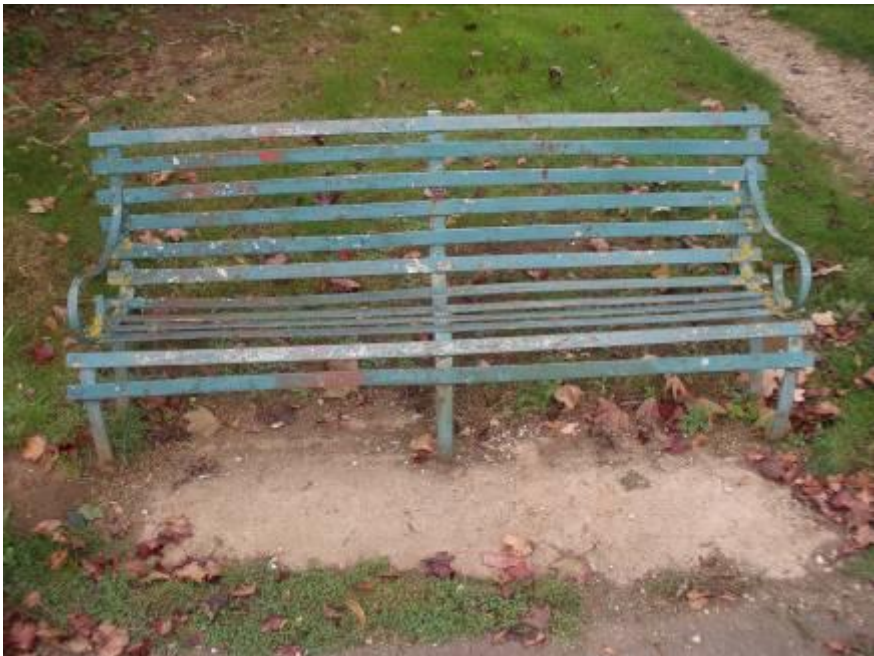
SERIAL NO:	ADD/07
LOCATION: Along the main path through the Lucy Placket playing field.

DATE ERECTED:	Unknown	
FRAME CONSTRUCTION:	Six legged metal frame	
FRAME FINISH:	Painted blue/green	
SEAT CONSTRUCTION:	Horizontal metal slats for seat and back rest	
SEAT FINISH:	Painted blue/green	
ANY INSCRIPTIONS?	No	
COMMENTS ON CONDITION:	Structure is generally sound but some seat slats are bent. Some rust patches and lichen growth.	
DATE PICTURE TAKEN AND INSPECTION MADE: 12 October 2010 MAINTENANCE RECOMMENDATION: Straighten bent seat slats. Sand blast old paint and rust and then prime and repaint. OR REPLACE.

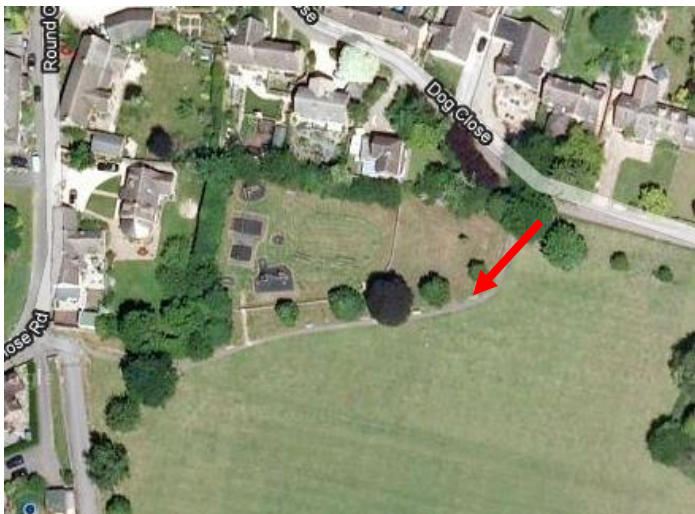
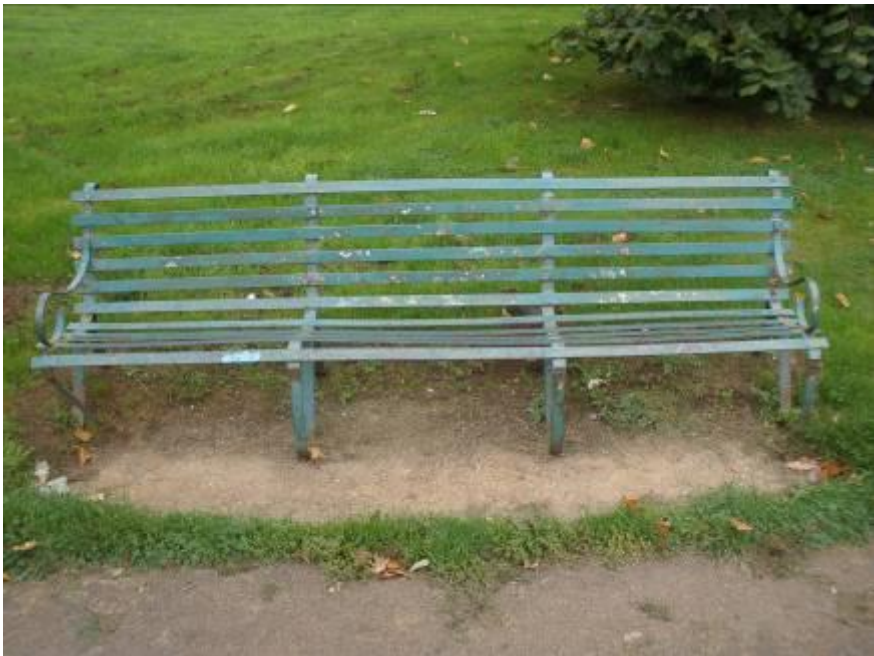
SERIAL NO:	ADD/09
LOCATION: Along the main path through the Lucy Placket playing field.

DATE ERECTED:	Unknown	
FRAME CONSTRUCTION:	Eight legged metal frame	
FRAME FINISH:	Painted blue/green	
SEAT CONSTRUCTION:	Horizontal metal slats for seat and back rest	
SEAT FINISH:	Painted blue/green	
ANY INSCRIPTIONS?	Brass plaque:	
COMMENTS ON CONDITION:	Structure is generally sound but some seat slats are bent. Some rust patches and lichen growth.	
DATE PICTURE TAKEN AND INSPECTION MADE: 12 October 2010 MAINTENANCE RECOMMENDATION: Straighten bent seat slats. Sand blast old paint and rust and then prime and repaint. Repair damaged front left leg. OR REPLACE.

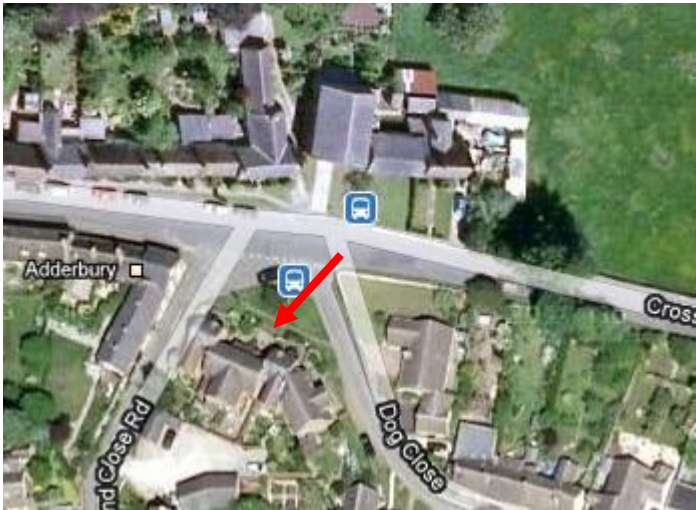
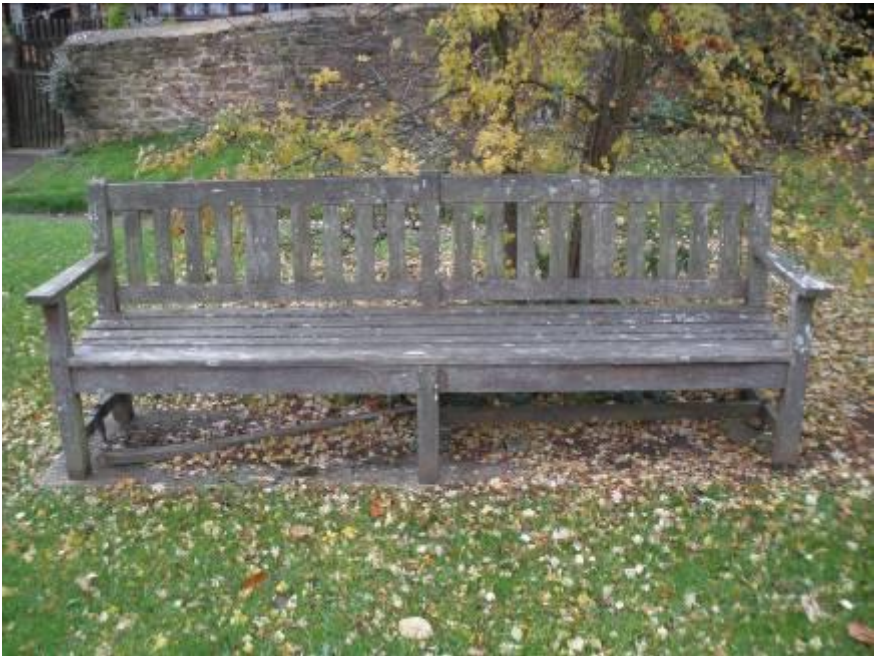
SERIAL NO:	ADD/10
LOCATION: At the junction of Round Close Road and Dog Close with Cross Hill Road – opposite the bus stop shelter.

DATE ERECTED:	Unknown	
FRAME CONSTRUCTION:	Six legged wooden frame	
FRAME FINISH:	Oiled	
SEAT CONSTRUCTION:	Horizontal wooden slats for seat and vertical for back rest	
SEAT FINISH:	Oiled	
ANY INSCRIPTIONS?	No	
COMMENTS ON CONDITION:	Structure is generally sound but supporting cross spar at bottom has broken on left hand side. Wood has become greyed with age and with minor greening.	
DATE PICTURE TAKEN AND INSPECTION MADE: 12 October 2010 MAINTENANCE RECOMMENDATION: Replace cross spar. Sand down and re-oil if deemed necessary.

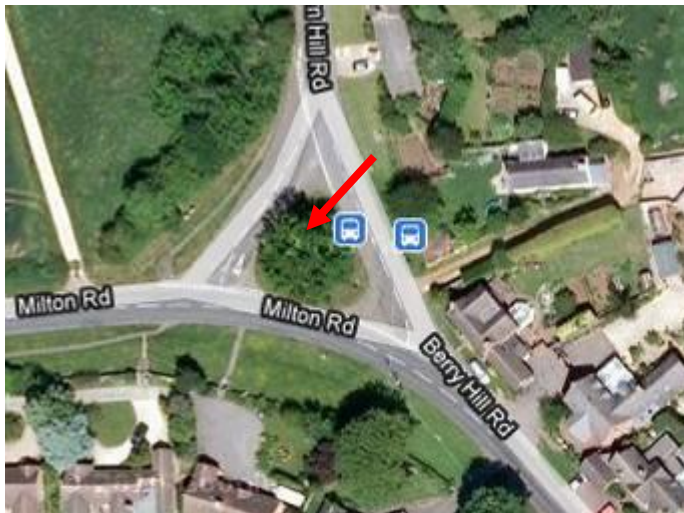
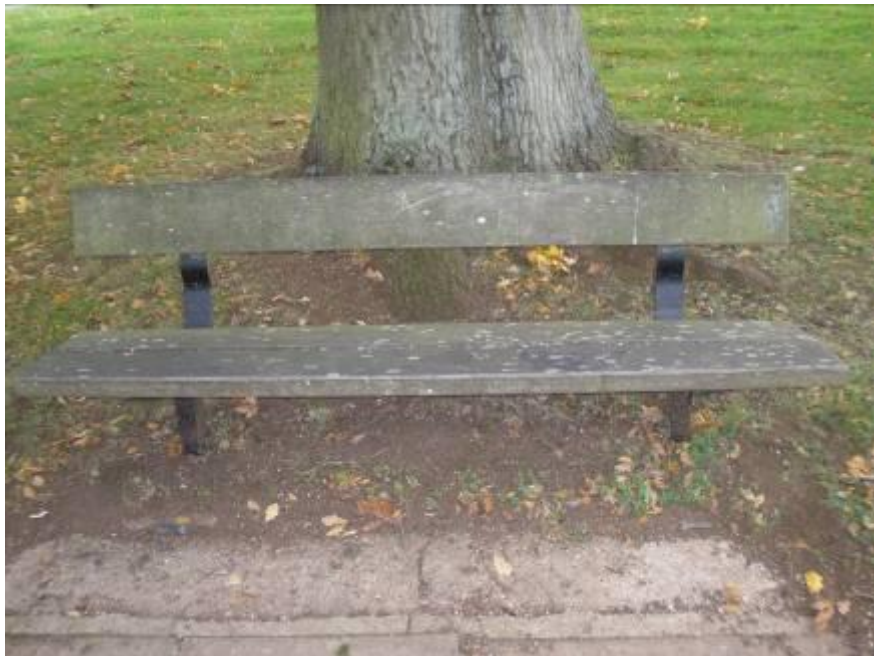
SERIAL NO:	ADD/12
LOCATION: Underneath the oak tree at the junction of Milton Road, Berry Hill Road and Horn Hill Road.

DATE ERECTED:	Unknown	
FRAME CONSTRUCTION:	Two legged metal frame	
FRAME FINISH:	Powder coated black	
SEAT CONSTRUCTION:	Horizontal wooden slats for seat and one for back rest	
SEAT FINISH:	Oiled	
ANY INSCRIPTIONS?	No	
COMMENTS ON CONDITION:	Structure is sound. Wood is greyed with minor greening.	
DATE PICTURE TAKEN AND INSPECTION MADE: 12 October 2010 MAINTENANCE RECOMMENDATION: Sand down and re-oil if deemed necessary.

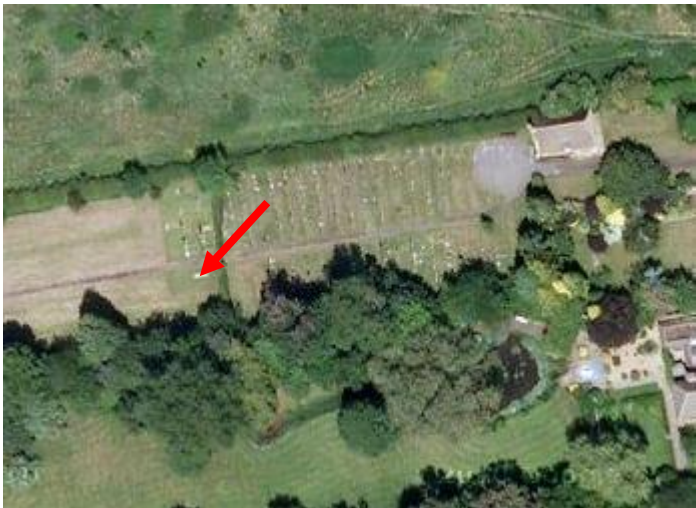
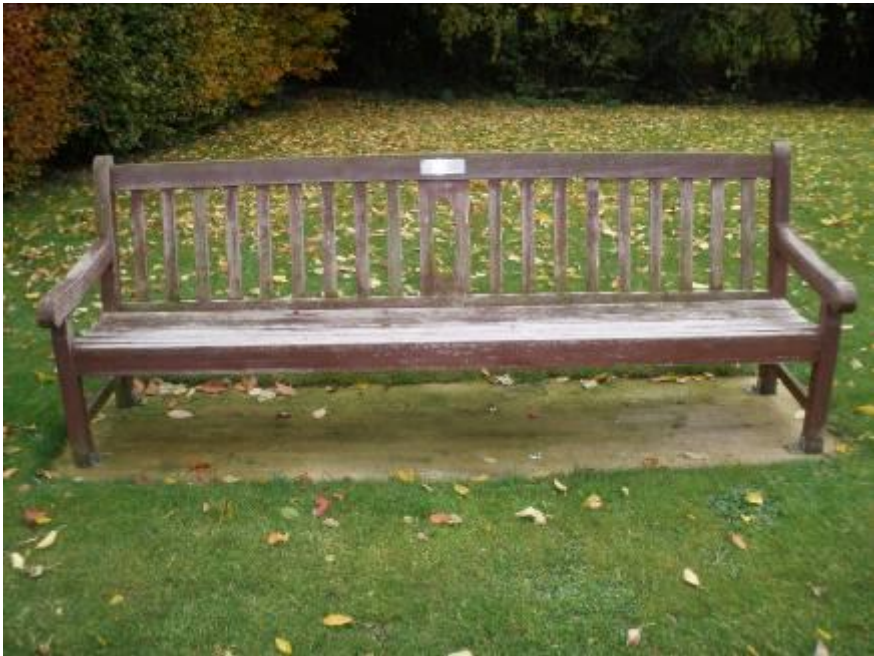
SERIAL NO:	ADD/14
LOCATION: Adderbury cemetery. PRIVATE OWNERSHIP?

DATE ERECTED:	2006	
FRAME CONSTRUCTION:	Four legged wooden frame	
FRAME FINISH:	Stained brown	
SEAT CONSTRUCTION:	Horizontal wooden slats for seat and vertical for back rest	
SEAT FINISH:	Stained brown	
ANY INSCRIPTIONS?	Plaque: This seat is dedicated to the memory of my lovely wife Dilys Shillito who fell asleep 27-12-06 aged 79 years	
COMMENTS ON CONDITION:	Structure is sound. Staining has been badly weathered in places.	
DATE PICTURE TAKEN AND INSPECTION MADE: 12 October 2010 MAINTENANCE RECOMMENDATION: Re-stain if deemed necessary.

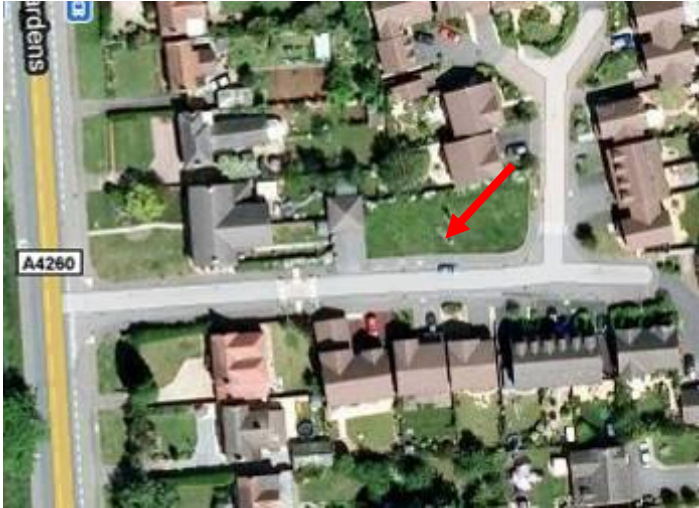
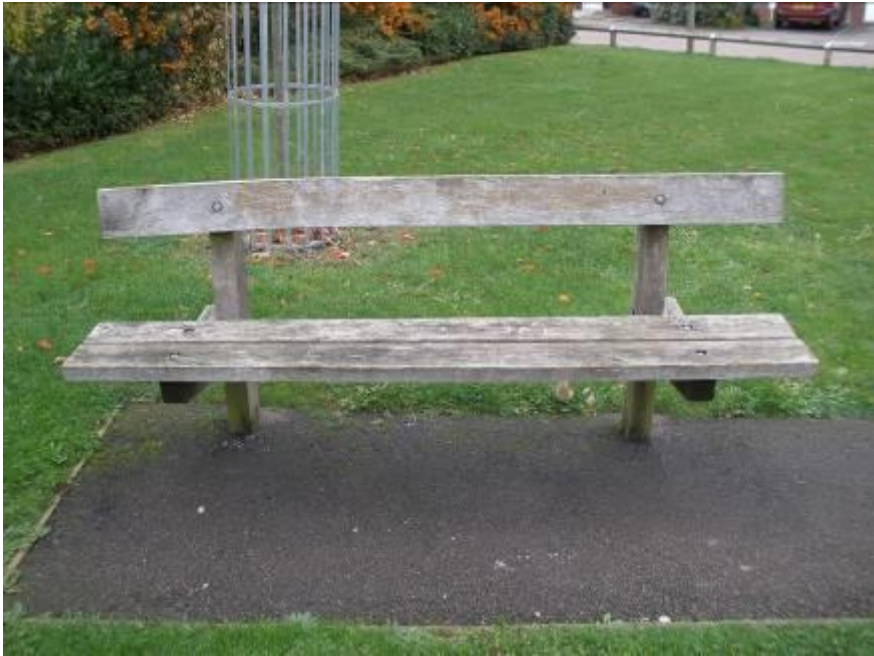
SERIAL NO:	ADD/16
LOCATION: Griffin Close.

DATE ERECTED:	Unknown	
FRAME CONSTRUCTION:	Two legged wooden frame	
FRAME FINISH:	Oiled	
SEAT CONSTRUCTION:	Horizontal wooden slats for seat and back rest	
SEAT FINISH:	Oiled	
ANY INSCRIPTIONS?	Nil	
COMMENTS ON CONDITION:	Structure is sound and in good condition. Wood has greyed slightly.	
DATE PICTURE TAKEN AND INSPECTION MADE: 09 November 2010 MAINTENANCE RECOMMENDATION: Sand down and re-oil if deemed necessary.

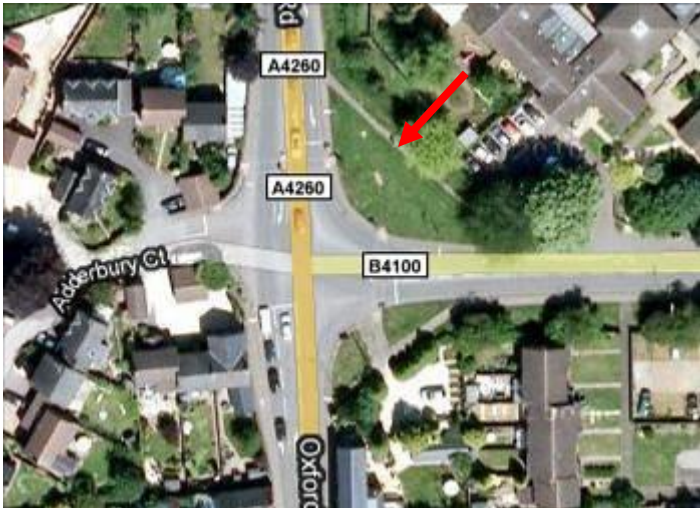
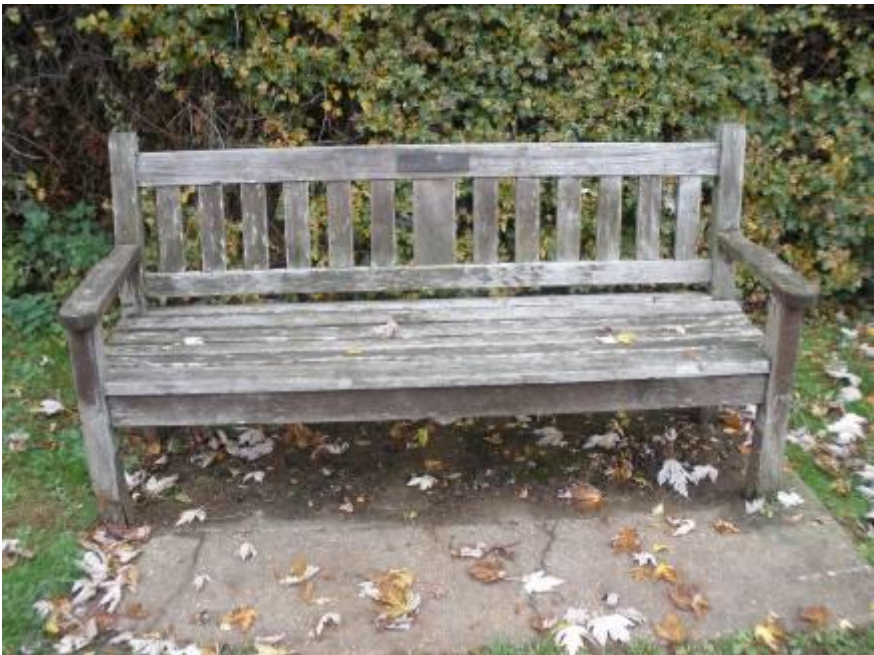
SERIAL NO:	ADD/21
LOCATION: Corner of Aynho Road and A4260 Banbury Road.

DATE ERECTED:	1981	
FRAME CONSTRUCTION:	Four legged wooden frame	
FRAME FINISH:	Oiled	
SEAT CONSTRUCTION:	Horizontal wooden slats for seat and vertical for back rest	
SEAT FINISH:	Oiled	
ANY INSCRIPTIONS?	Plaque: BANBURY HOMES & GARDENS Presented by Banbury Homes & Gardens Limited 1981	
COMMENTS ON CONDITION:	Structure is sound and in good condition. Wood is greyed with some greening visible.	
DATE PICTURE TAKEN AND INSPECTION MADE: 09 November 2010 MAINTENANCE RECOMMENDATION: Sand down and re-oil if deemed necessary.
