5.6: Banbury Road – A4260

v 1.0 – 16/10/19

Adderbury Parish Council Environment Committee
Traffic Calming Proposals

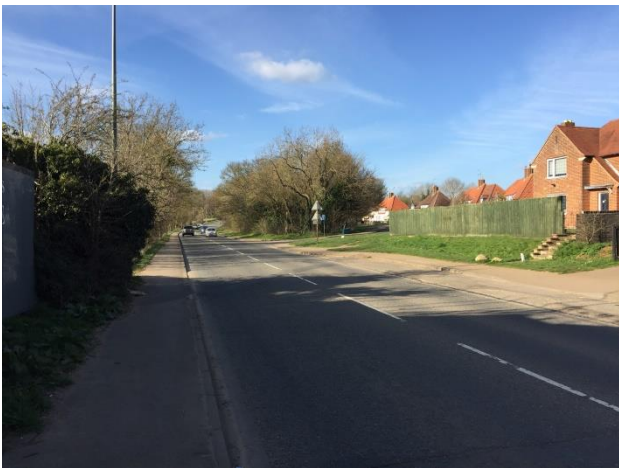
N/B From the Primary School towards The Rise

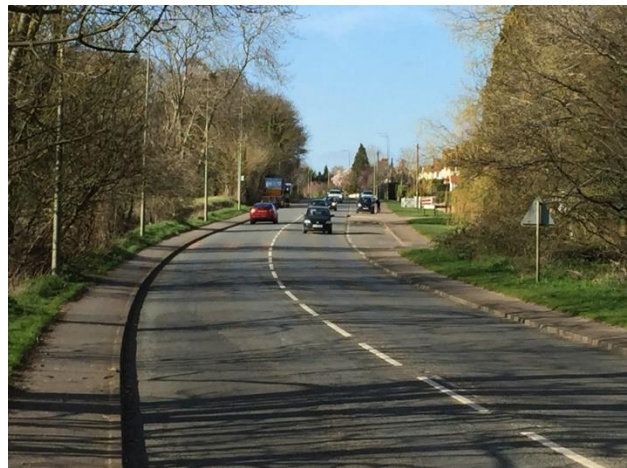
N/B At the corner beside the field

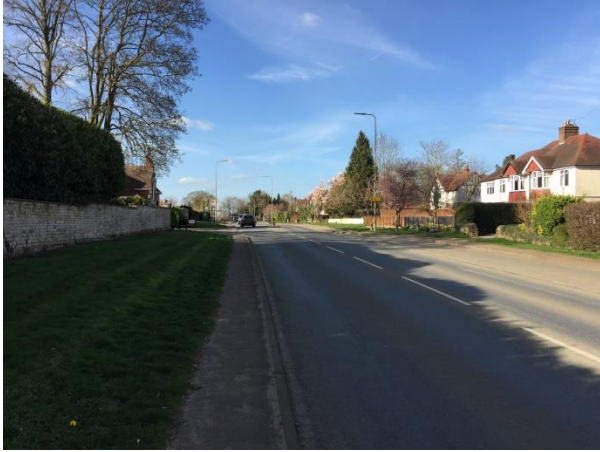
N/B Showing LHS verges & RHS parking bay

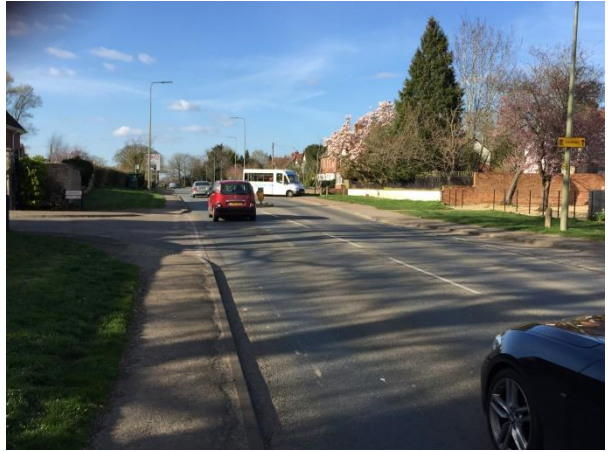
N/B Towards Bowls Club & Twyford Grove

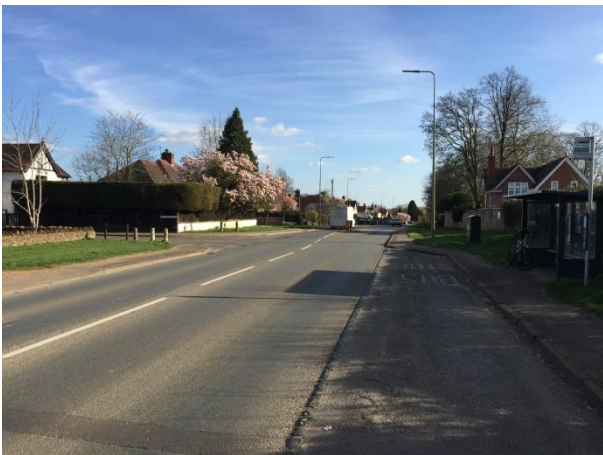
S/B Splitter Island by Bowls Club

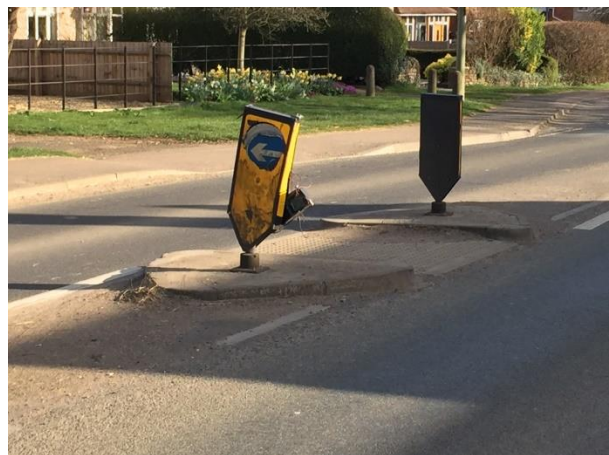
S/B Vehicle Impact at Splitter Island

It is clear that the splitter island that was recently installed has had some success in slowing traffic at that point. It is however of minimal construction and the 'Keep Left' bollard has not been repaired in some time. **Action OCC Highways to replace damaged bollard.**

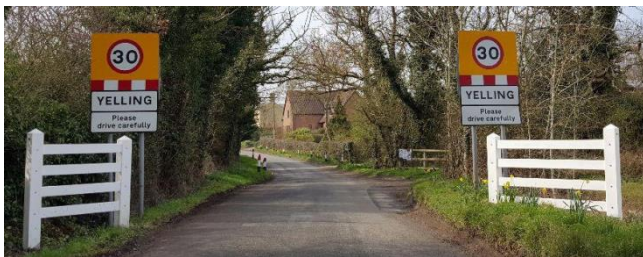
Painted Gates Enhancing Visibility of Village Entry

Existing gates to be painted white to improve visibility **[COMPLETE]**

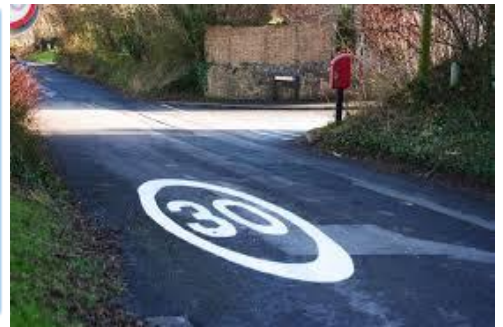
Diagram 880 Speed Repeater Signs and Roundels

Install Diagram 880 speed repeater signs as noted plus white painted 30mph speed roundels on adjacent roadway

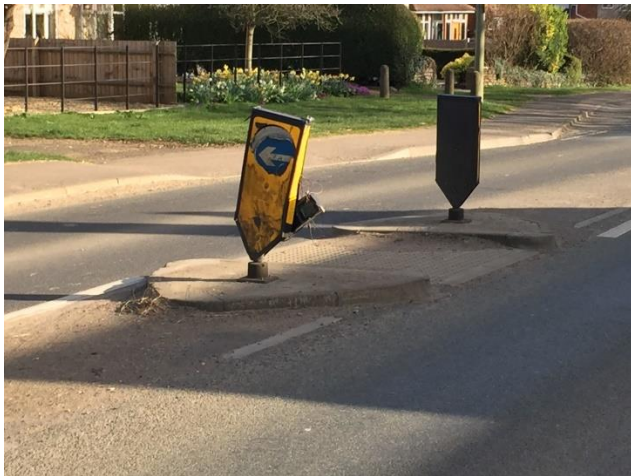
Vehicle Impact at Splitter Island requiring repair

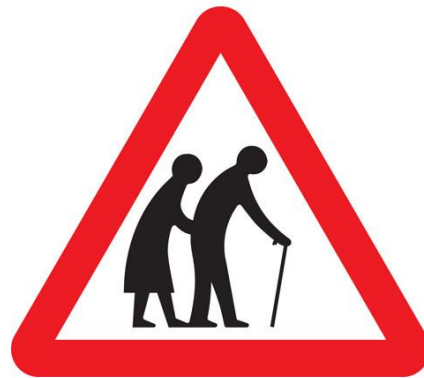
Frail Pedestrians signage

Add 'Frail Pedestrians' signs on both approaches to the Residential Home & Bowls Club:
