Annual Inspection

Adderbury Parish Council

The Rise

Inspection Ref: 1219532

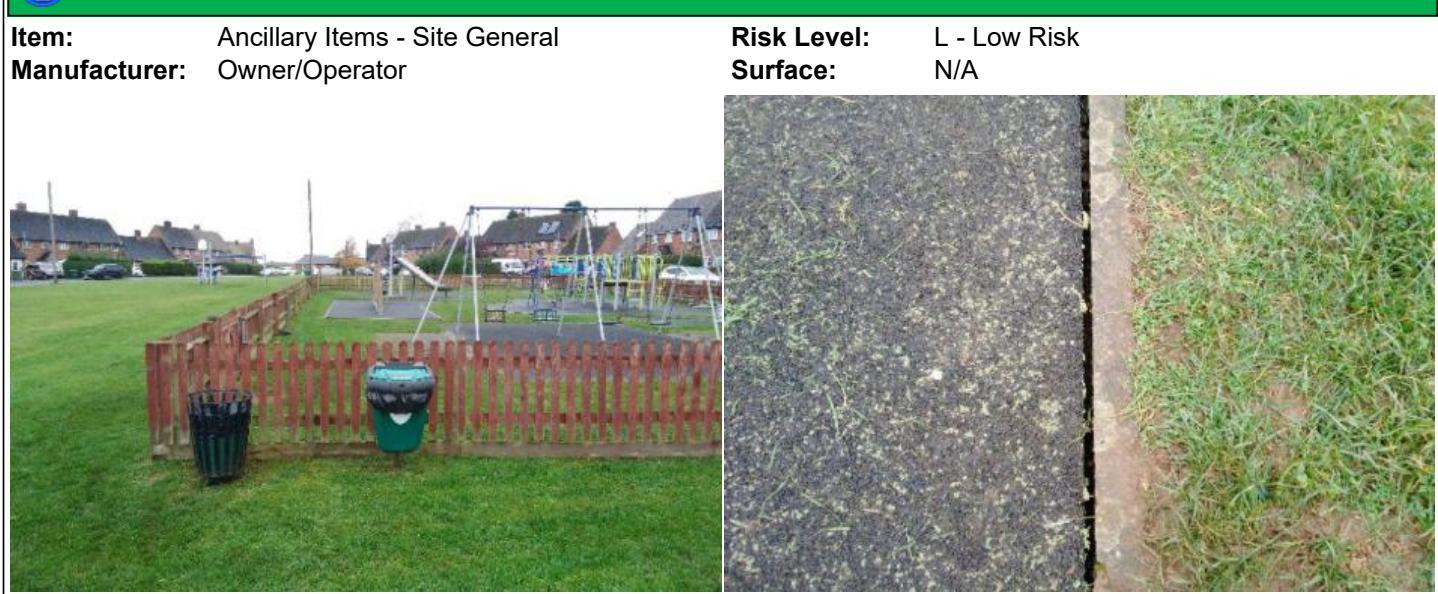
😭 6 - Low Risk (Finding 3)

Finding: There are gaps opening between the surfacing and **Action:** Monitor for any further deterioration and repair as the edging surround or between the joints in the surfacing required

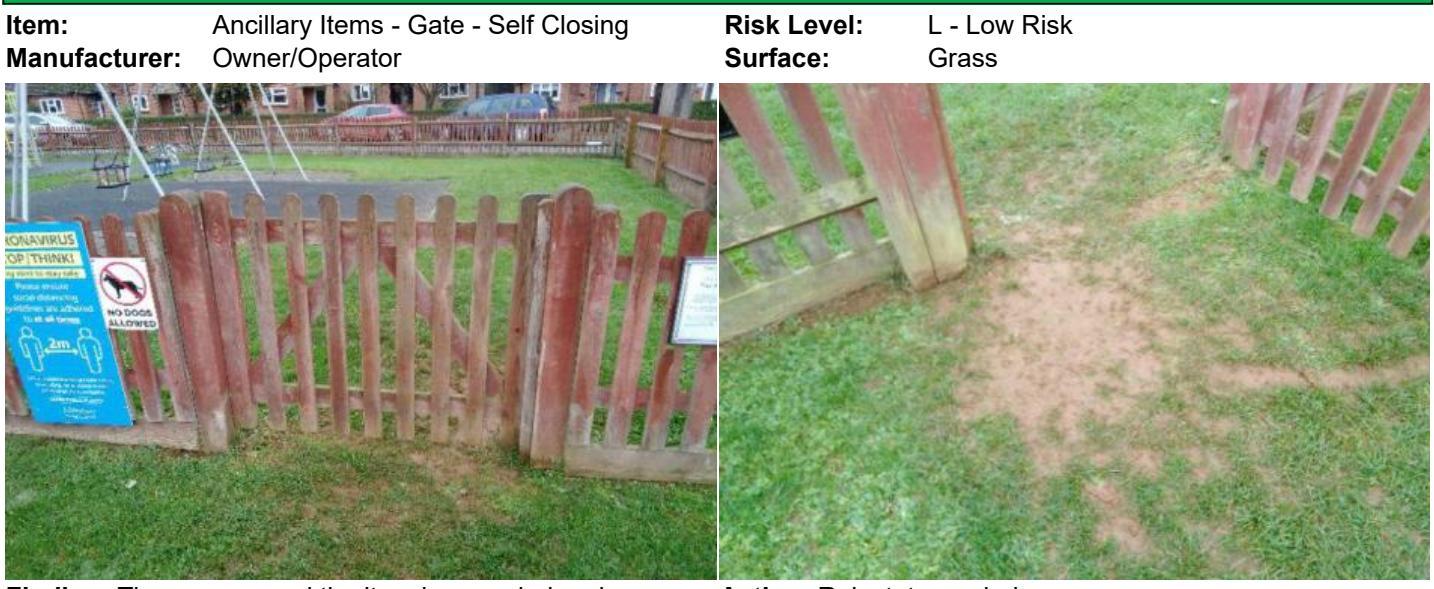
8 - Low Risk (Finding 3)

Finding: The area around the item has eroded and may become slippery

Action: Reinstate eroded area

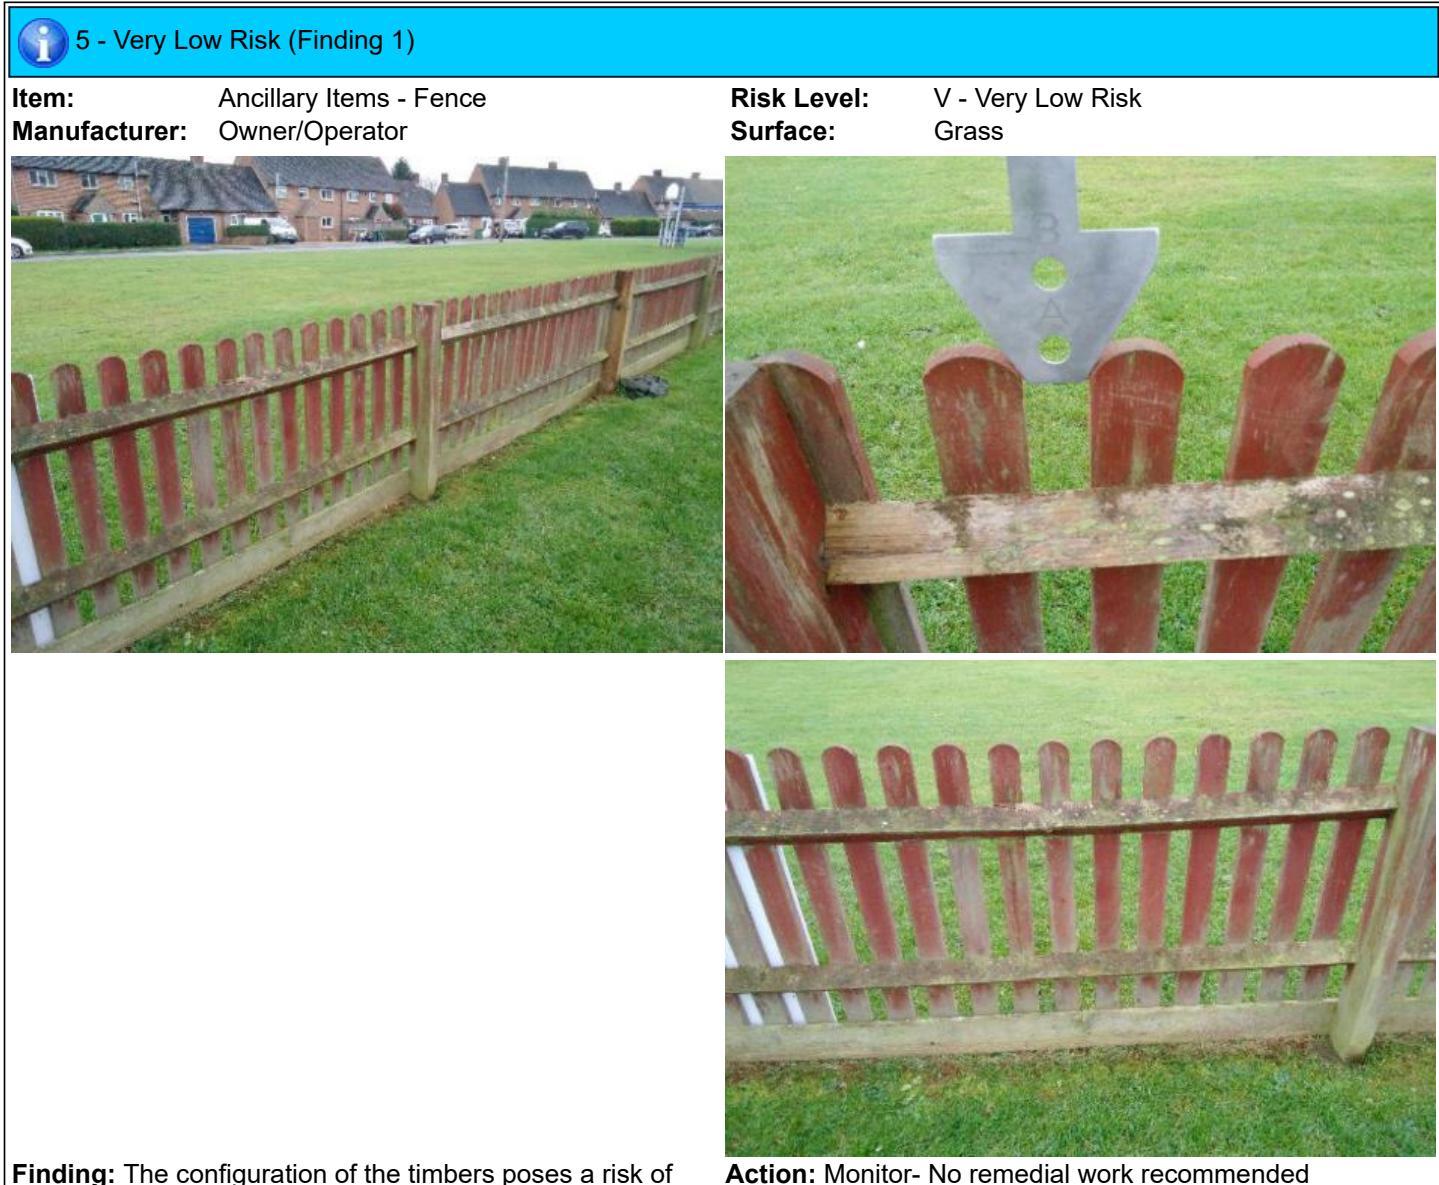
Finding: The configuration of the timbers poses a risk of head and neck entrapment in the fence tops

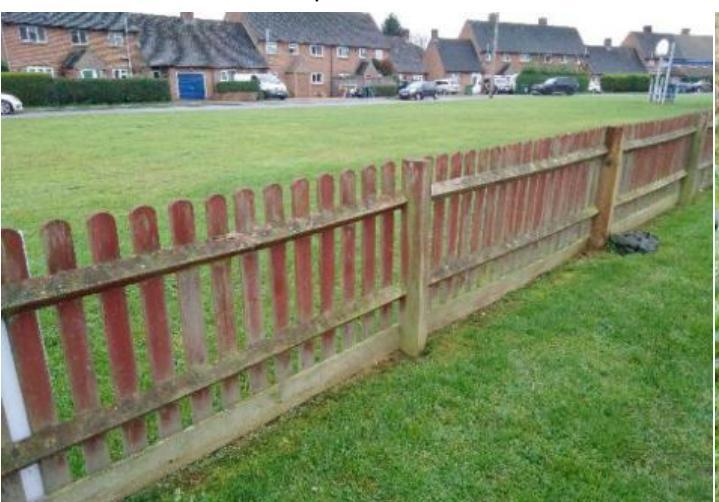
Finding: There is some strimmer / machinery damage apparent on the posts, this can penetrate the preservative applied to the timber and accelerate the rotting process

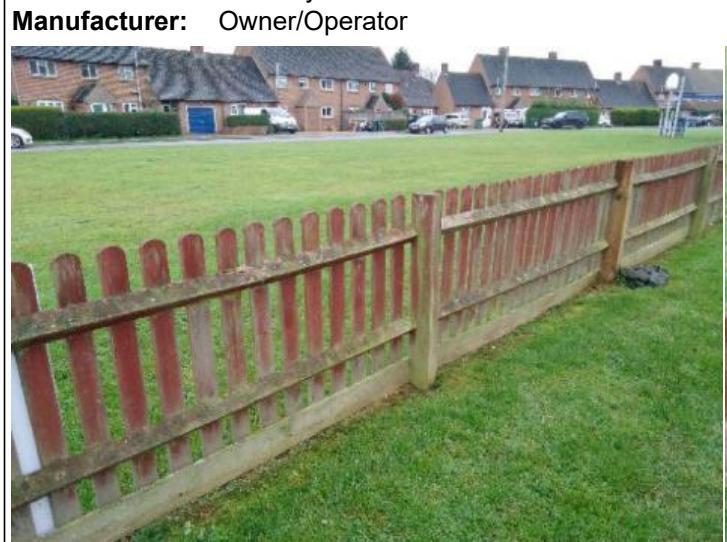
6 - Low Risk (Finding 3)

Finding: There are a number of loose posts around the fence

Action: Monitor for any further deterioration and reset as required

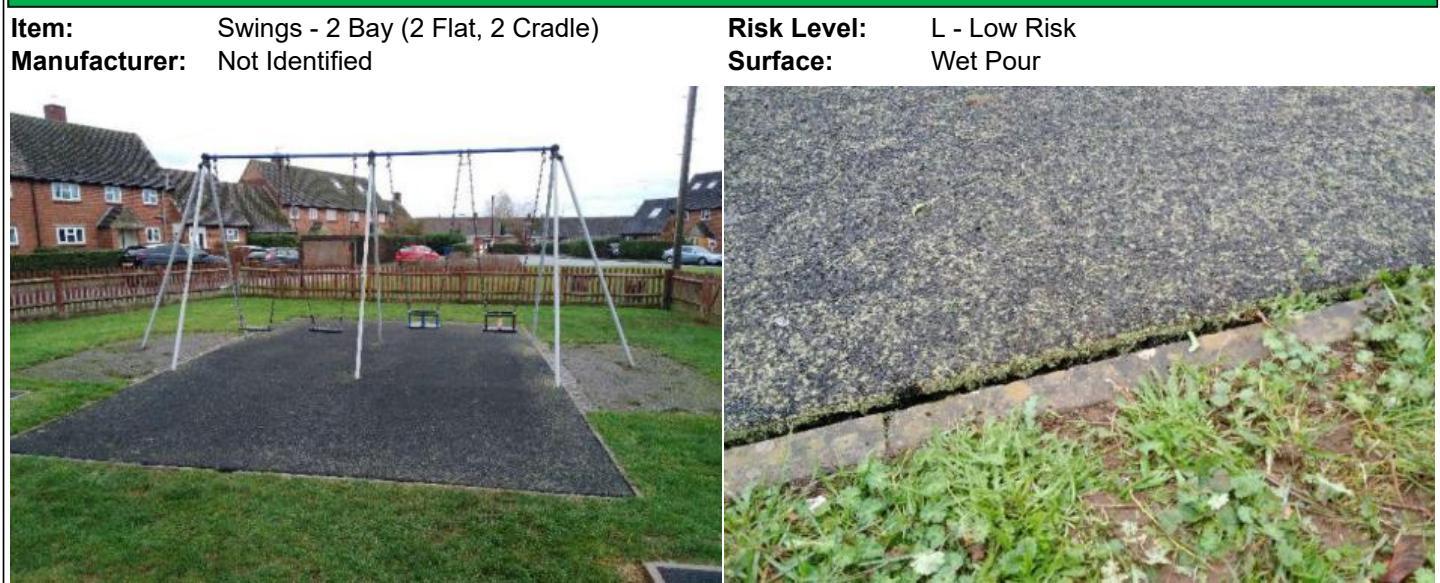
8 - Low Risk (Finding 2)

Finding: The surface is lifting at the edges and creating trip **Action:** Repair perimeter of surfacing to remove trip points

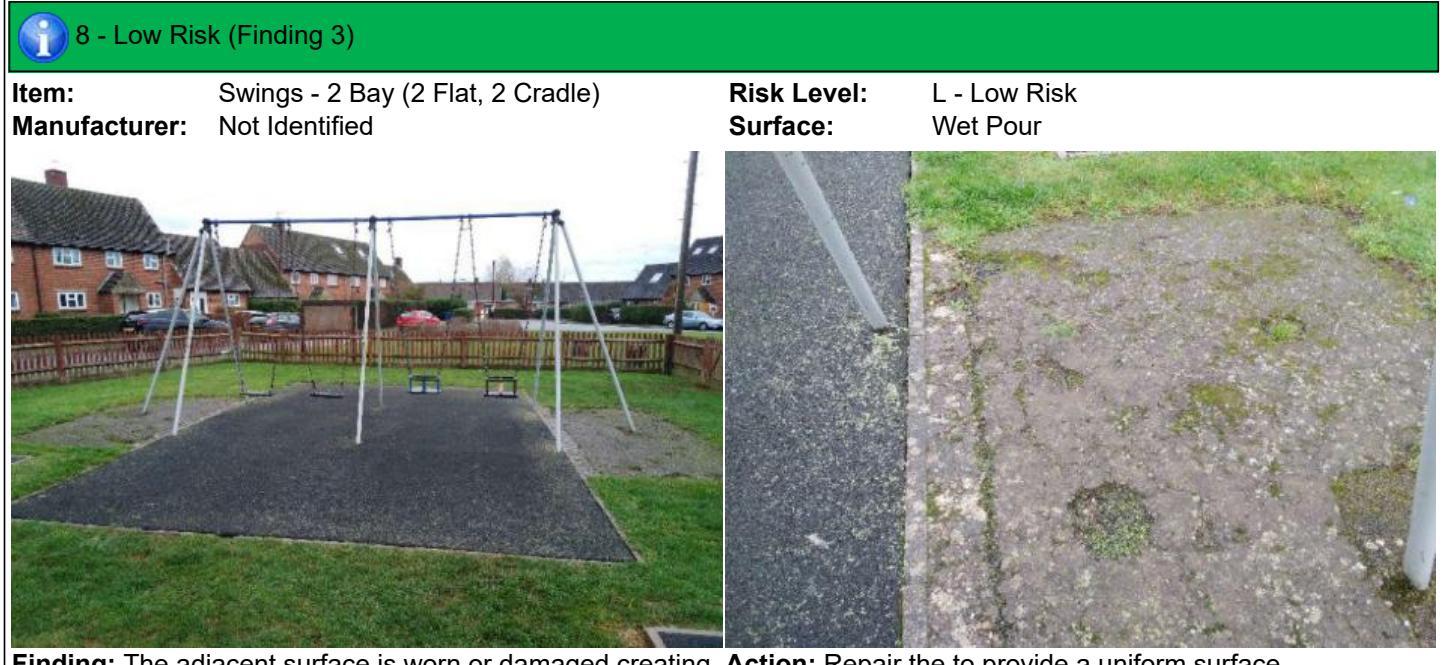
Finding: The adjacent surface is worn or damaged creating **Action:** Repair the to provide a uniform surface trip points

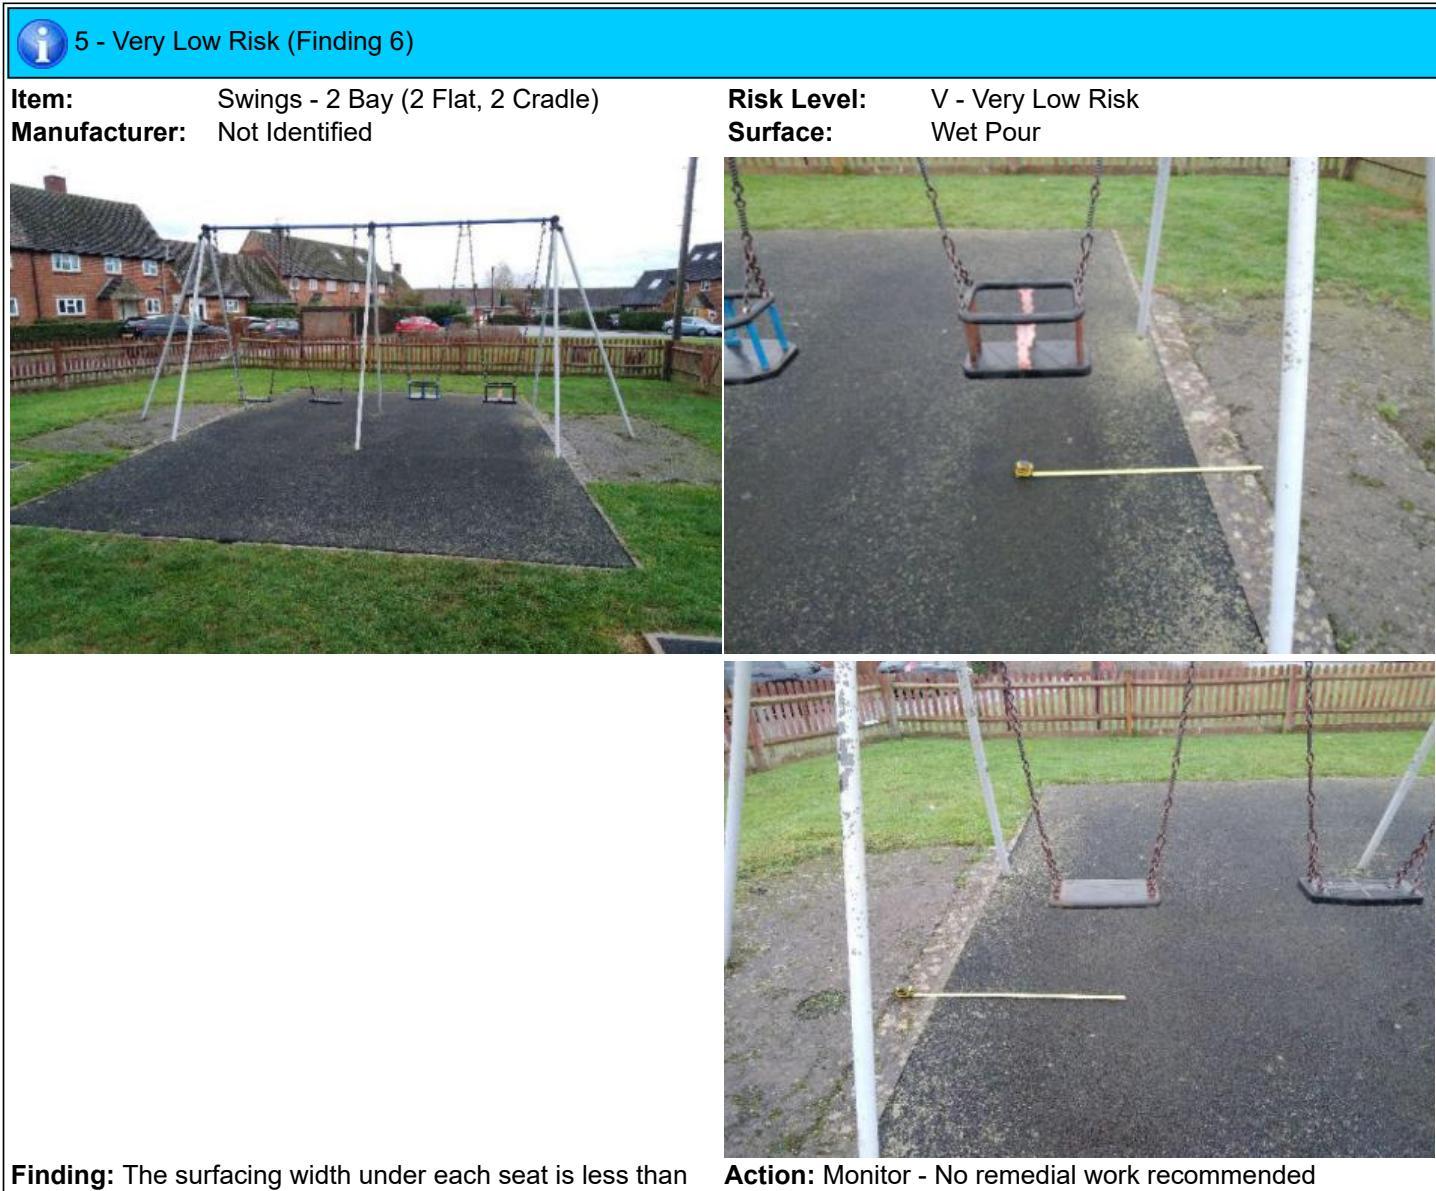
Finding: The surfacing width under each seat is less than 1.75 metres and fails the requirements of BS EN 1176 Part 2

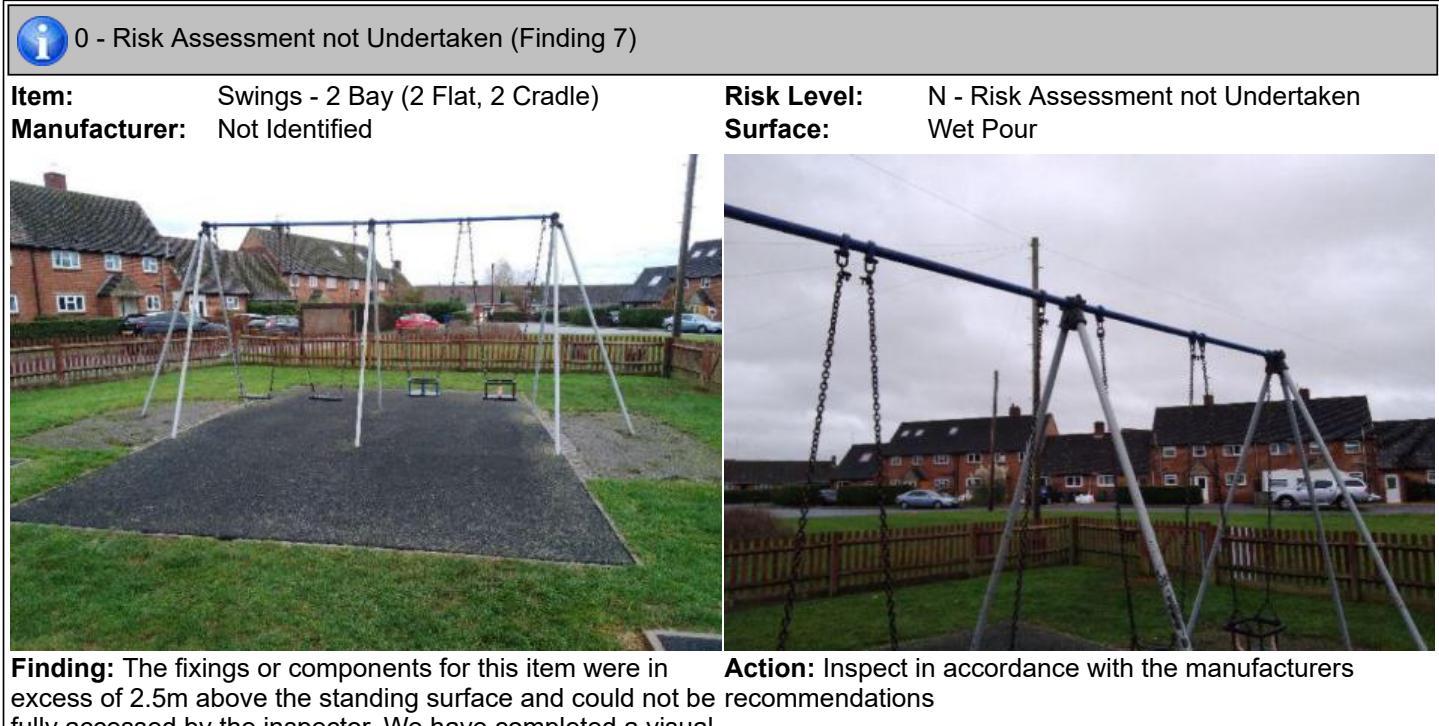
Finding: The fixings or components for this item were in excess of 2.5m above the standing surface and could not be reco fully accessed by the inspector. We have completed a visual inspection of the fixings from ground level but a maintenance inspection should be undertaken to assess the condition, security and wear of the components at intervals in accordance with the manufacturers recommendations.

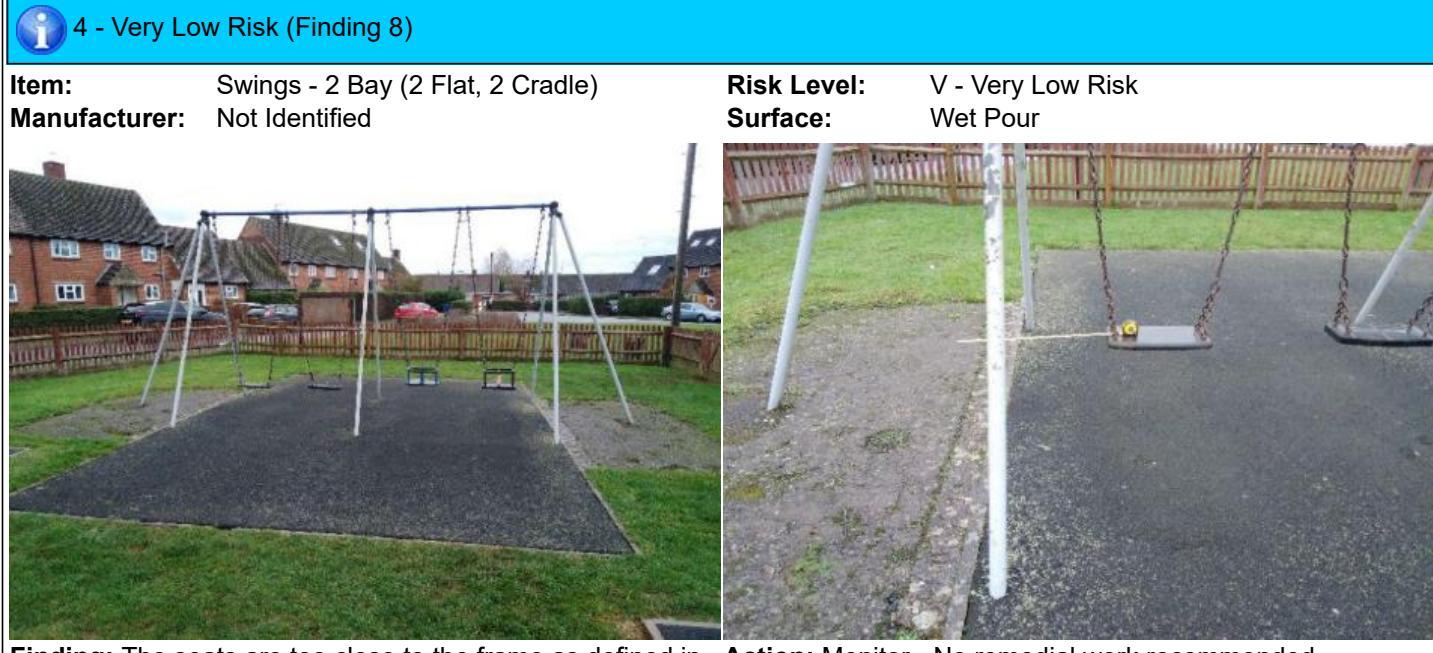
Finding: The seats are too close to the frame as defined in **Action:** Monitor - No remedial work recommended BS EN 1176 Part 2; this is a low risk failure and no remedial action is required

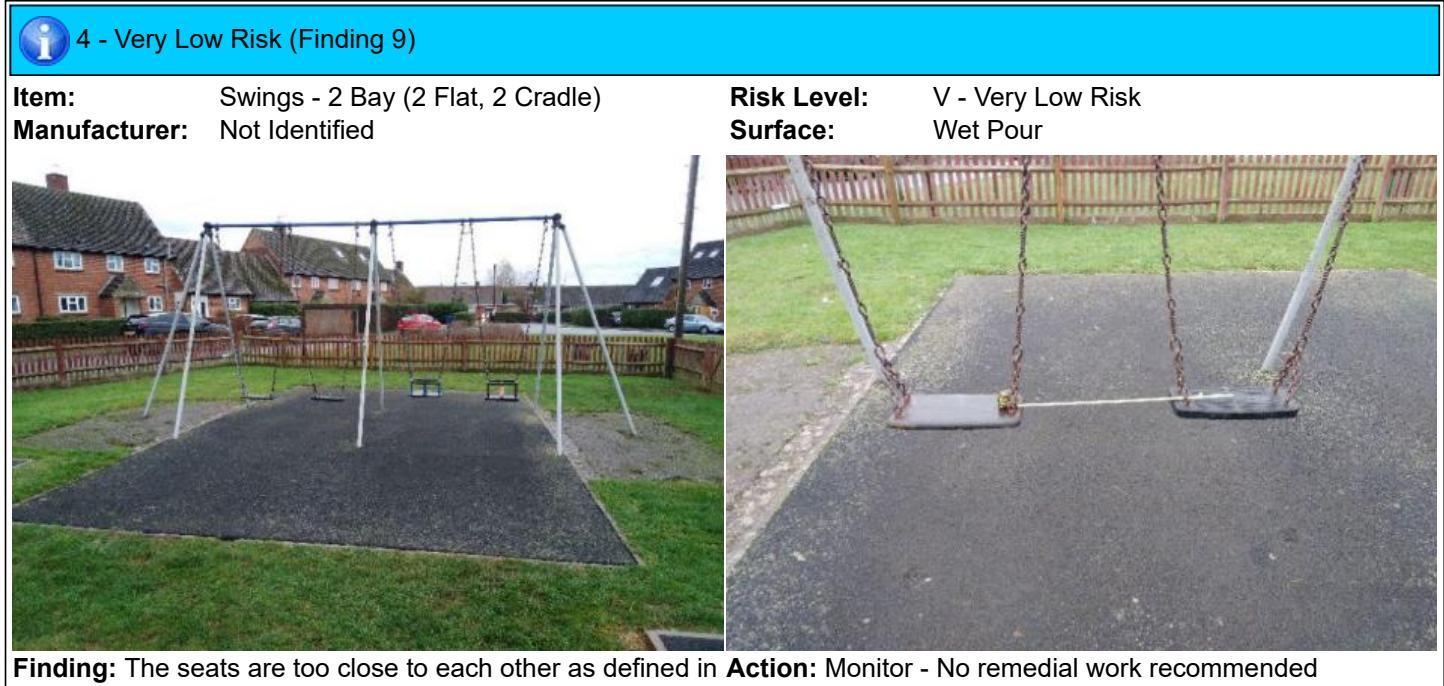
Finding: The seats are too close to each other as defined in **Action:** Monitor - No remedial work recommended BS EN 1176 Part 2; this is a low risk failure and no remedial action is required

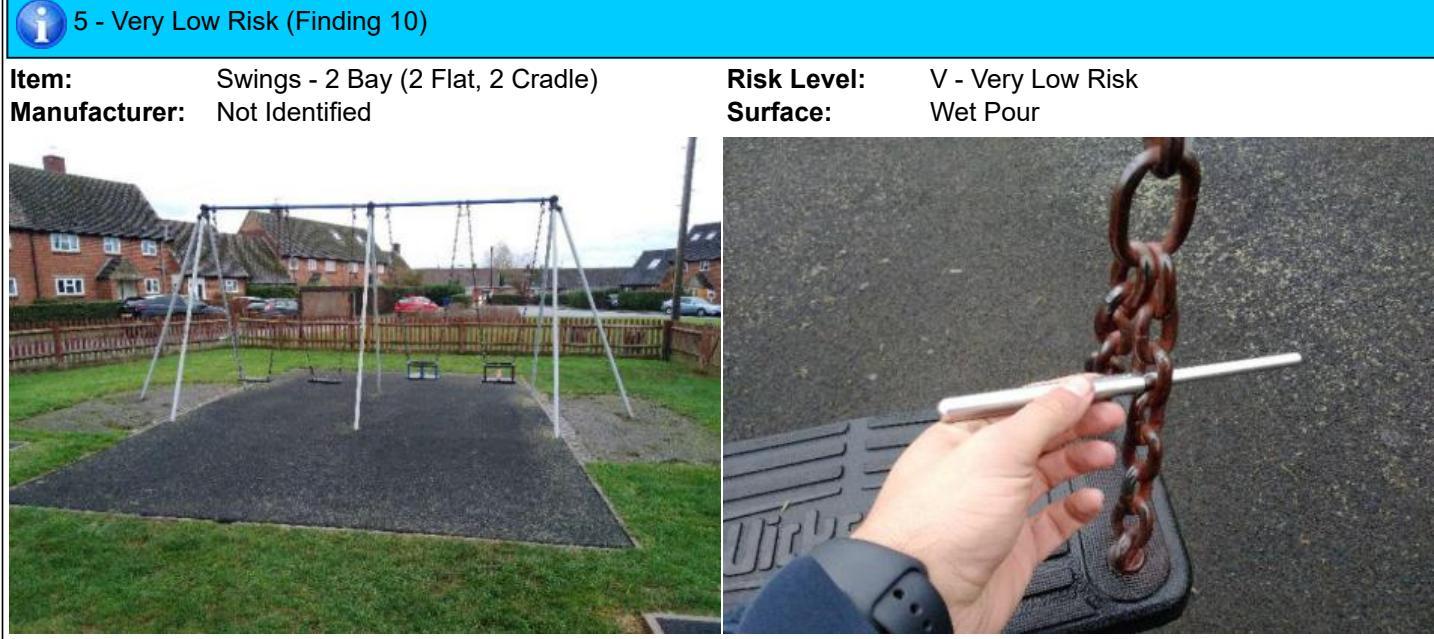
Finding: The chain openings are in excess of the 8.6mm as Action: Monitor - No remedial work recommended recommended by BS EN 1176

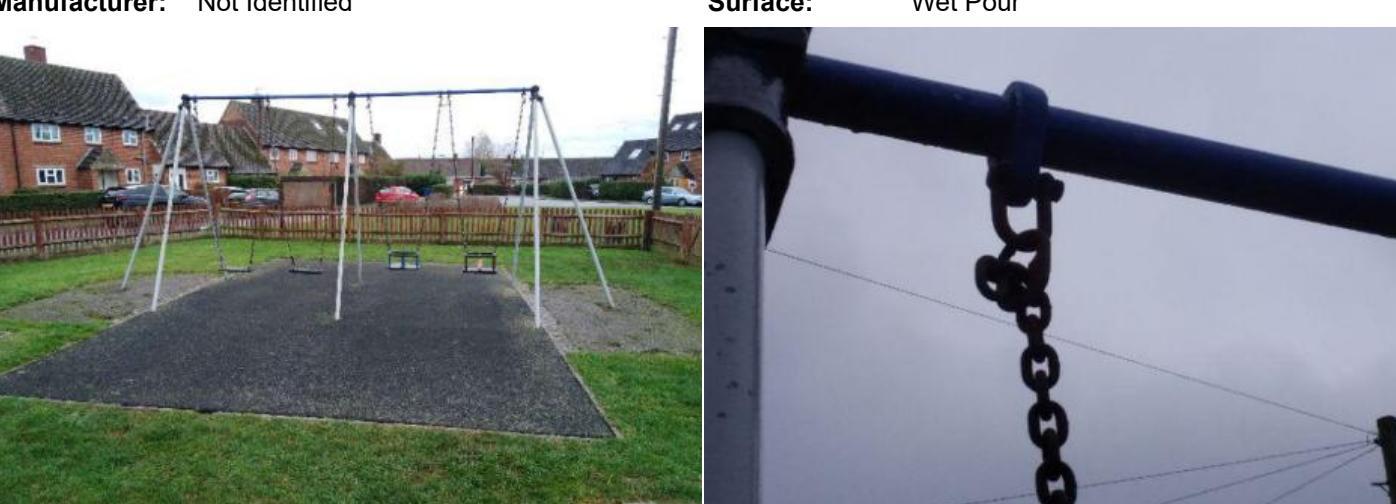
Finding: The shackles are worn in excess of 40% and require renewing

Action: Replace worn shackles

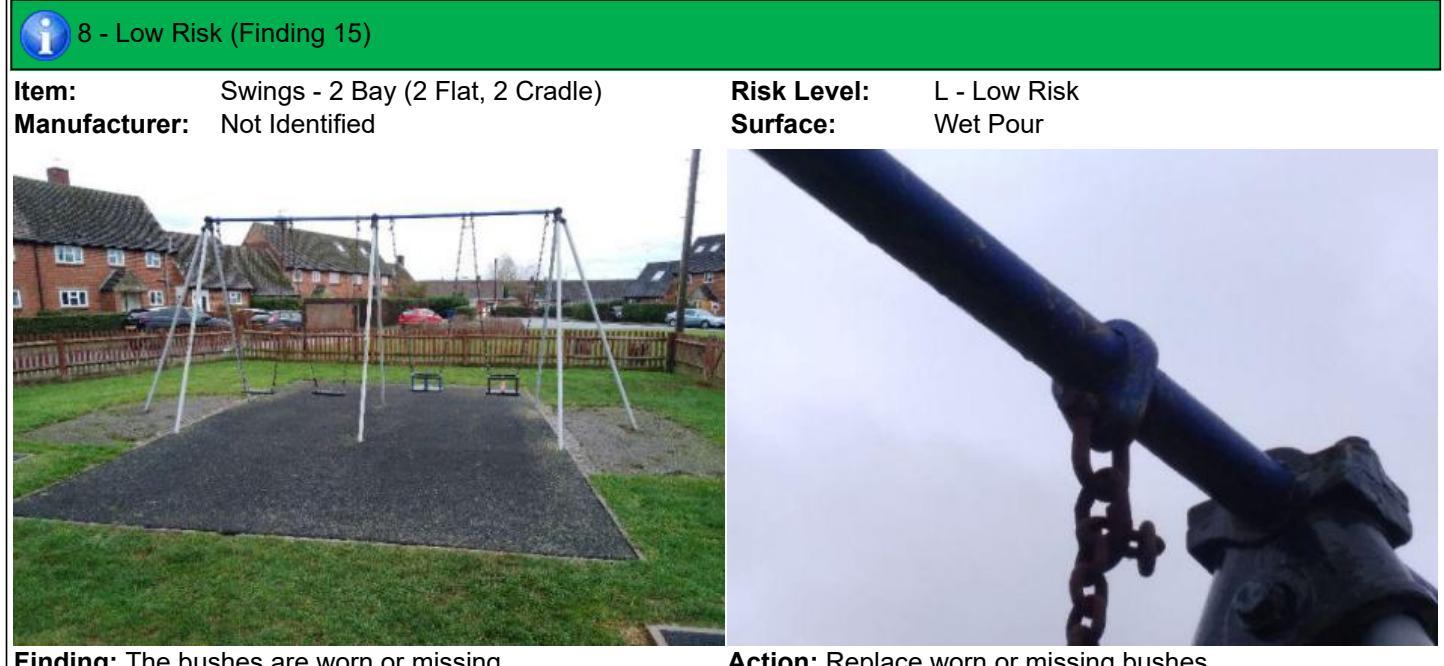
Finding: The bushes are worn or missing

Action: Replace worn or missing bushes

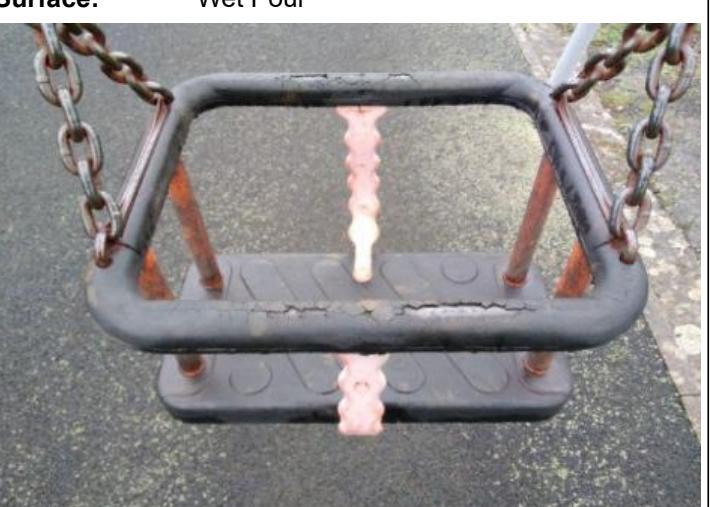
Finding: The seat has minor damage or wear

Action: Monitor for any further deterioration and replace as required

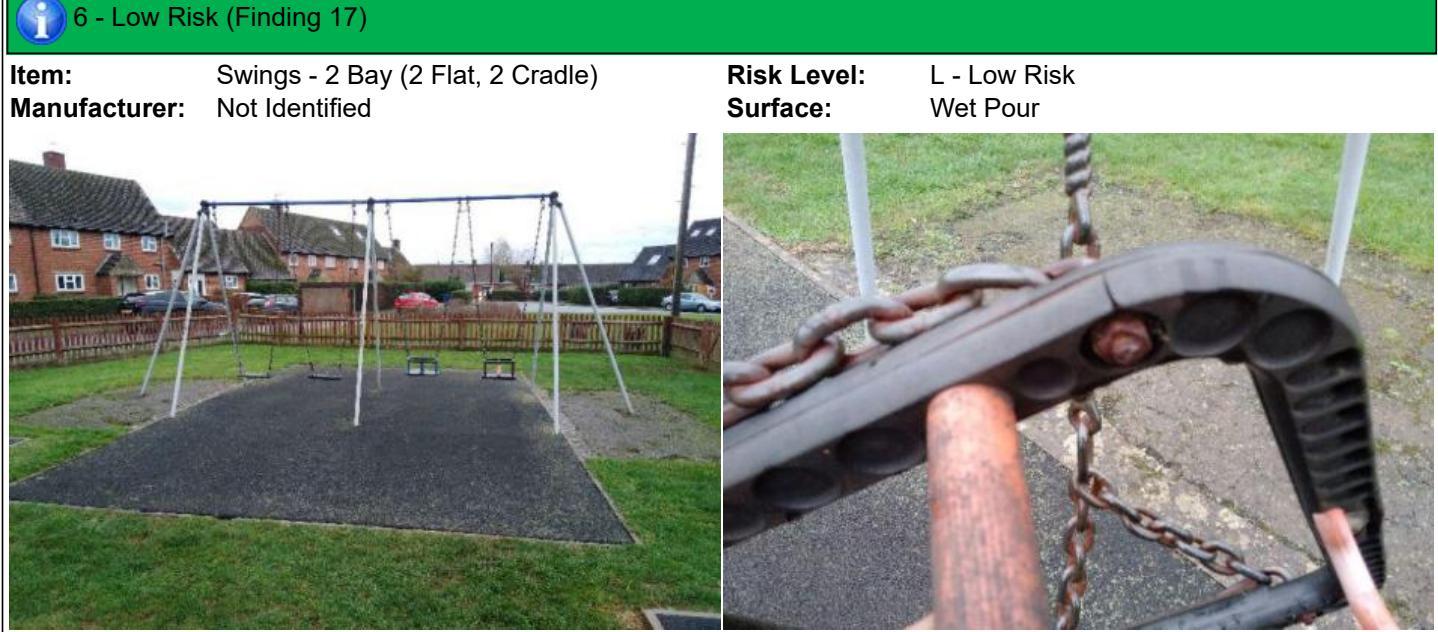
Finding: There are caps missing from the underside of the **Action:** Replace missing caps under the seats seats

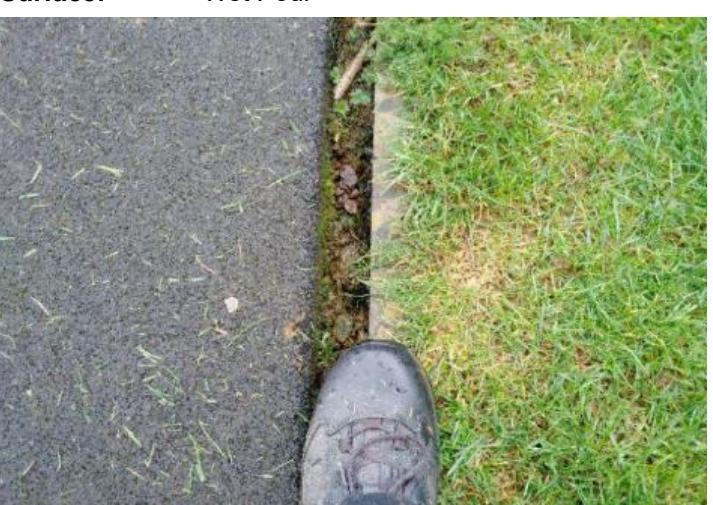
Finding: There are significant gaps (over 30mm) between the surface and the edging or between the joints in the surface; these are large enough for a small foot to enter

Action: Repair surfacing

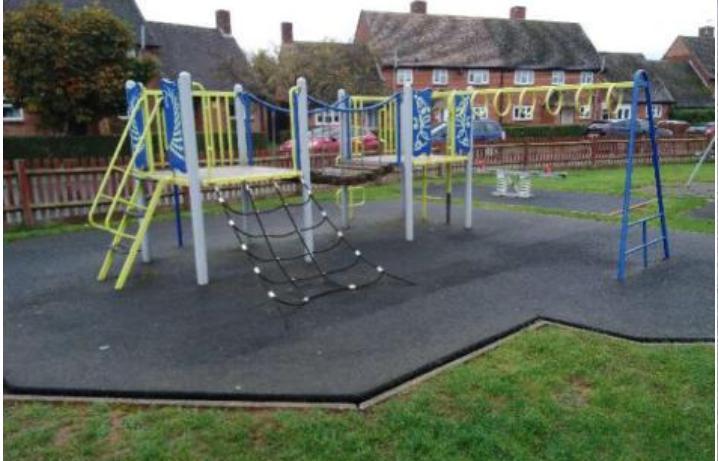
6 - Low Risk (Finding 5)

Finding: The ropes/nets are worn/damaged in places

Action: Monitor for any further deterioration and repair or replace as required

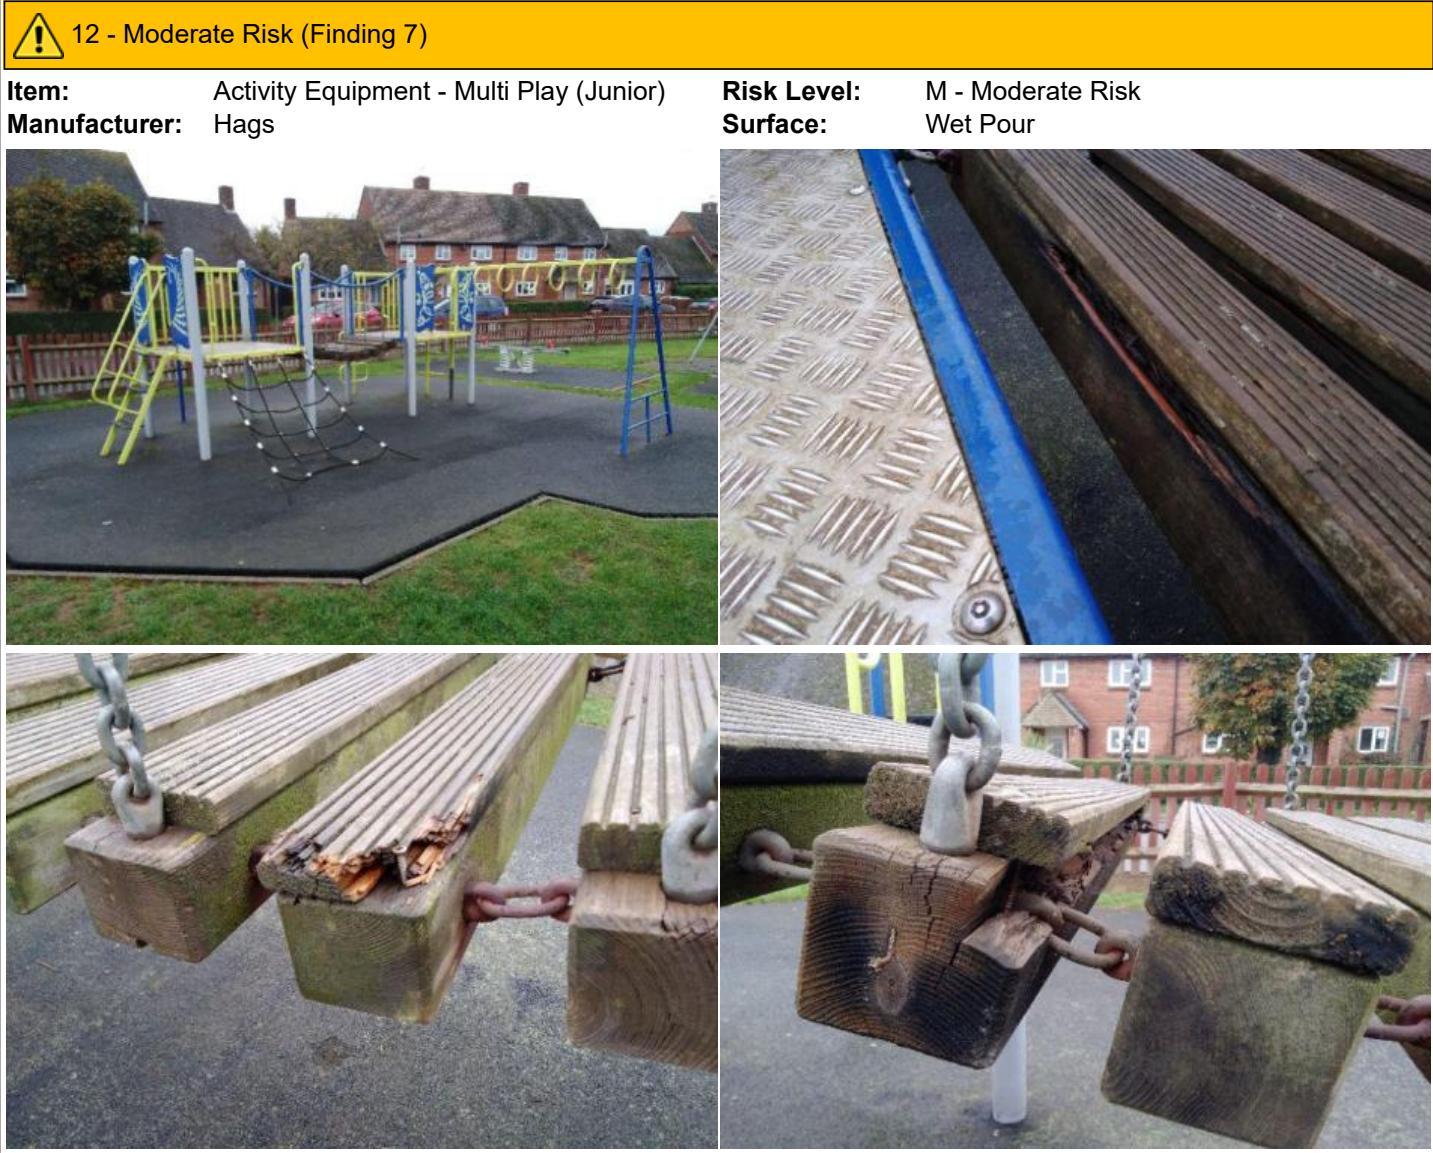
Finding: Several of the timber bridge slats on the structure **Action:** Replace all affected timbers have rotted

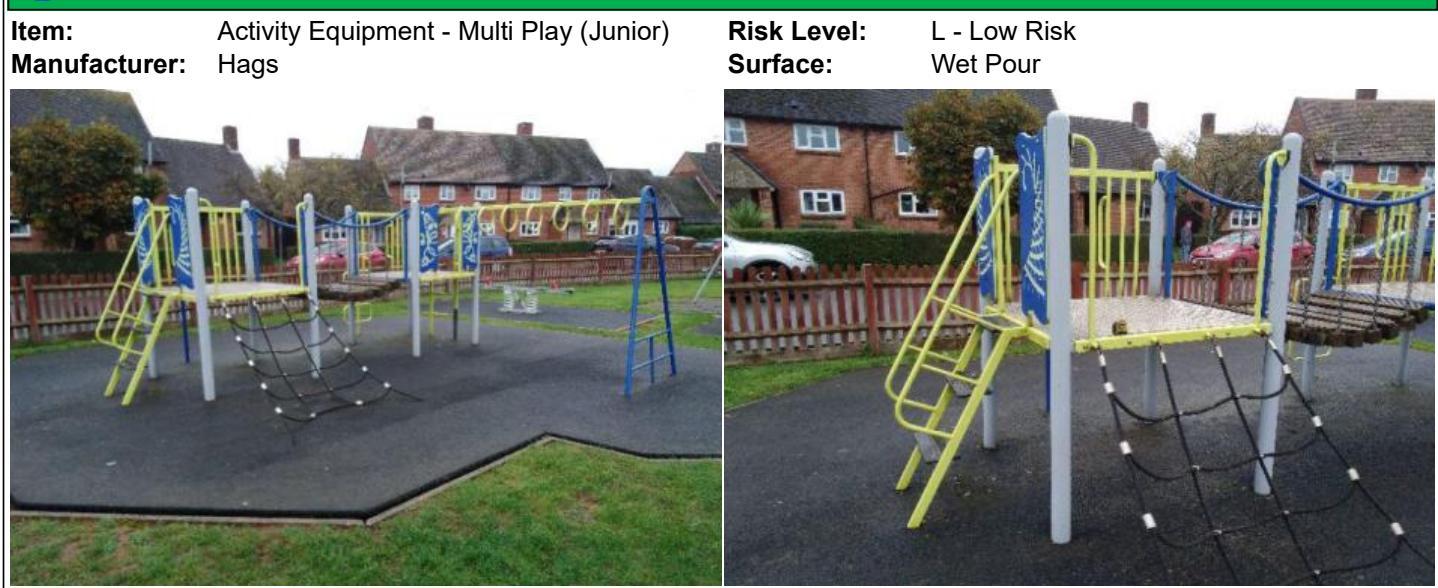
6 - Low Risk (Finding 10)

Finding: The unit is easily accessible and has an opening in Action: Monitor - No remedial work recommended the barrier to steep play elements in excess of 500mm in contravention of BS EN 1176 Part 1

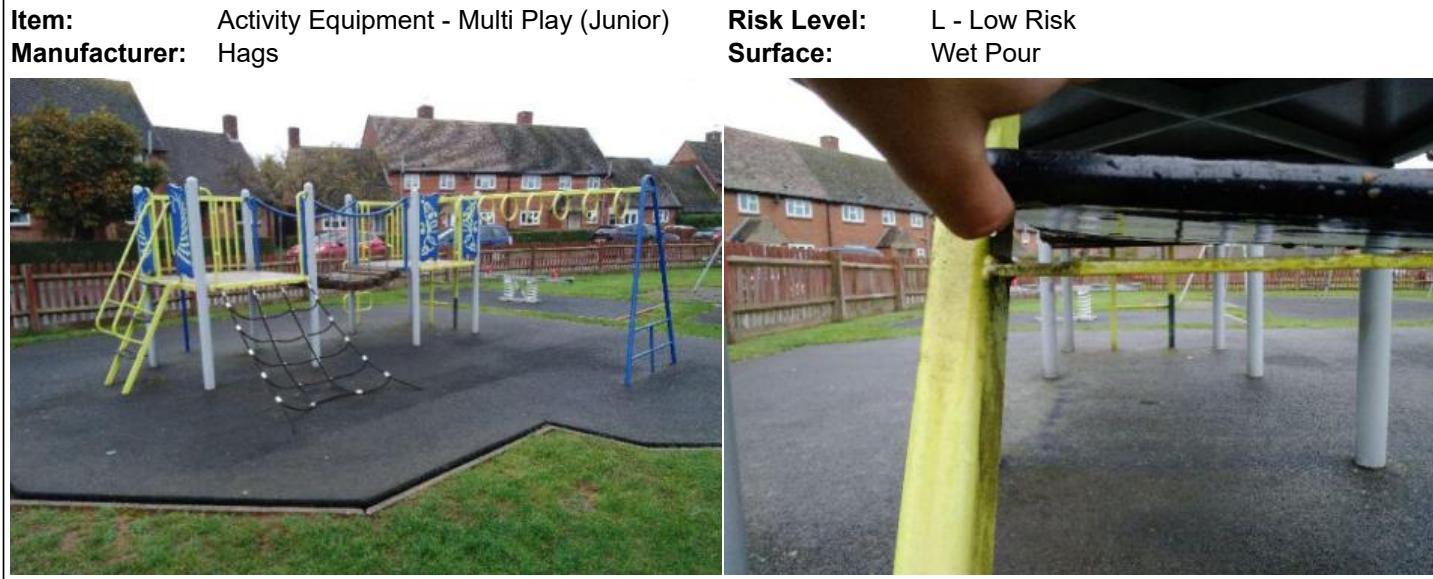
😭 8 - Low Risk (Finding 12)

Finding: There is or are fixings missing on the steps

Action: Replace all missing fixings

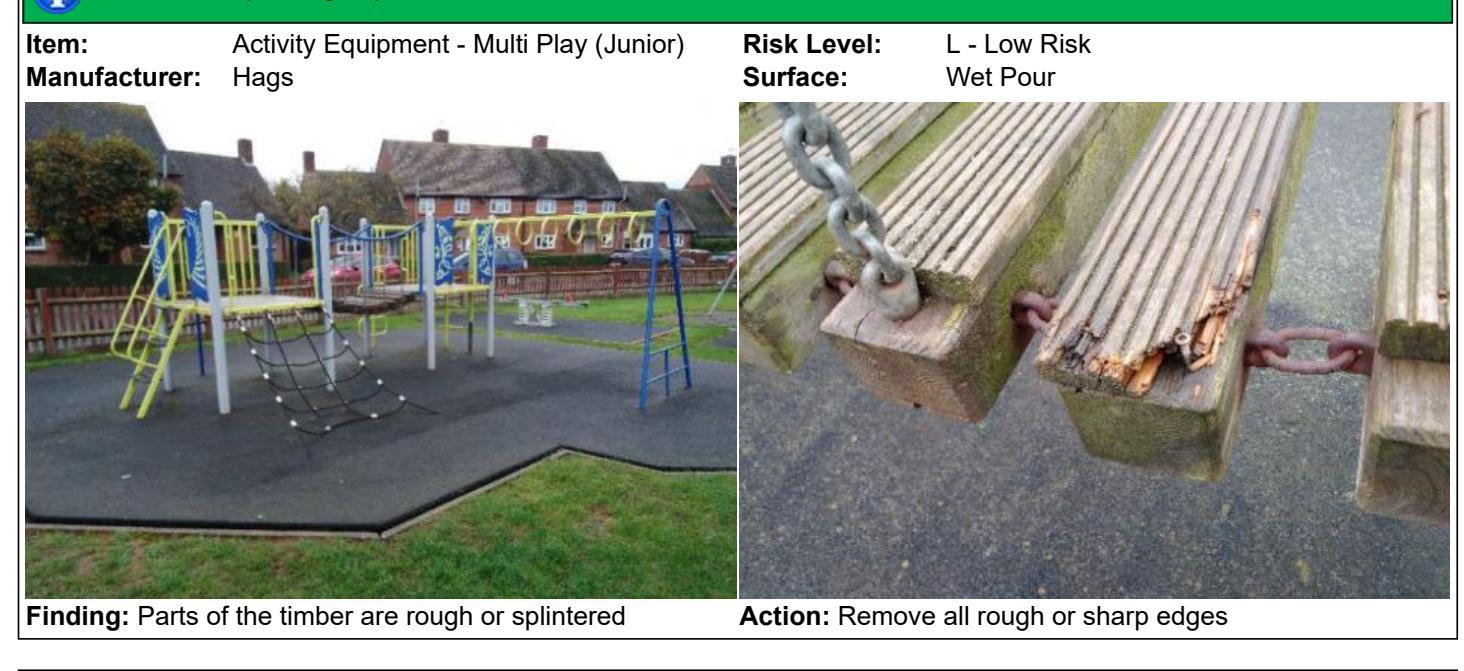
8 - Low Risk (Finding 1) Item: Rocking Equipment - Spring Rabbit Manufacturer: SMP Risk Level: L - Low Risk Surface: Wet Pour

Finding: The surface is lifting at the edges and creating trip **Action:** Repair perimeter of surfacing to remove trip points

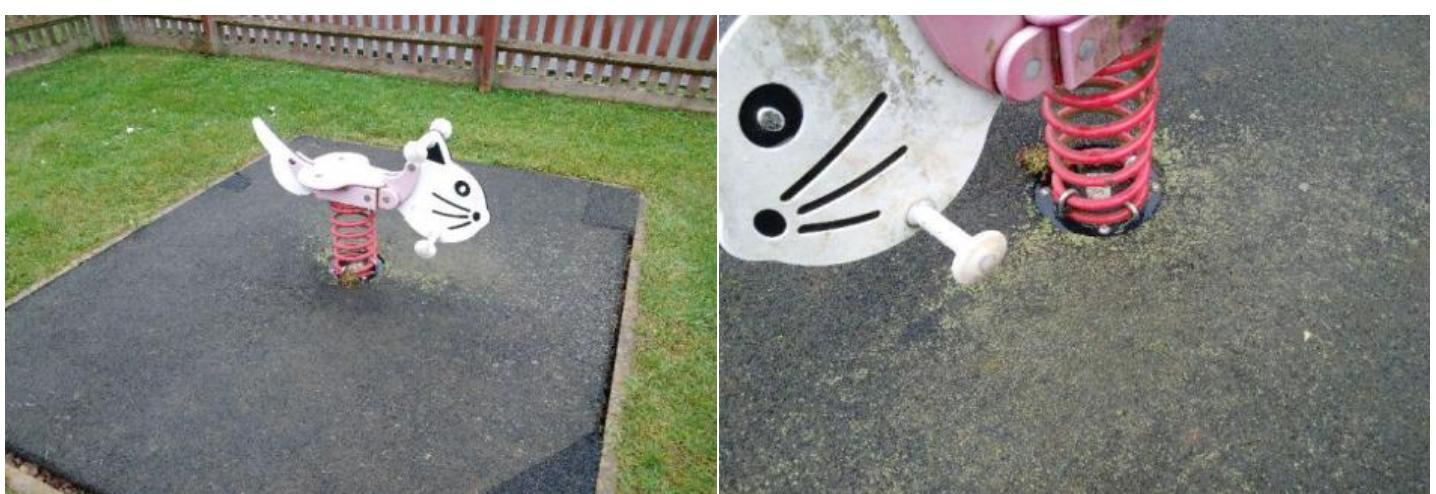
Finding: There is algae or moss growth on the surface resulting in slippery conditions

Action: Clean and treat appropriately

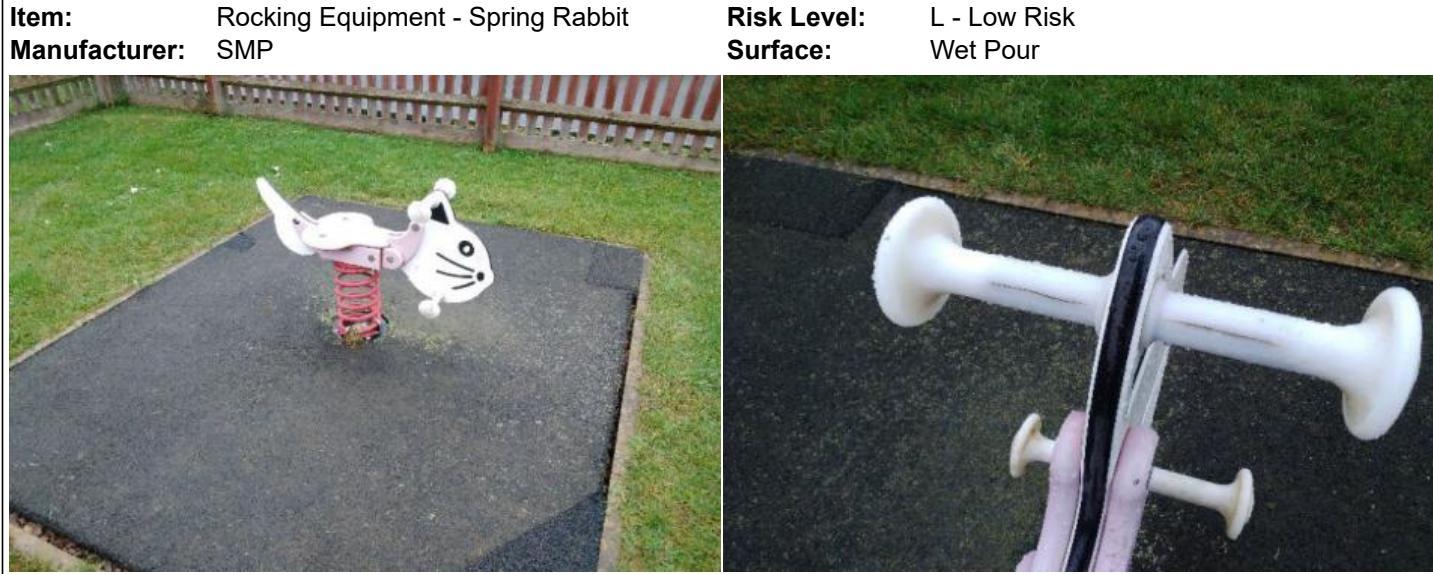
6 - Low Risk (Finding 3)

Finding: The item has been damaged

Action: Monitor for any further deterioration and replace as required

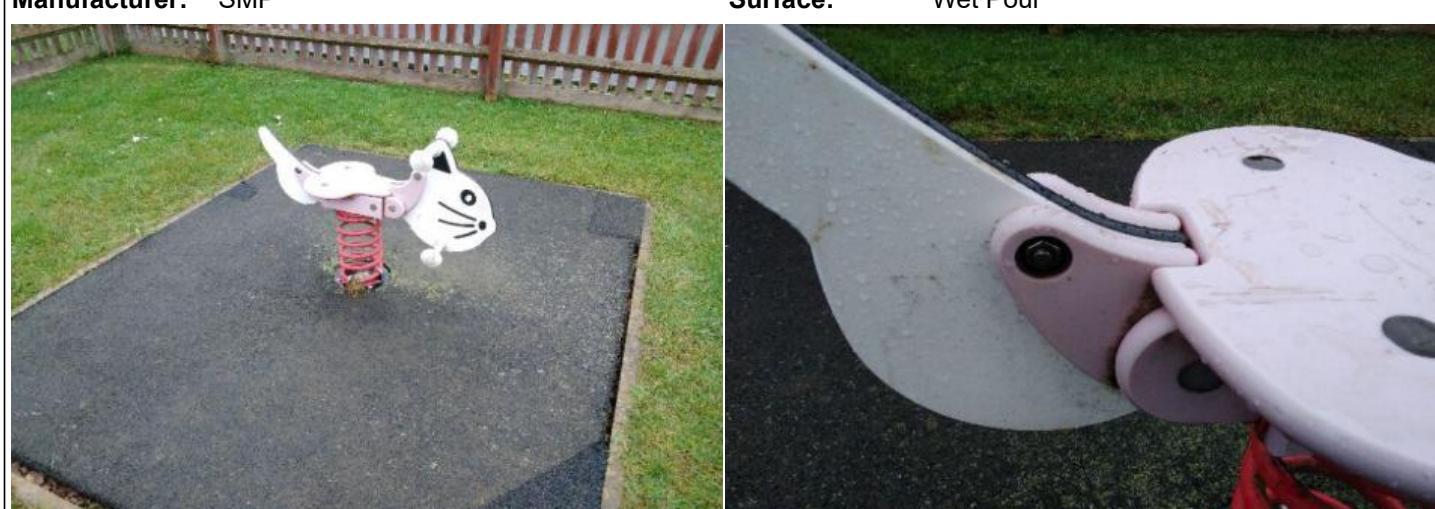
Finding: There is/are bolt cap covers missing or damaged Action: Replace missing or damaged bolt cap covers on the item
