Annual Inspection

Adderbury Parish Council

The Rise

Inspection Ref: 1219532

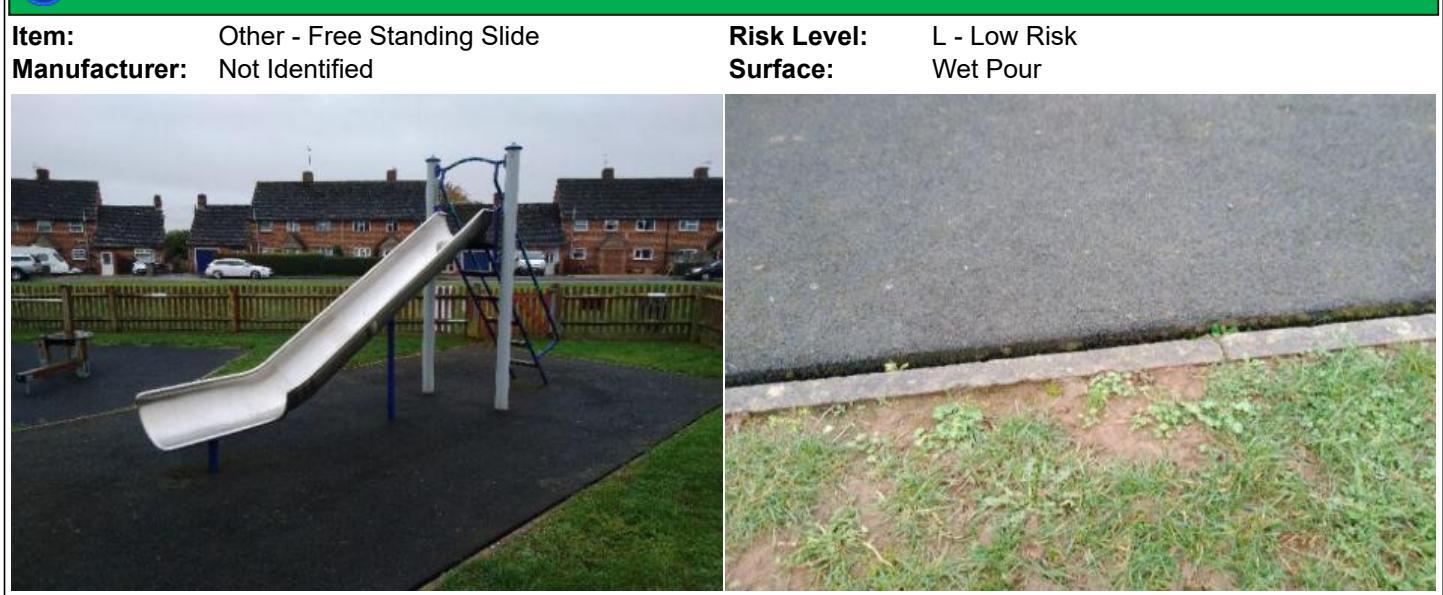
8 - Low Risk (Finding 1)

Finding: The surface is lifting at the edges and creating trip **Action:** Repair perimeter of surfacing to remove trip points points

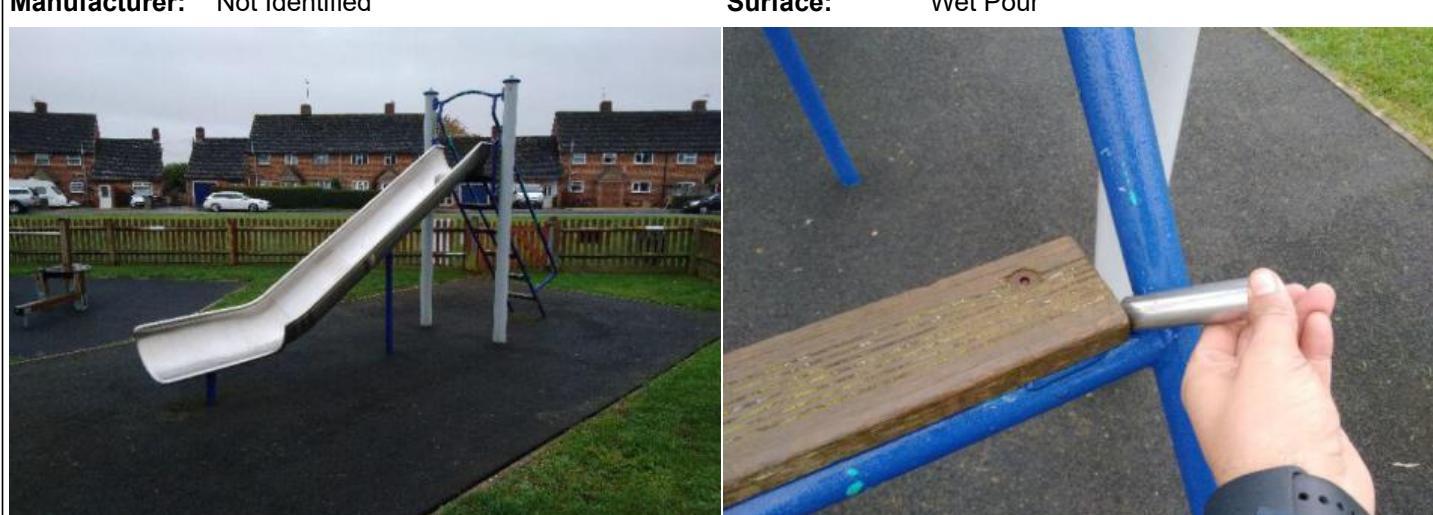
Finding: There is/are finger entrapment/s in the steps and Action: Monitor - No remedial work recommended the item fails to meet the requirements of BS EN 1176 Part 1 4.2.7.6 Entrapment of fingers

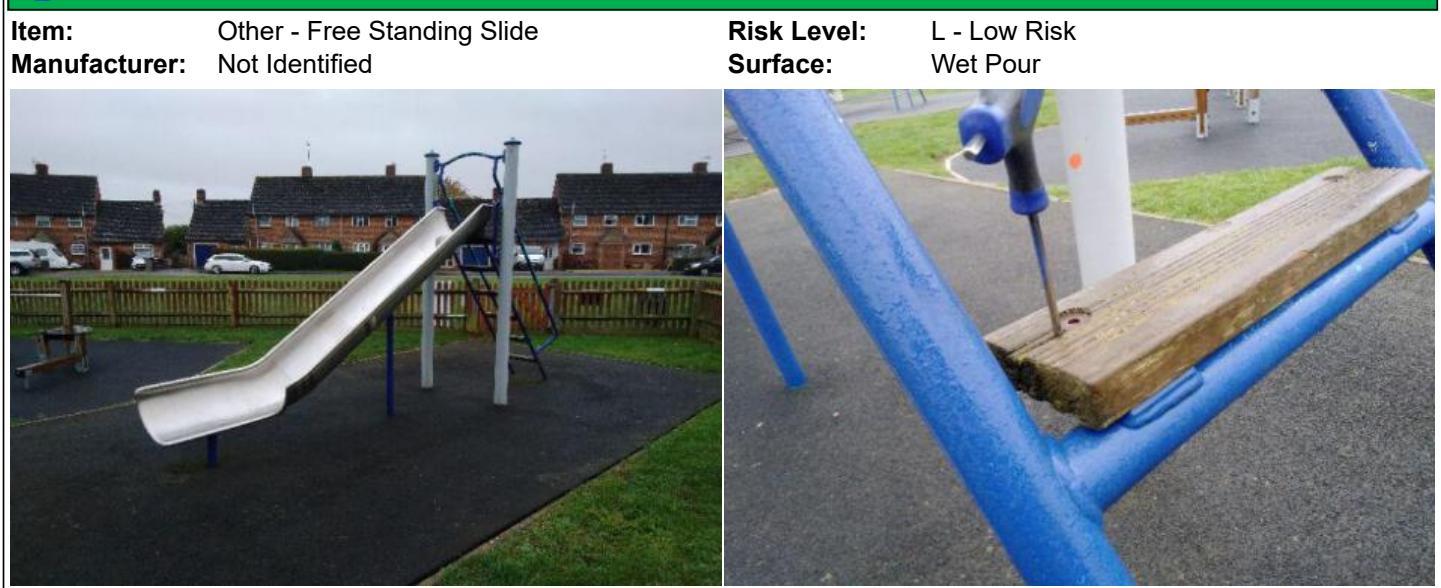
8 - Low Risk (Finding 7)

Finding: There are areas or parts of the timber steps on the **Action:** Replace all affected timbers structure that have rotted

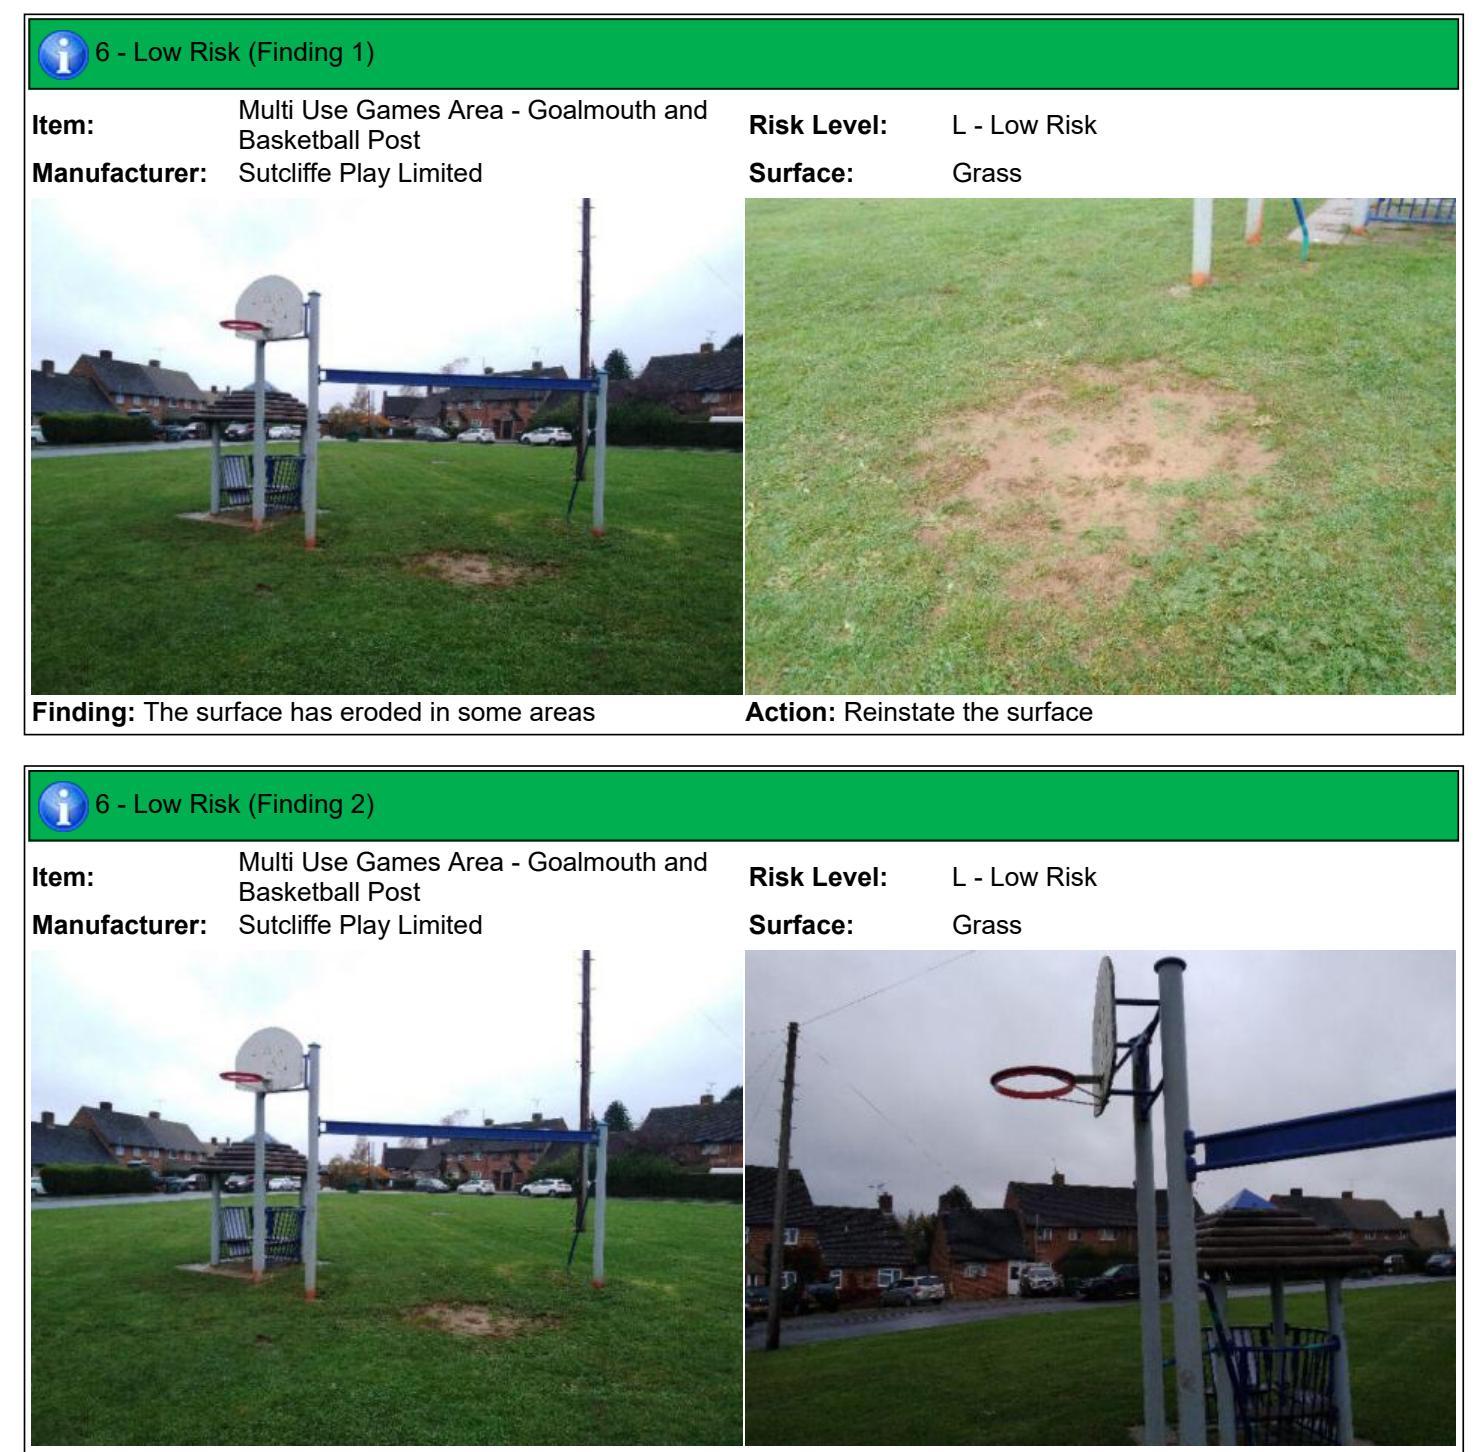
Finding: The free space between the backboard and the framework is less than 600mm and fails the requirements of BS EN15312:2007 +A1 2010

Action: Monitor - No remedial work recommended

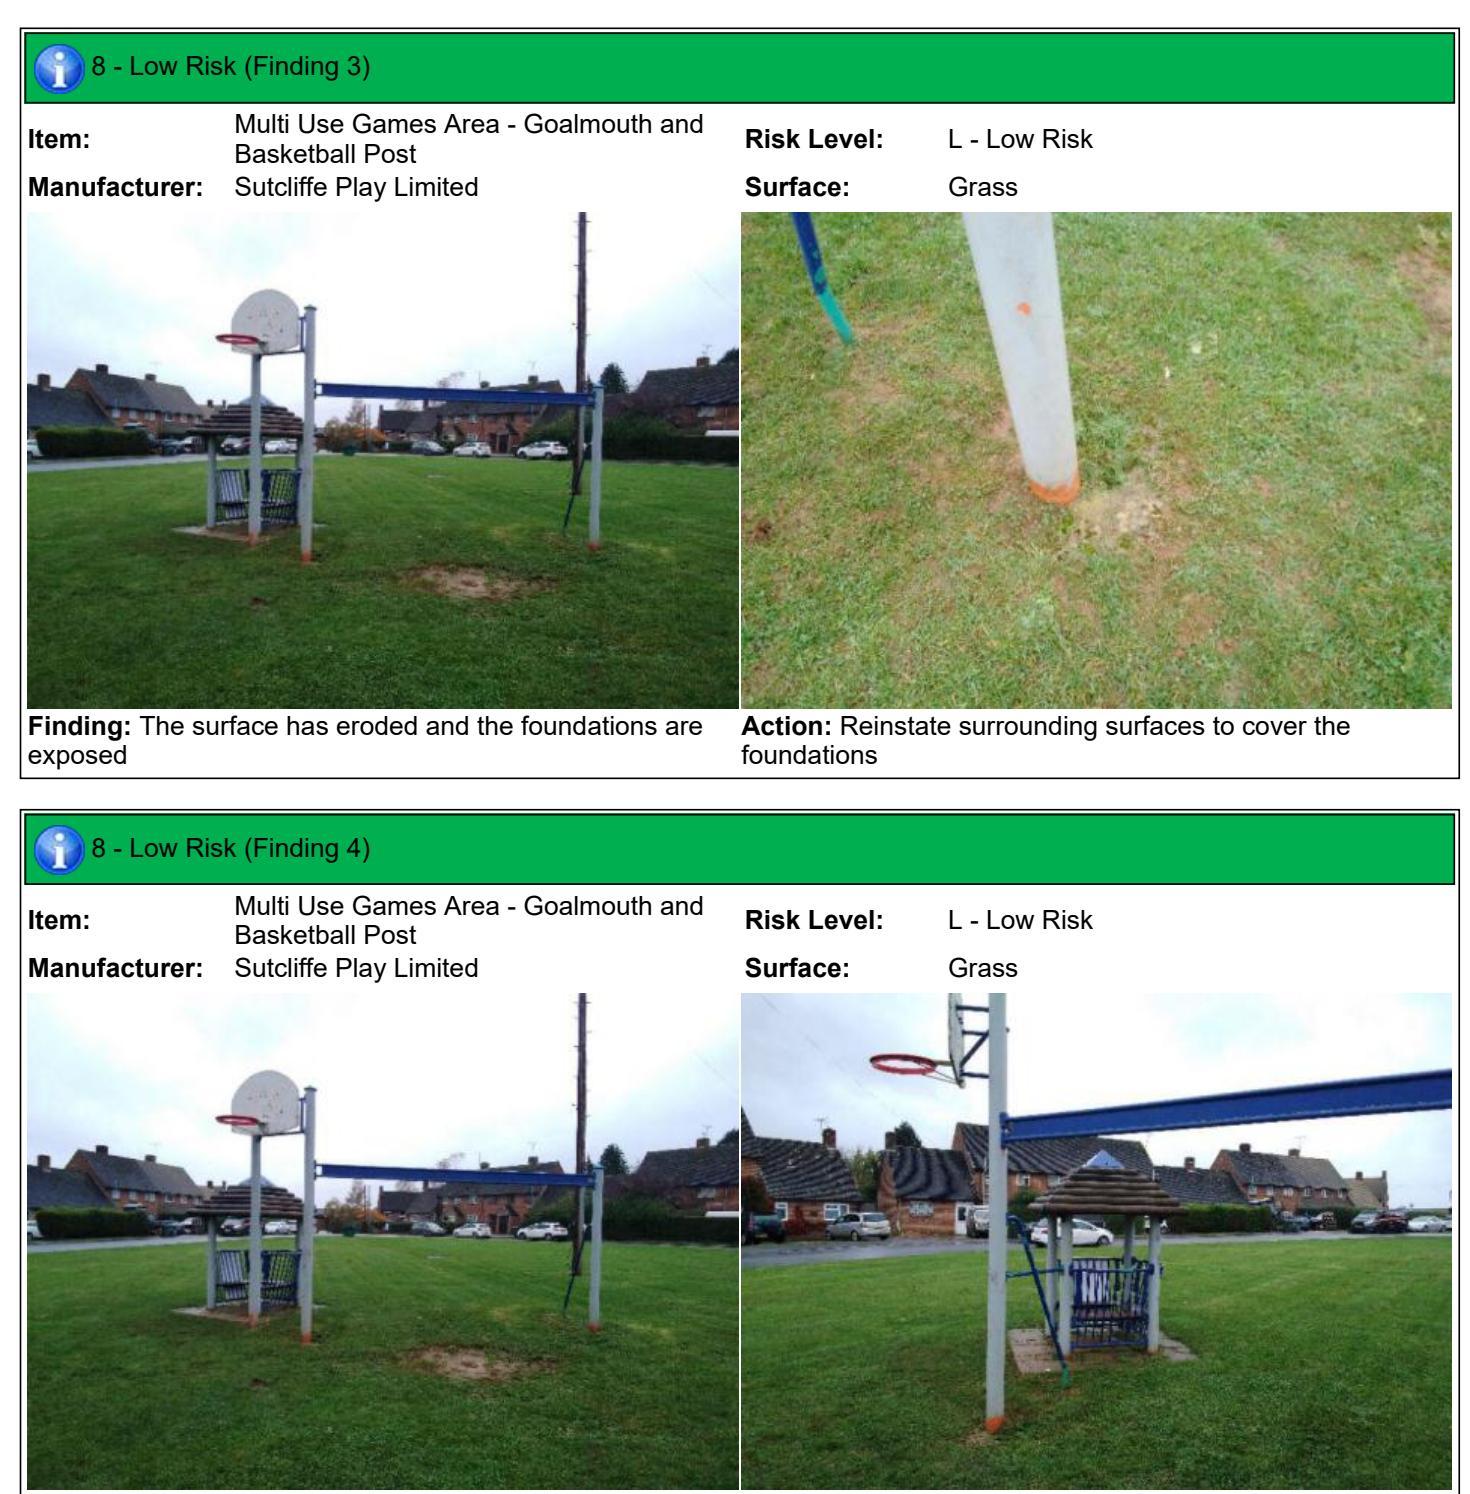
Finding: The location of the adjacent shelter may result in users being struck by stray balls

Action: Monitor use and review risk assessment regularly

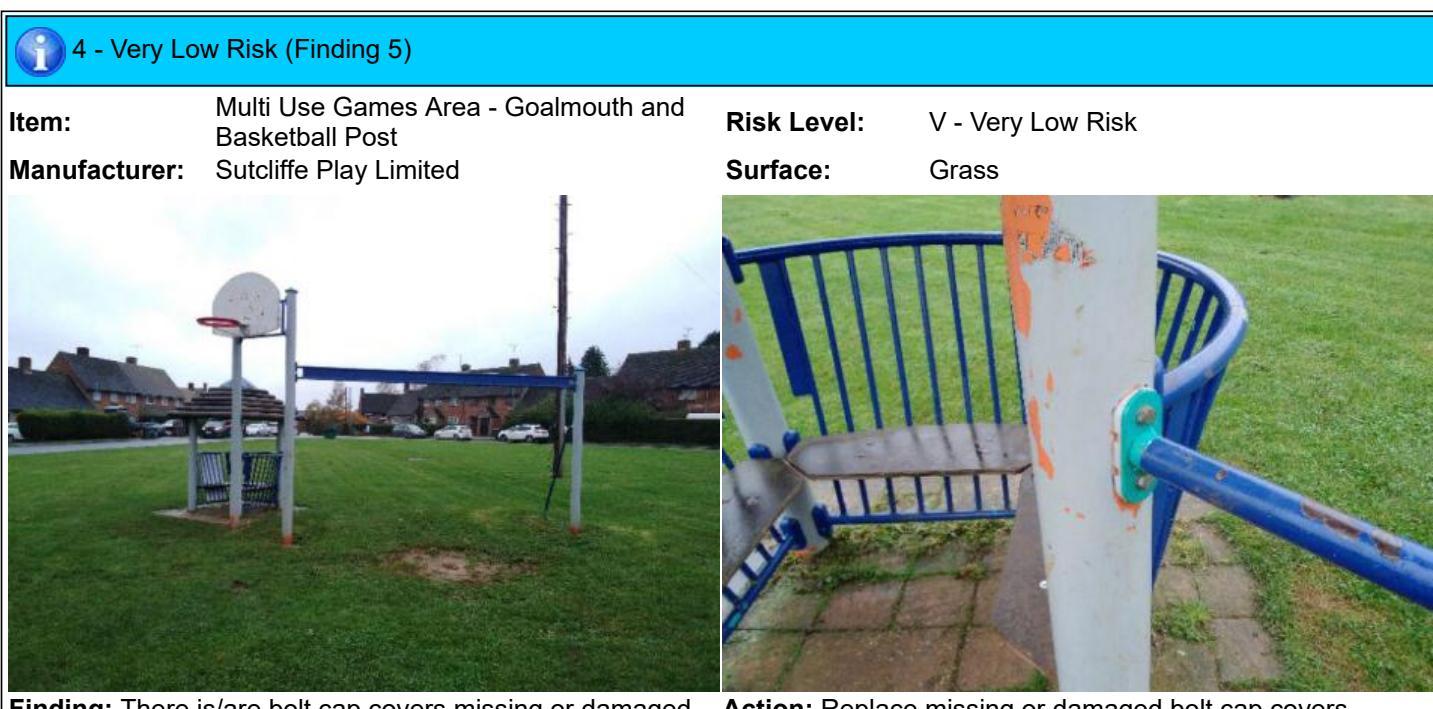
Finding: There is/are bolt cap covers missing or damaged on the item

Action: Replace missing or damaged bolt cap covers

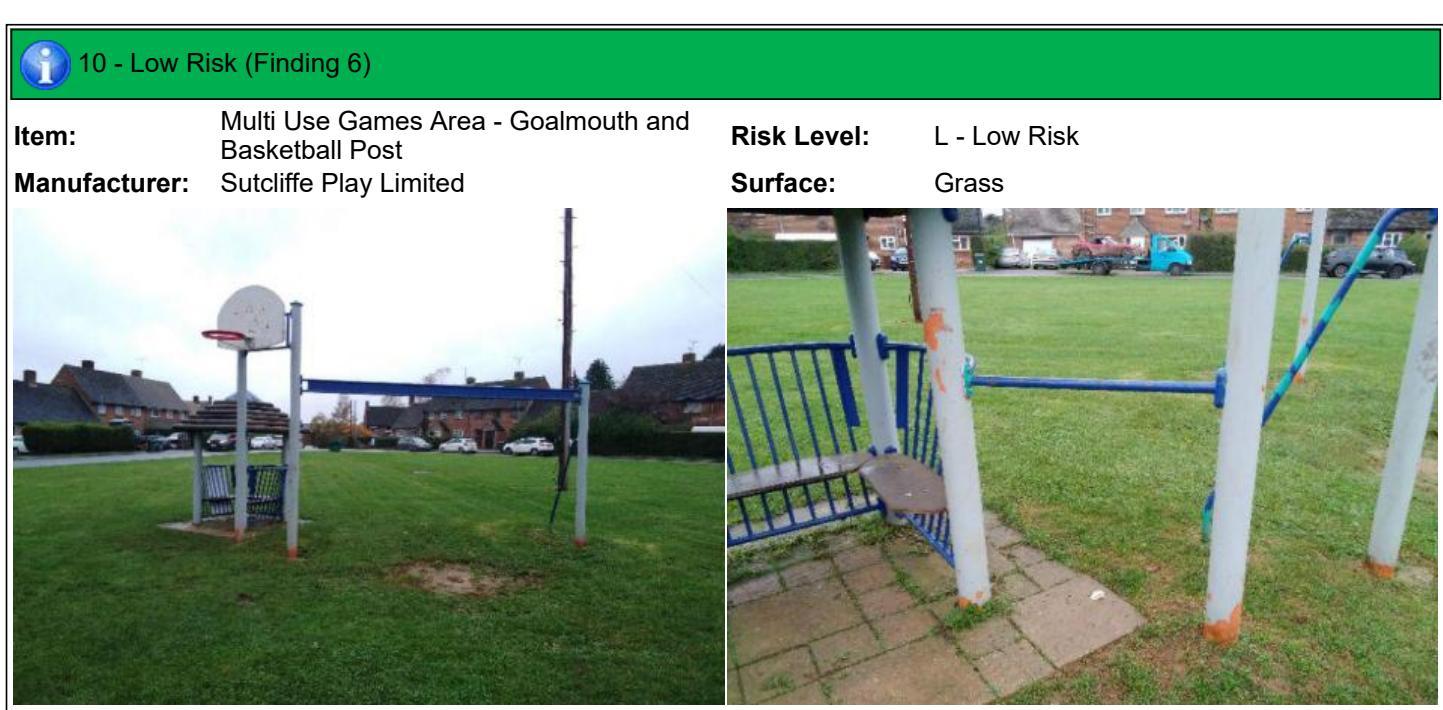
Finding: The design of the equipment may encourage users **Action:** Monitor use and consider providing an appropriate to treat the connecting bar as play equipment and there are impact attenuation surface extending 1500mm from the bar falls over 1000mm onto a hard surface

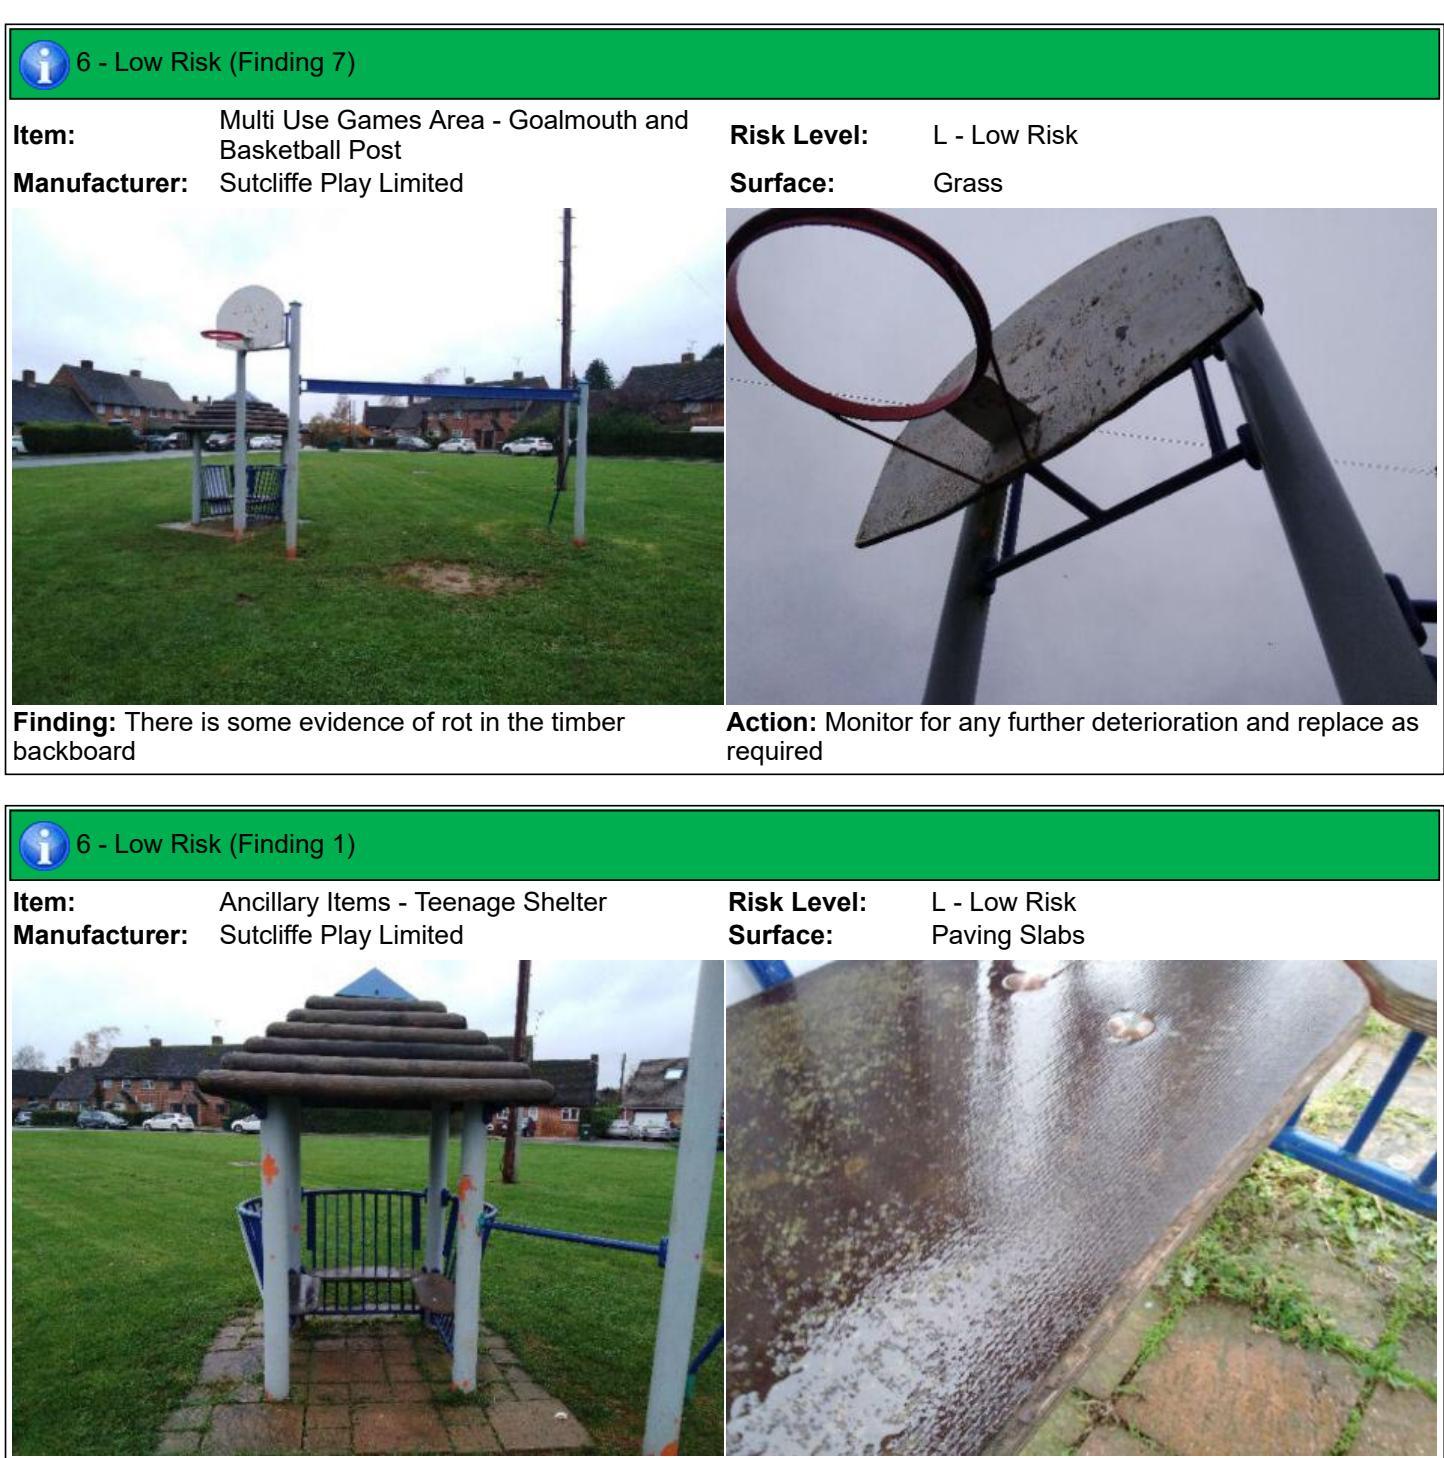
Finding: The timber is rough and worn

Action: Sand down and treat affected areas

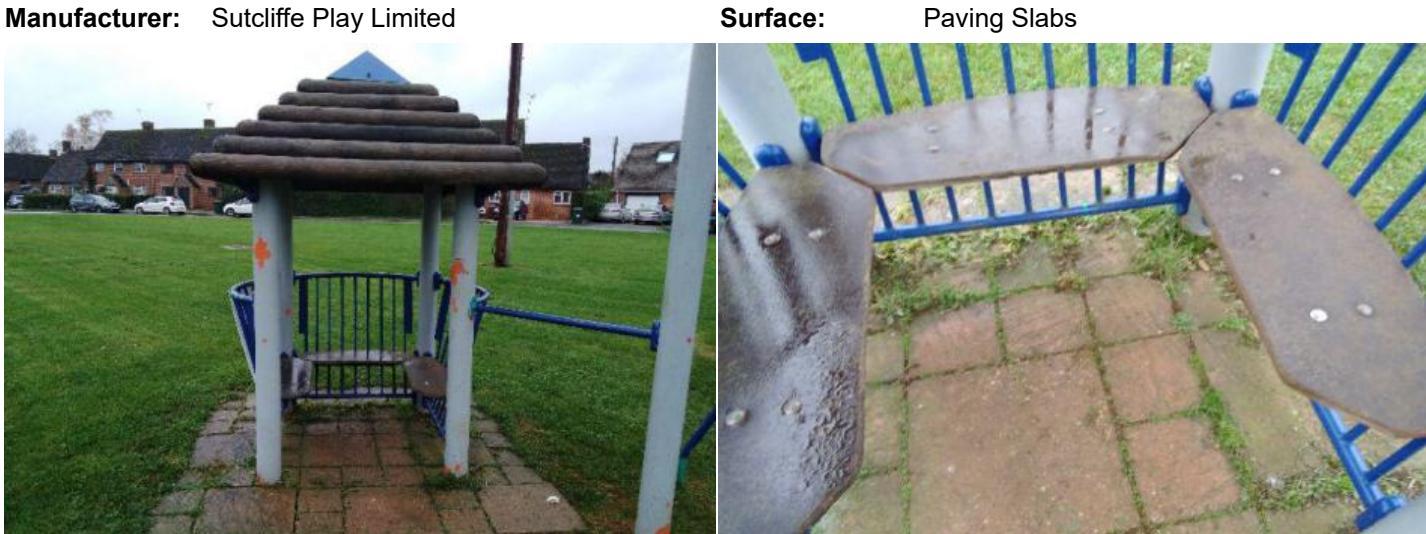
Finding: There are weeds/vegetation growth between or around the edges of the surfacing

Action: Remove weeds/vegetation growth

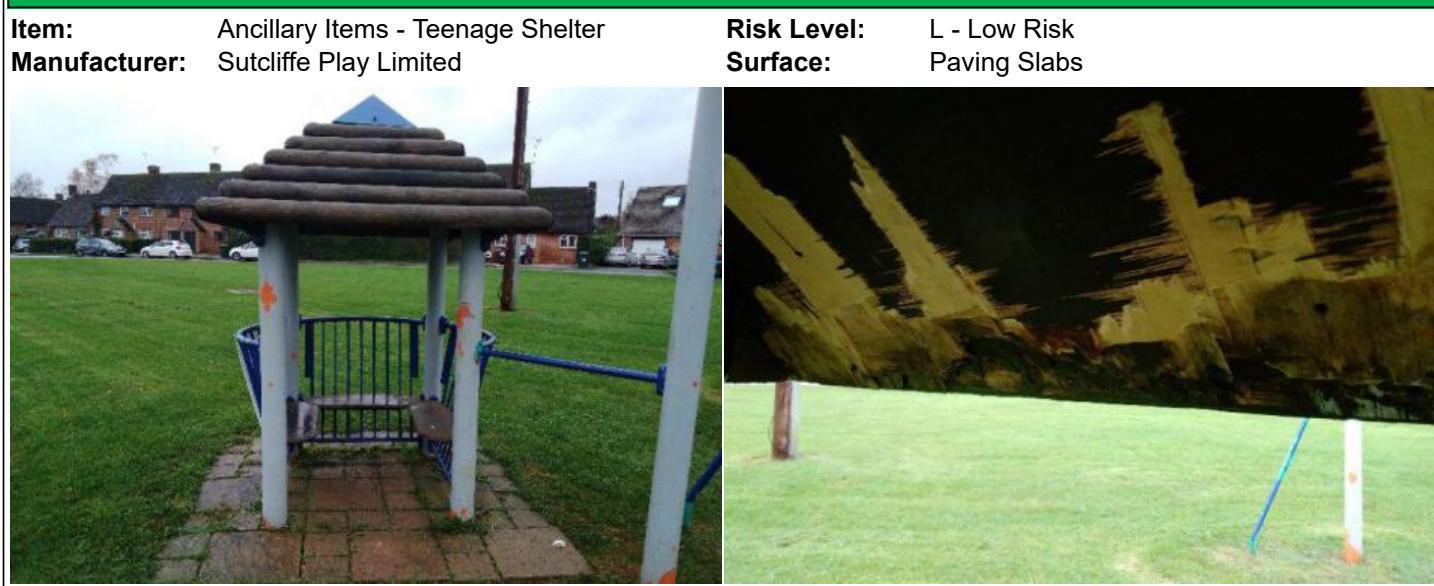
9 - Low Risk (Finding 3)

Finding: There are areas or parts of the timber roof on the Action: Replace all affected timbers structure that have rotted
