the play inspection company

Annual Inspection

Adderbury Parish Council

Lucy Placket Playing Field

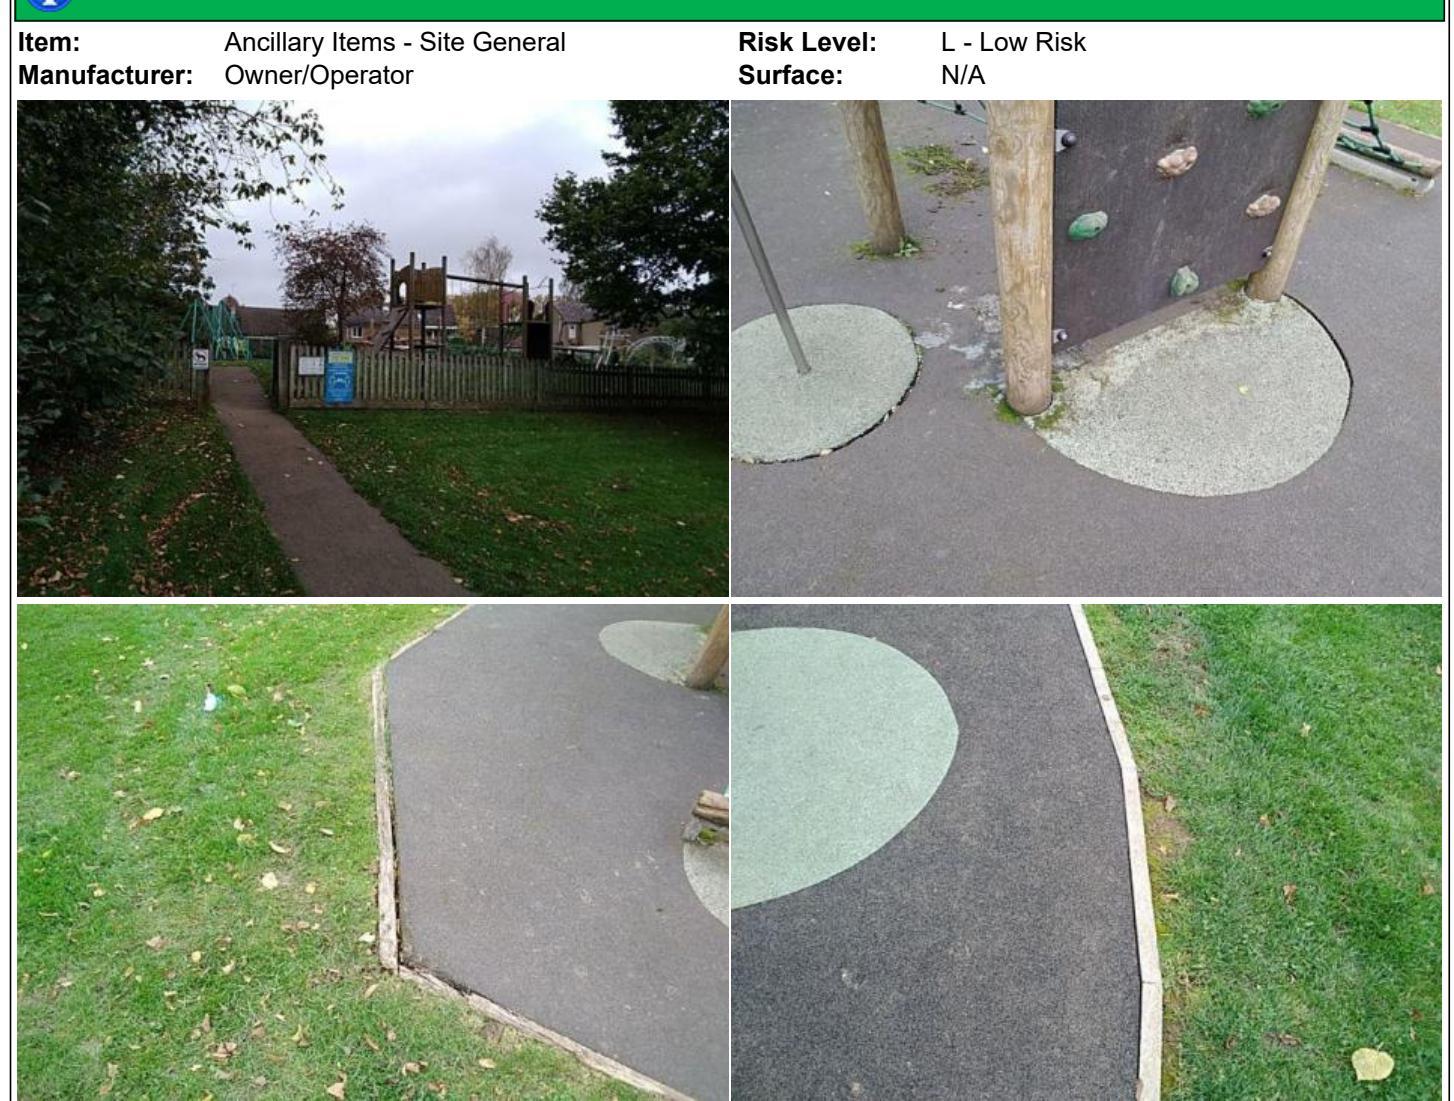
6 - Low Risk (Finding 2)

Finding: There are gaps opening between the surfacing and **Action:** Monitor for any further deterioration and repair as the edging surround or between the joints in the surfacing required

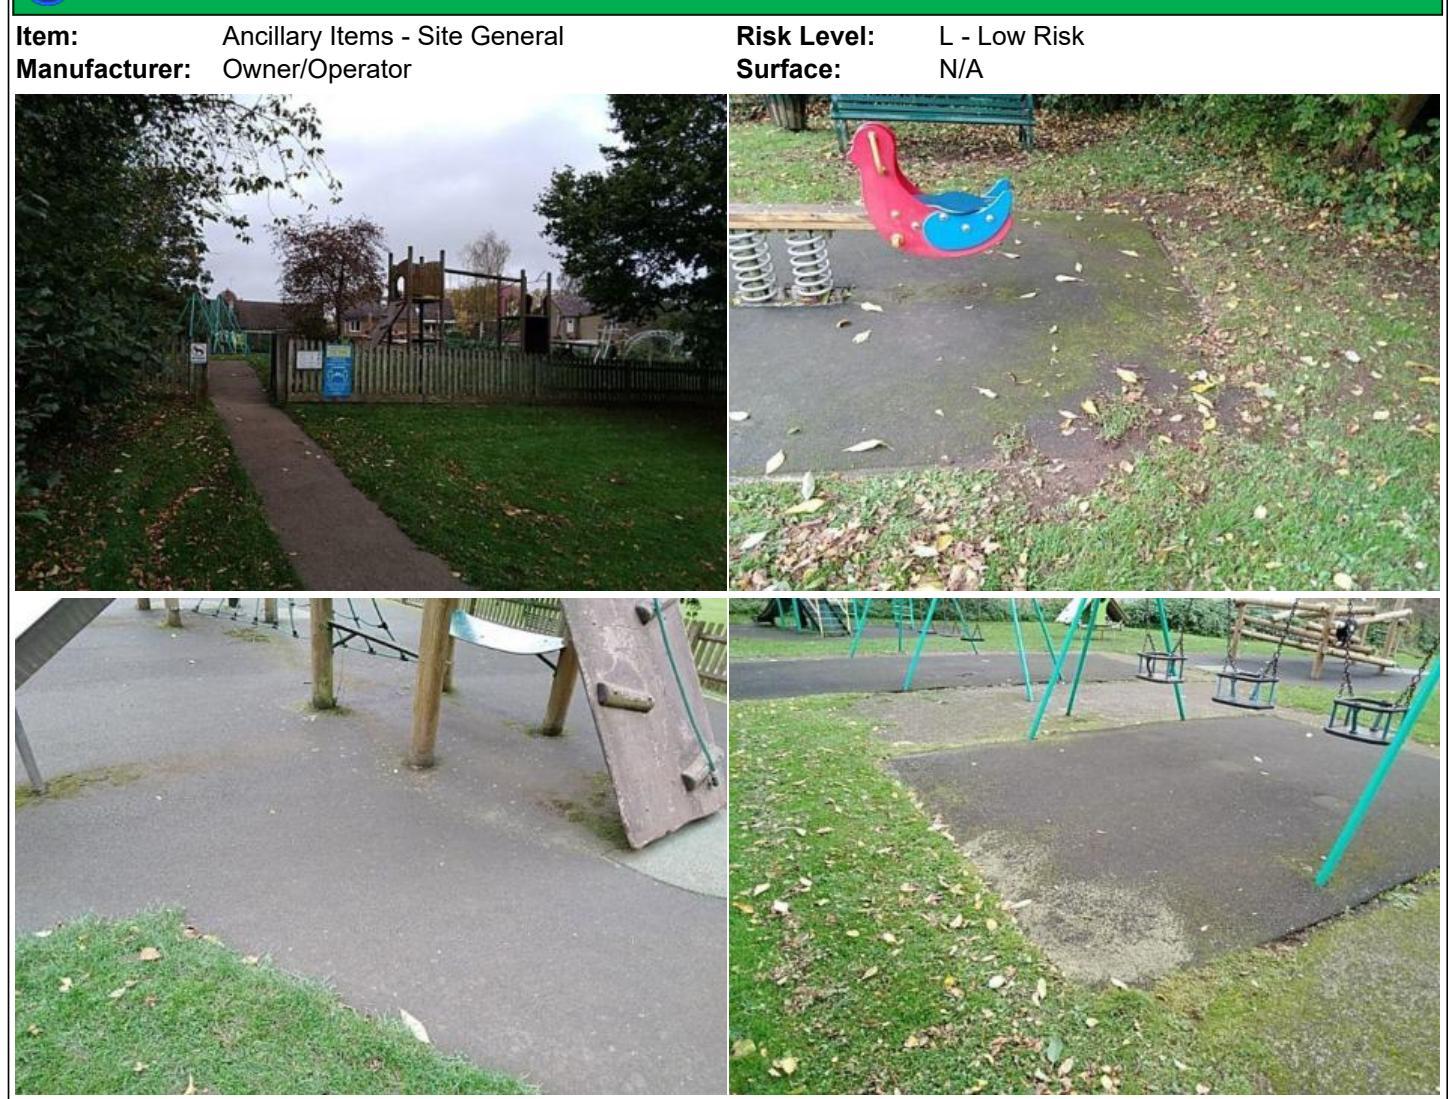
8 - Low Risk (Finding 3)

Finding: There is algae or moss growth on the surface resulting in slippery conditions

Action: Clean and treat appropriately

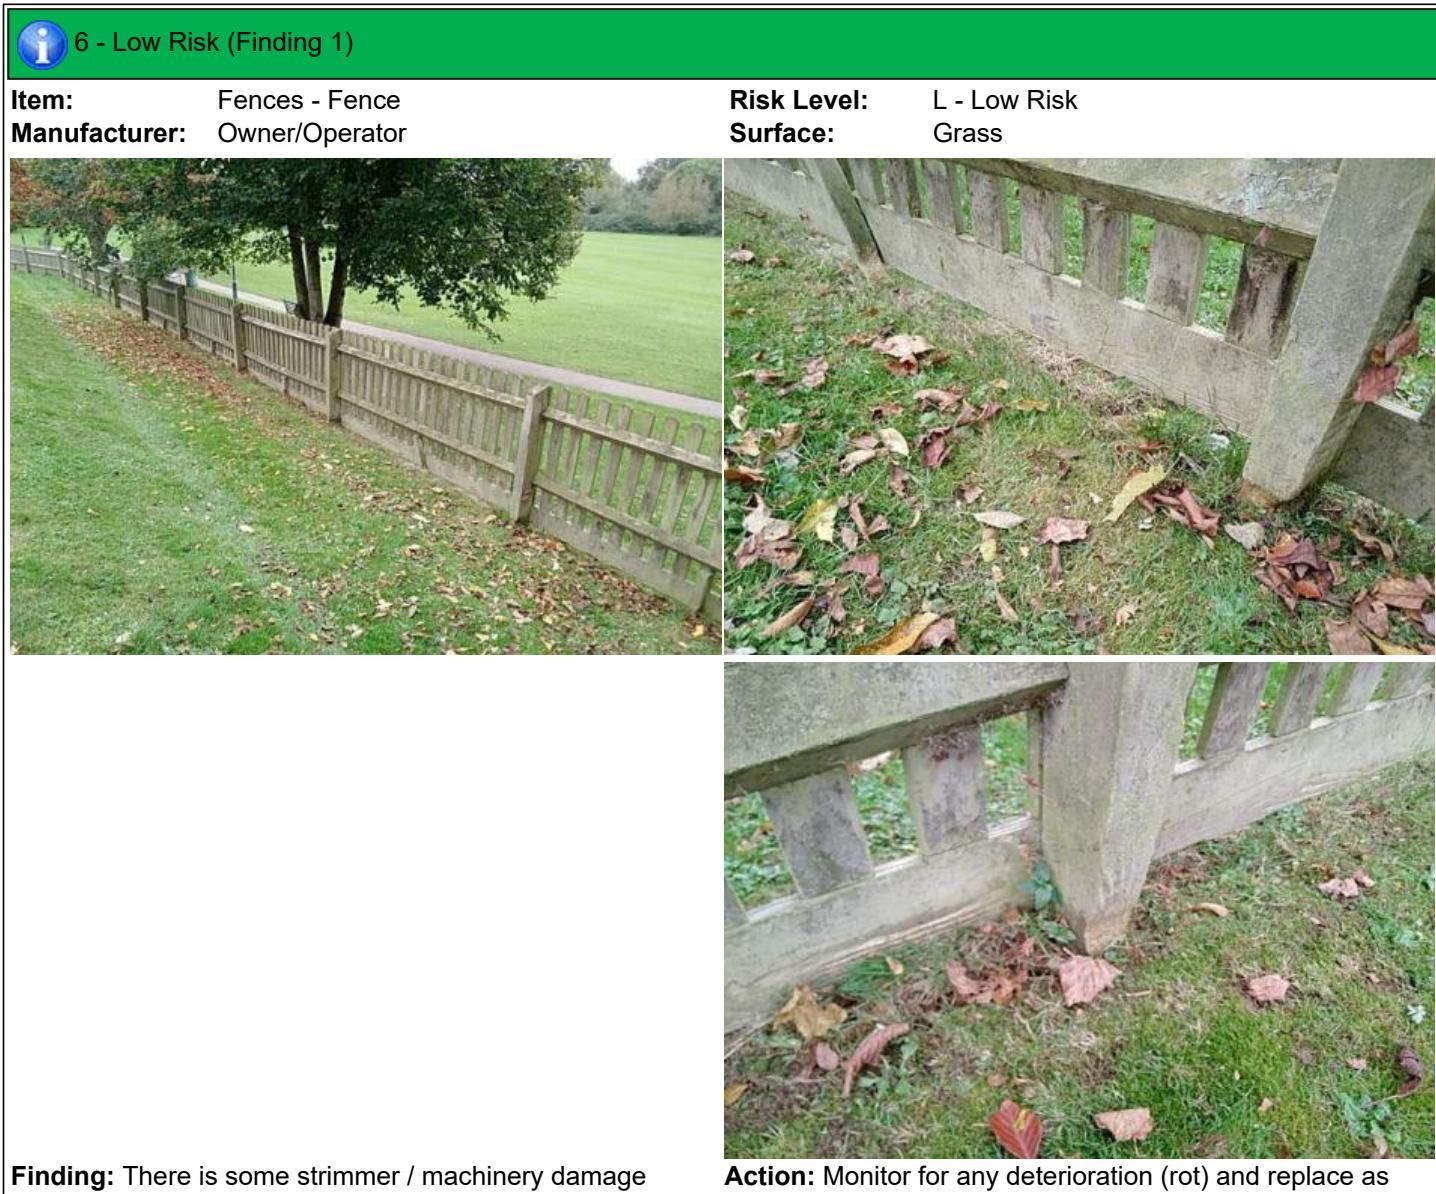
Finding: There is some strimmer / machinery damage apparent on the posts, this can penetrate the preservative applied to the timber and accelerate the rotting process

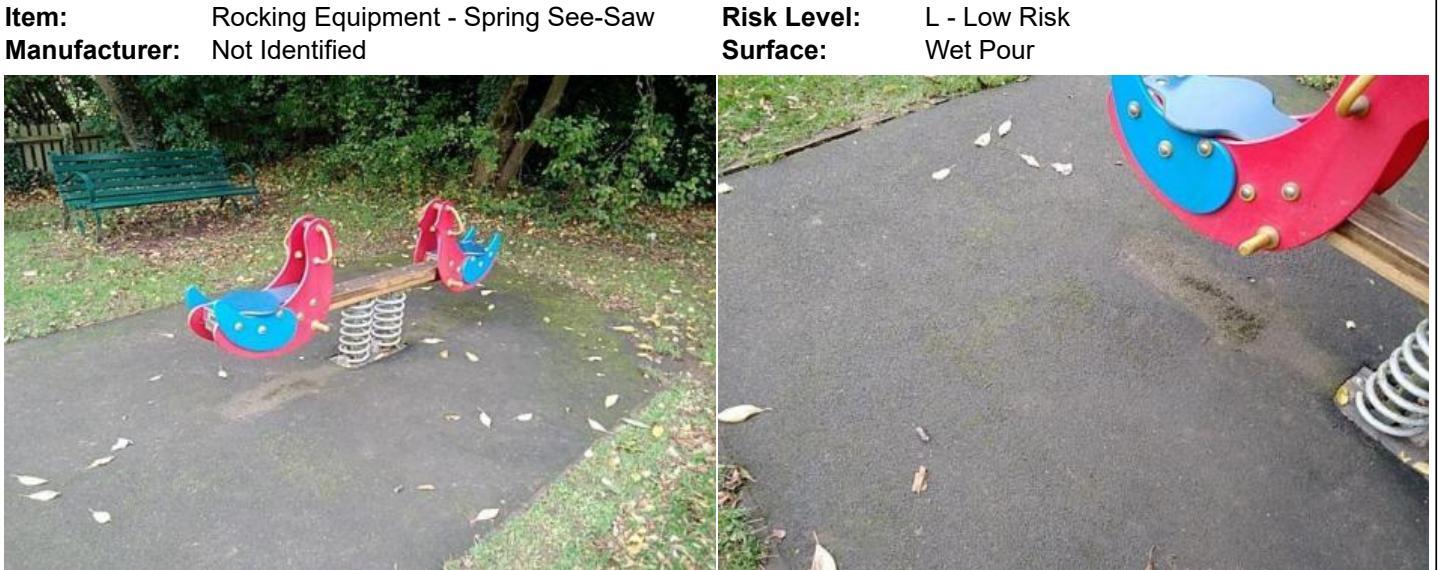
6 - Low Risk (Finding 2)

Finding: The safety surface around the area is beginning to Action: Monitor for any further deterioration and repair as required wear

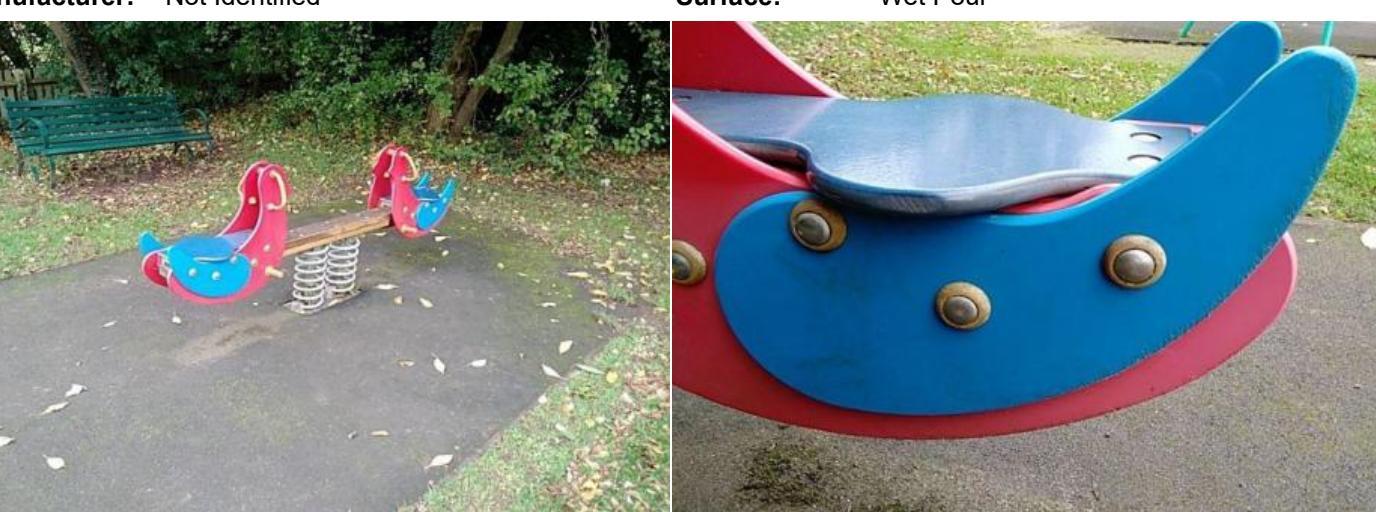
Finding: There is some damage to the item

Action: Monitor for any further deterioration and repair as required

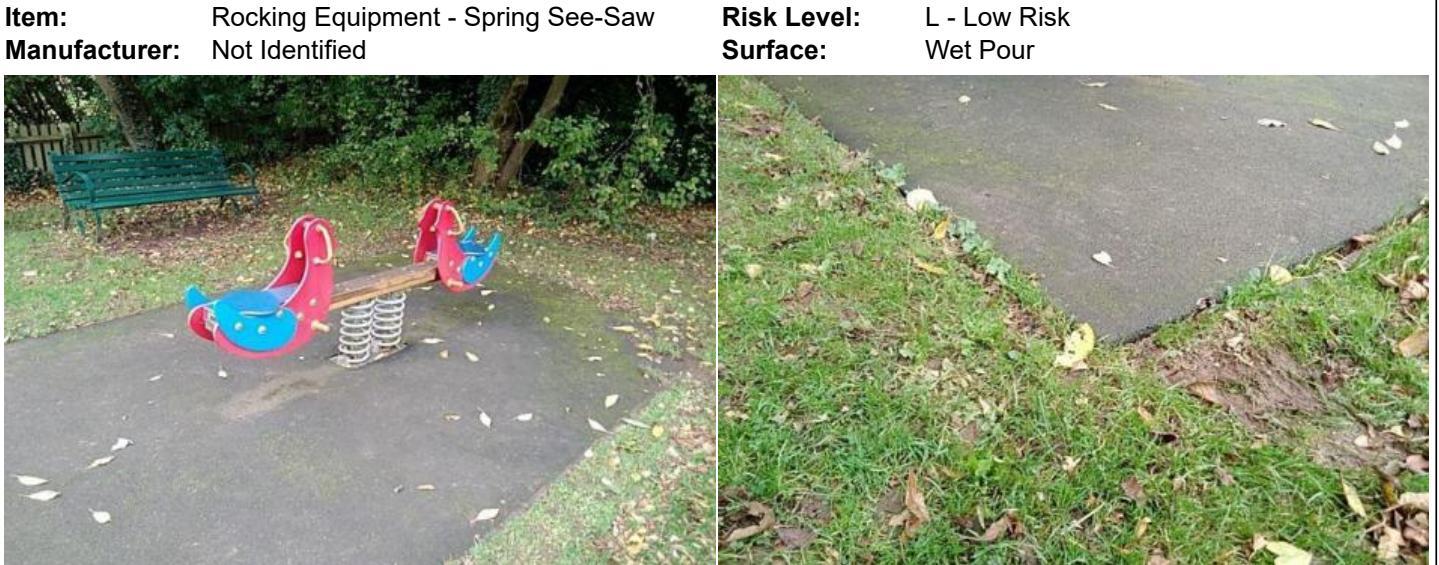
Finding: The surface is lifting at the edges and creating trip Action: Repair perimeter of surfacing to remove trip points points

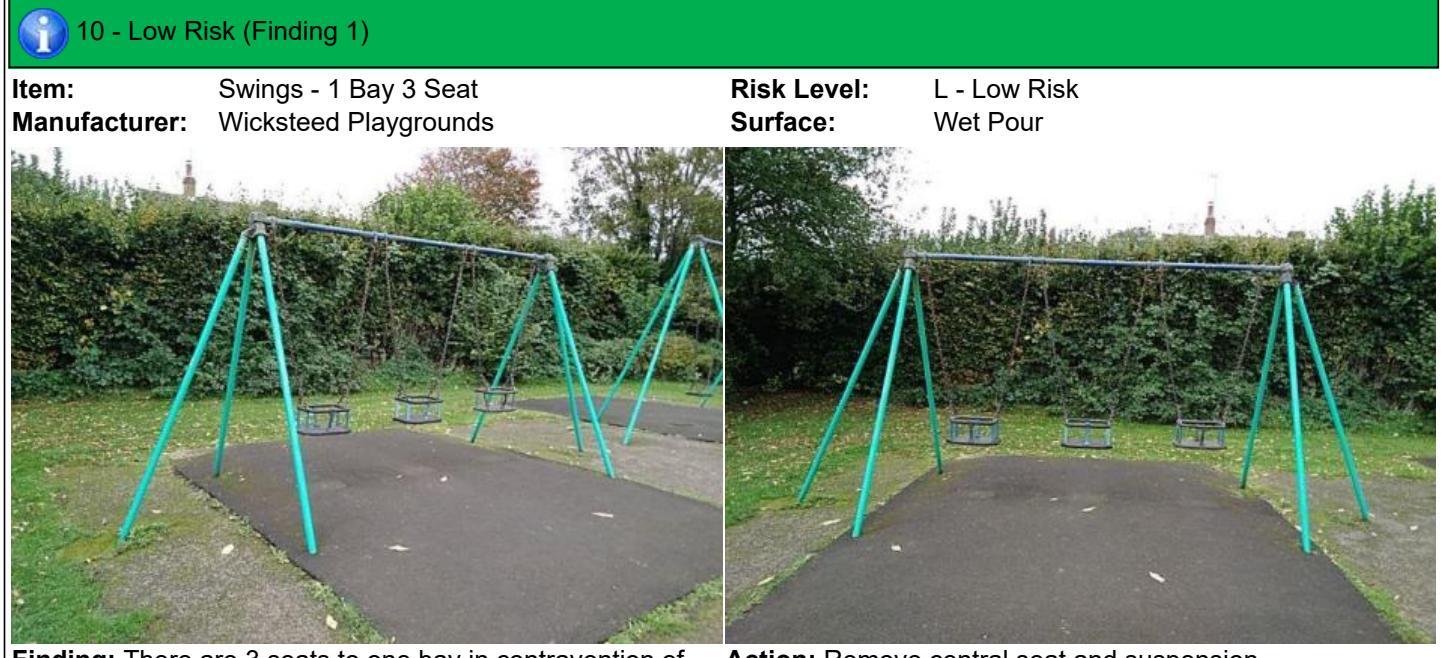
Finding: There are 3 seats to one bay in contravention of BS EN 1176 Part 2; the central suspension and seat should be removed to prevent users running into the adjacent seats

Action: Remove central seat and suspension

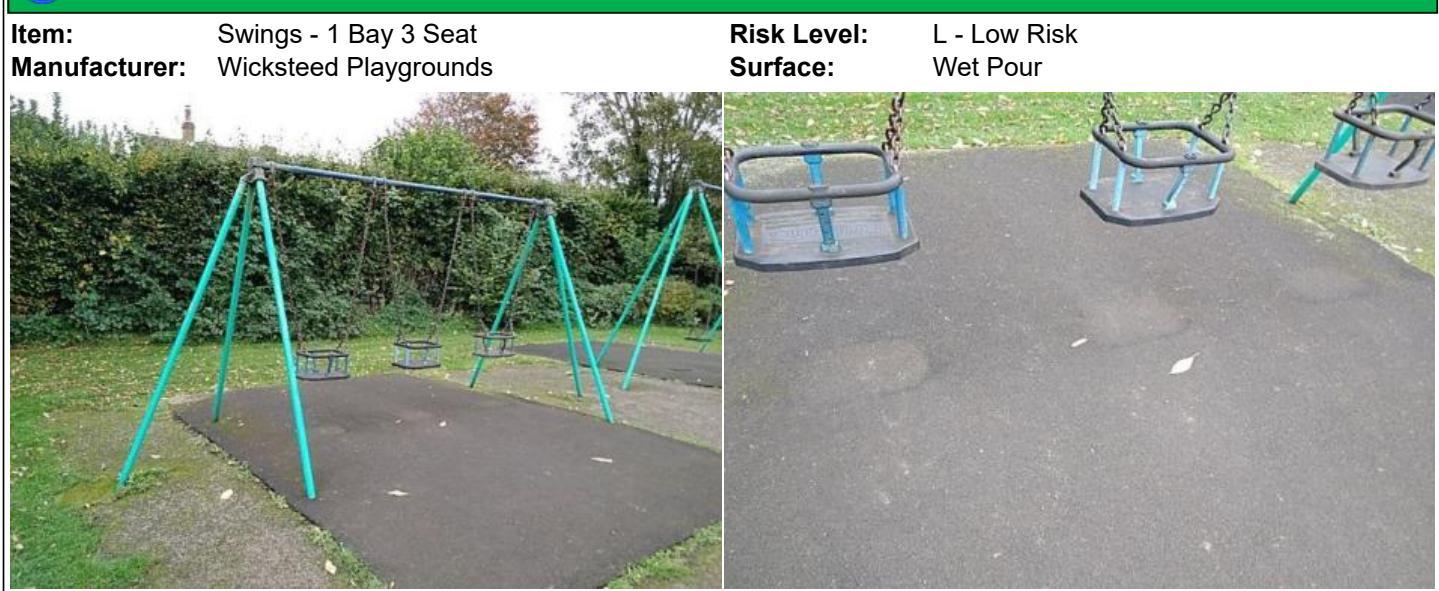
6 - Low Risk (Finding 2)

Finding: The safety surface around the area is beginning to wear **Action:** Monitor for any further deterioration and repair as required

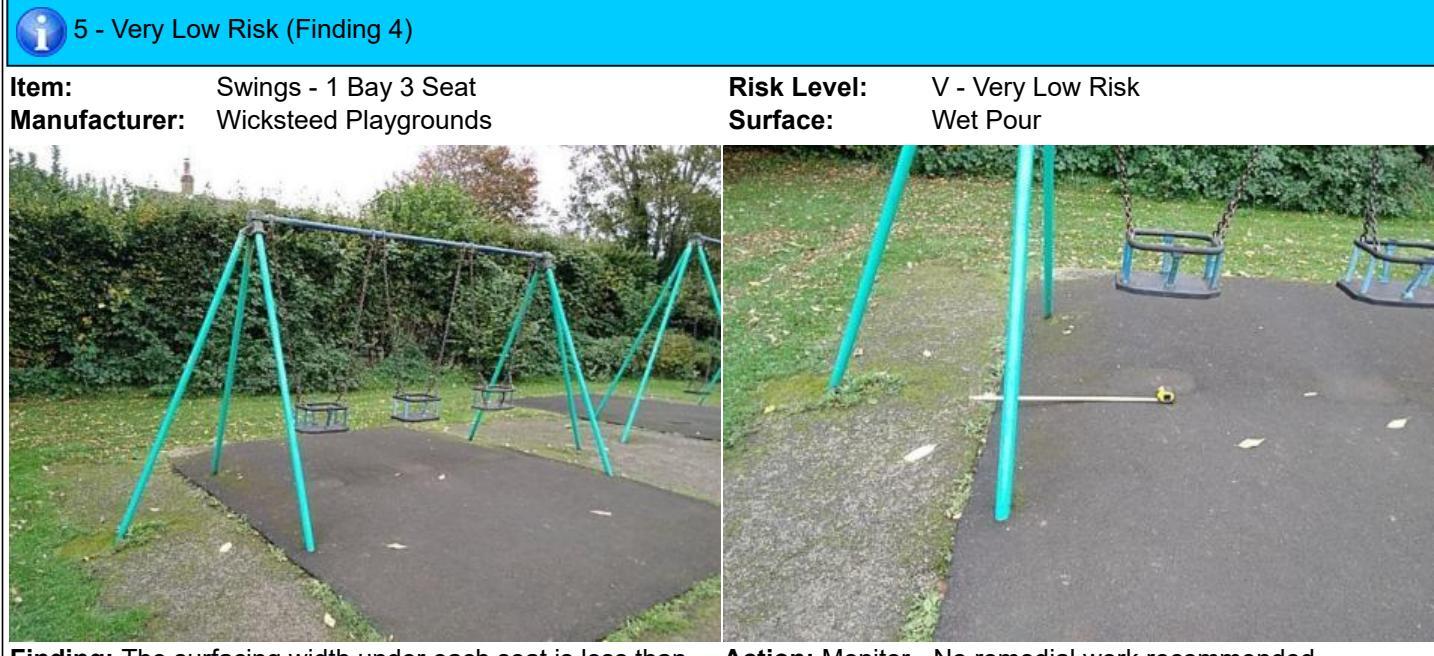
10 - Low Risk (Finding 3) Item: Swings - 1 Bay 3 Seat Manufacturer: Wicksteed Playgrounds Surface: Wet Pour

Finding: The surfacing width under each seat is less than **Action:** Monitor - No remedial work recommended 1.75 metres and fails the requirements of BS EN 1176 Part 2

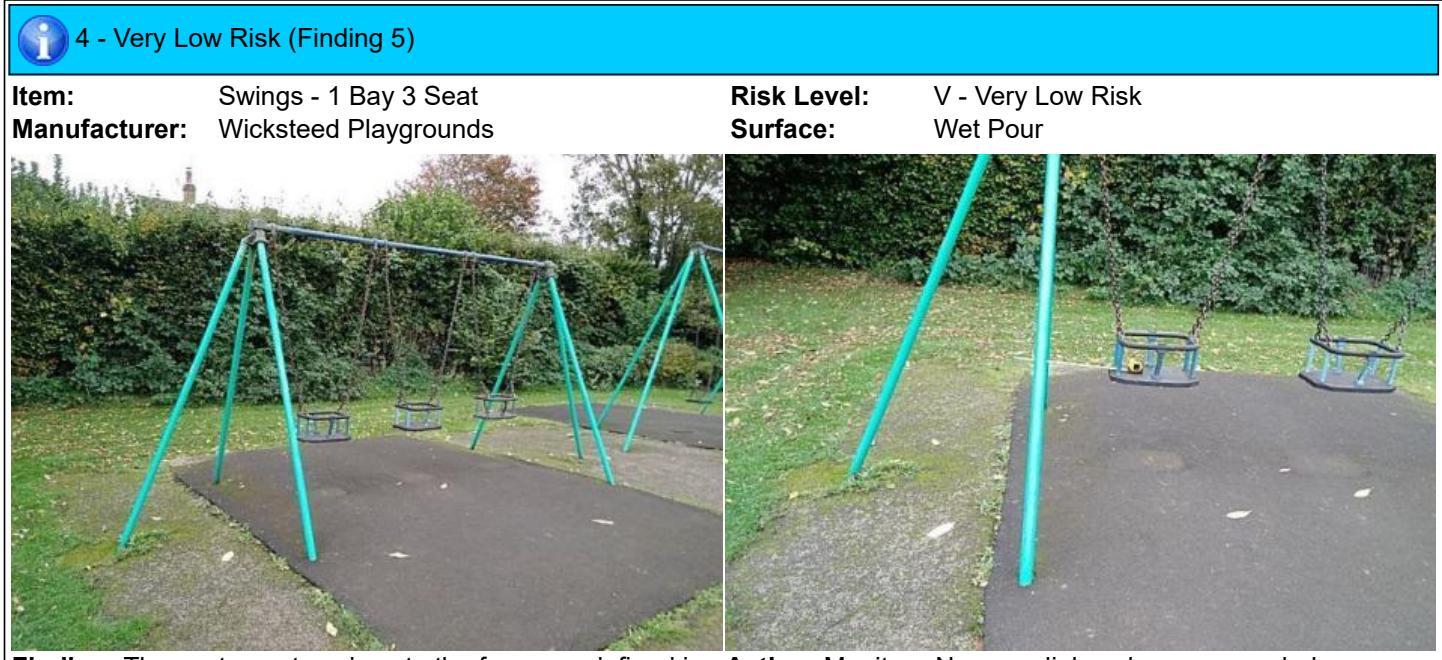
Finding: The seats are too close to the frame as defined in **Action:** Monitor - No remedial work recommended BS EN 1176 Part 2; this is a low risk failure and no remedial action is required

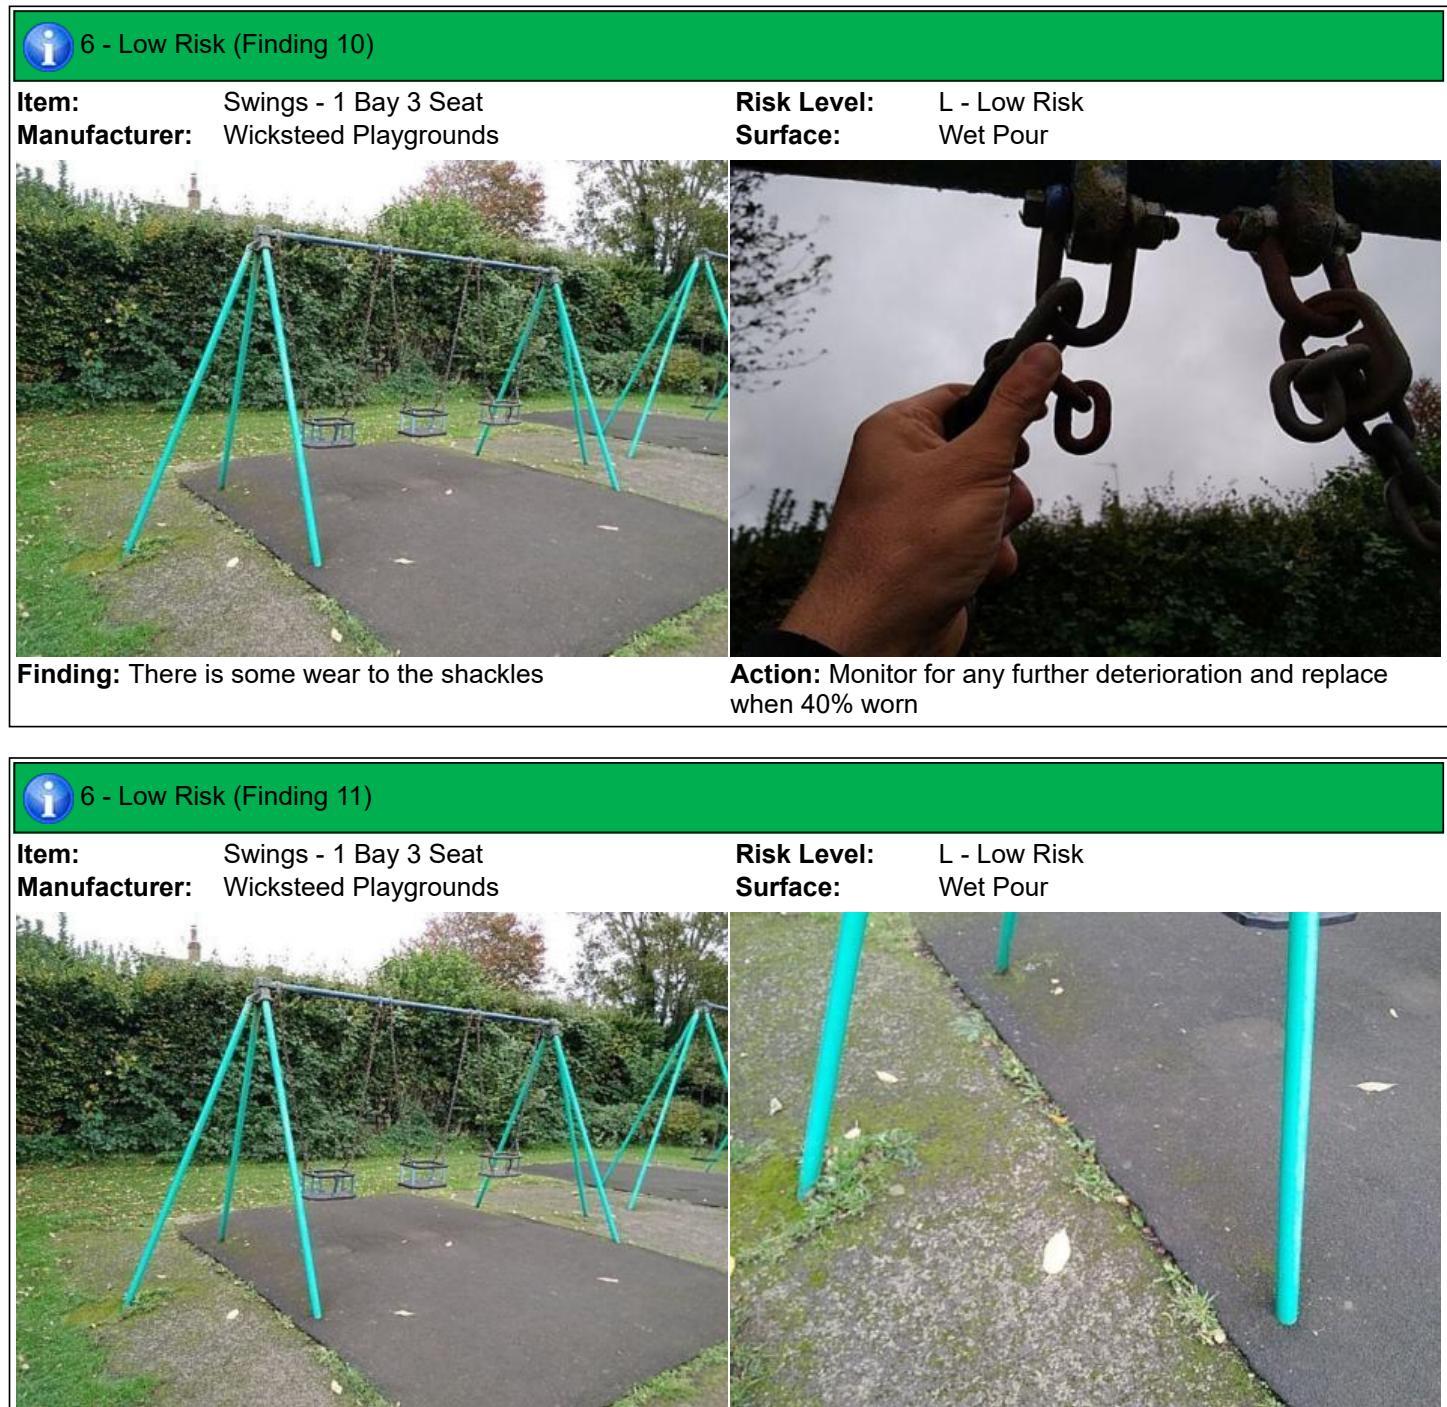
Finding: There is weed / vegetation growth on, between, or **Action:** Remove weed / vegetation growth around the edges of the surfacing

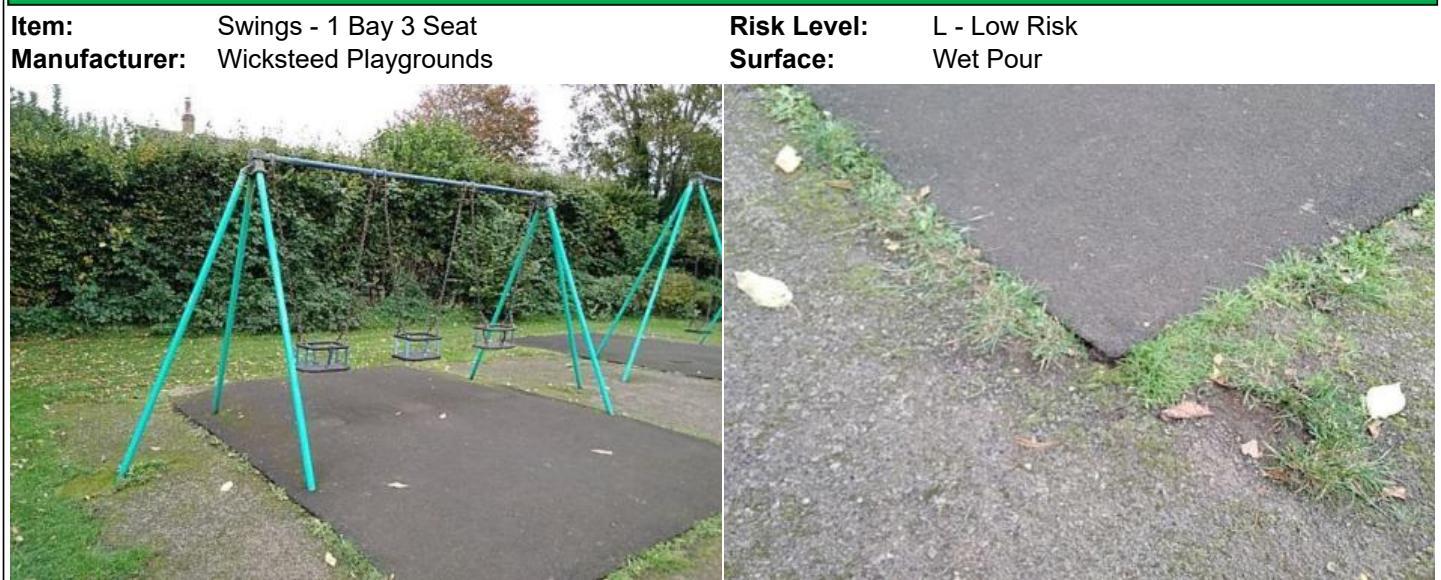
8 - Low Risk (Finding 12)

Finding: The surface is lifting at the edges and creating trip **Action:** Repair perimeter of surfacing to remove trip points points

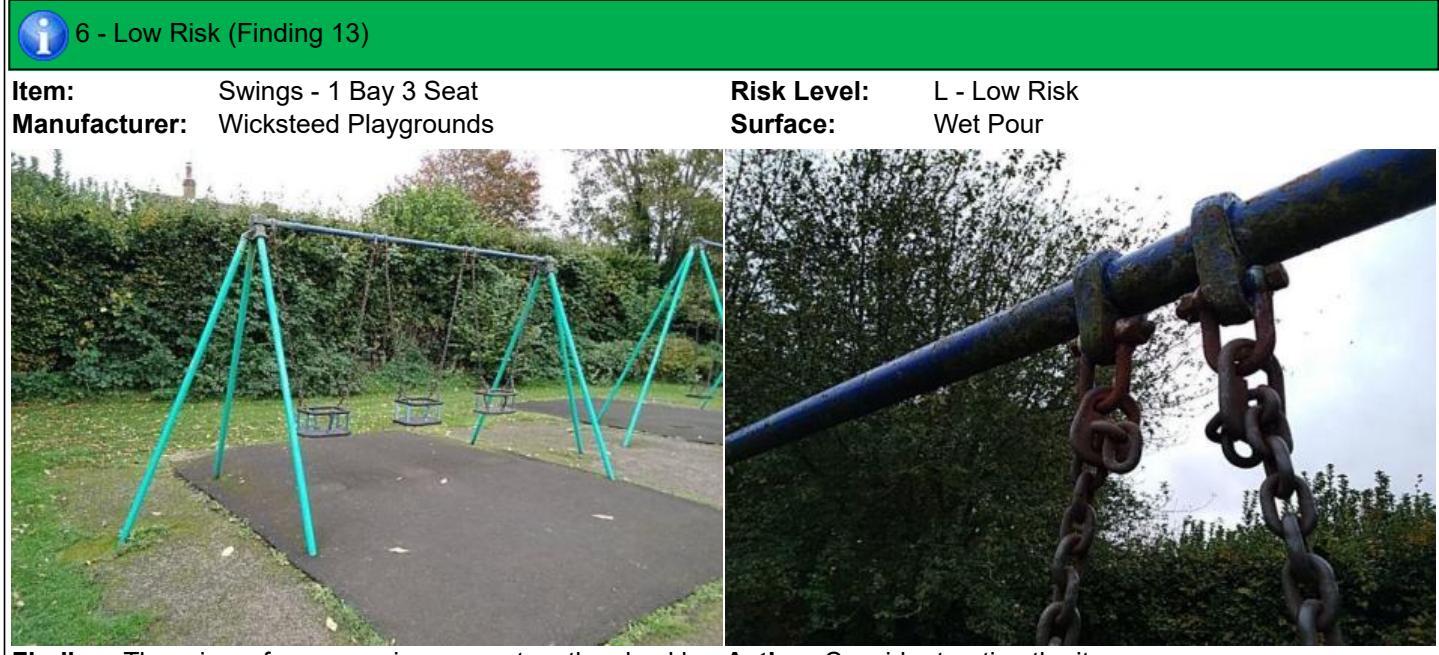
Finding: There is surface corrosion present on the shackles Action: Consider treating the item

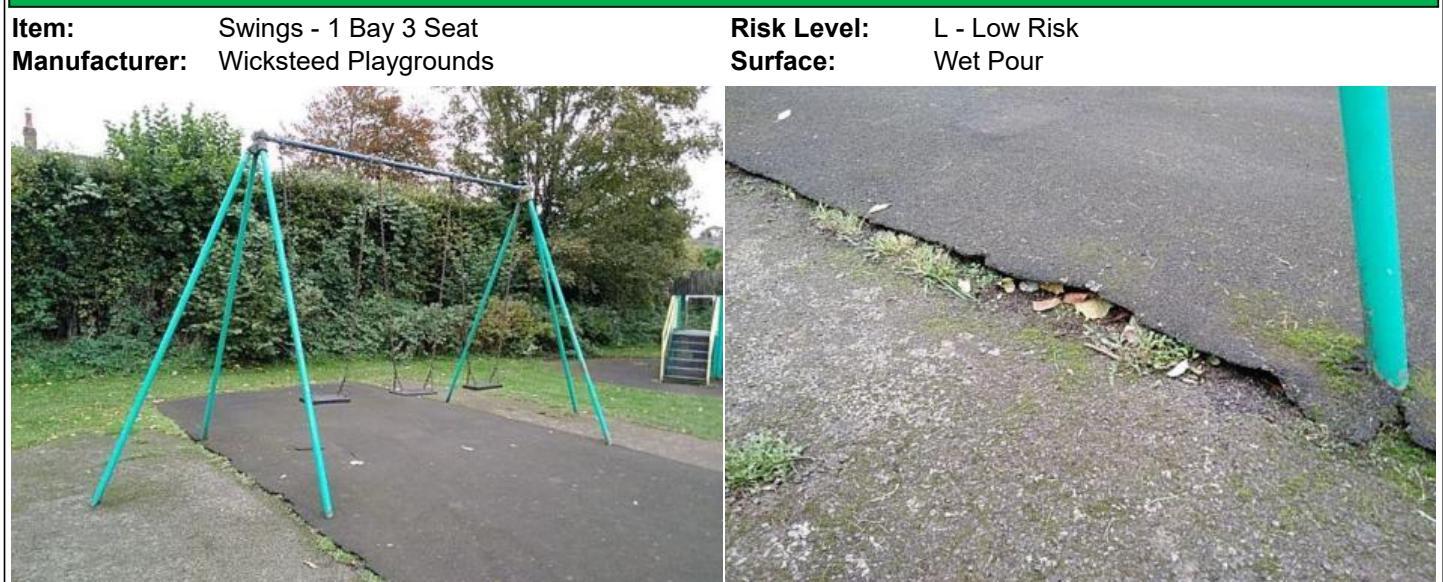
8 - Low Risk (Finding 3)

Finding: The surface is lifting at the edges and creating trip **Action:** Repair perimeter of surfacing to remove trip points

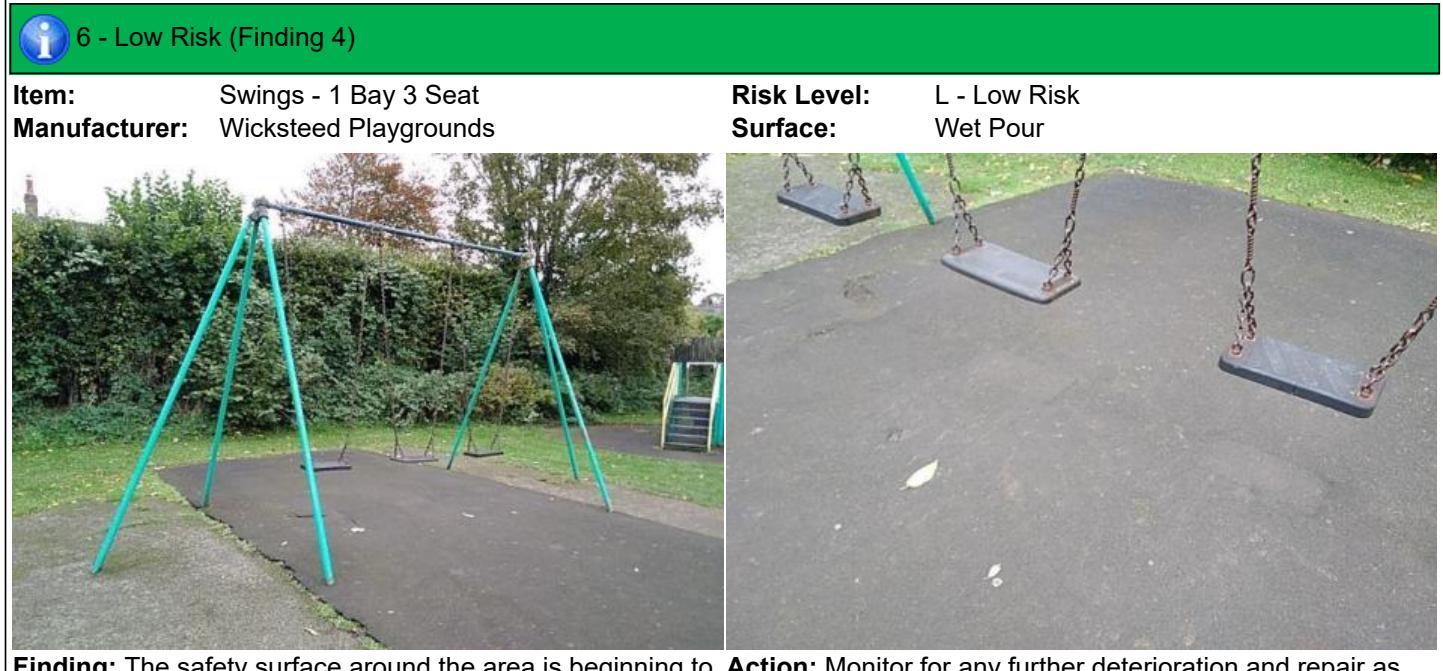
Finding: The safety surface around the area is beginning to Action: Monitor for any further deterioration and repair as required

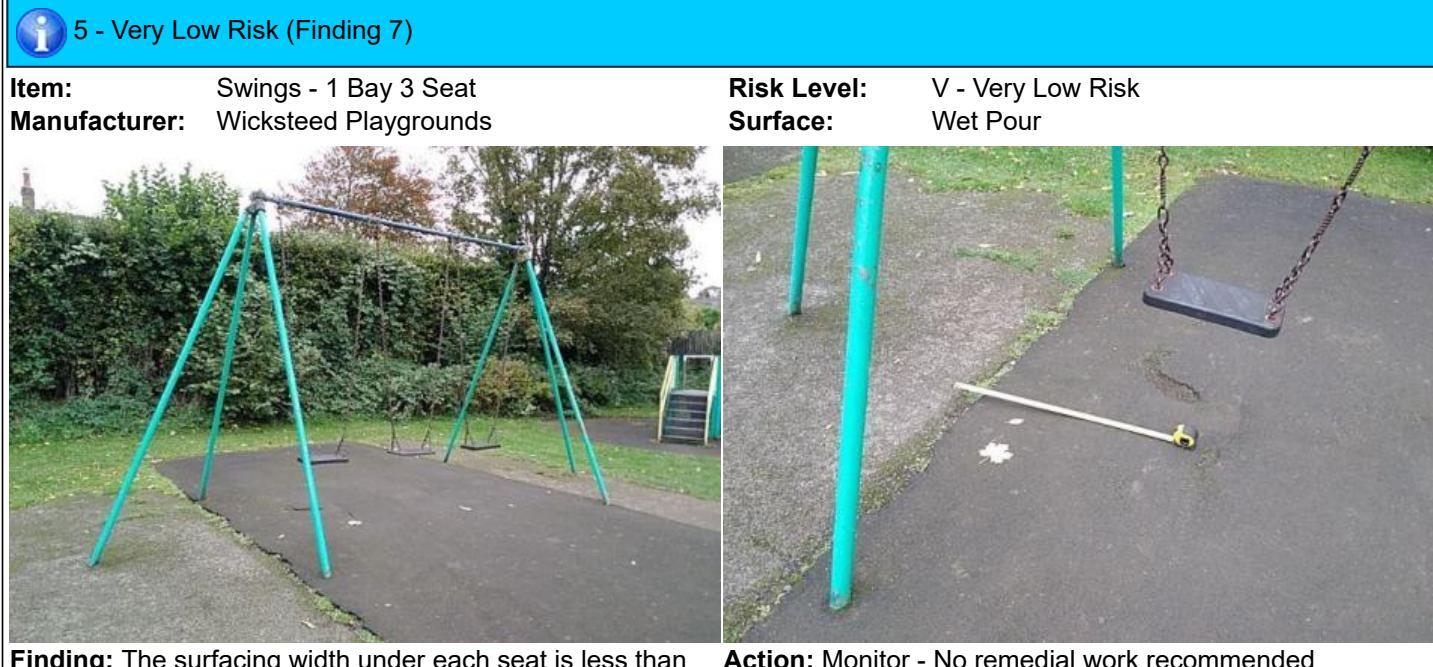
Finding: The surfacing width under each seat is less than Action: Monitor - No remedial work recommended 1.75 metres and fails the requirements of BS EN 1176 Part 2

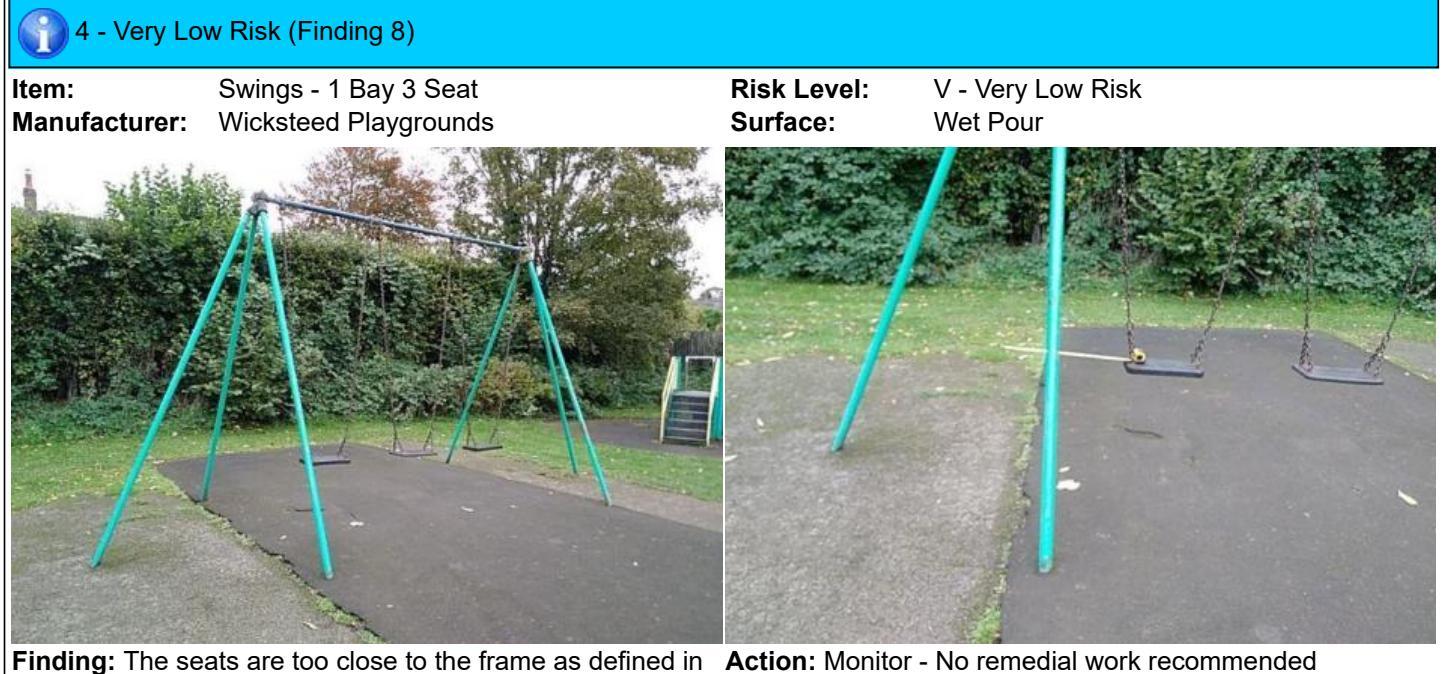
BS EN 1176 Part 2; this is a low risk failure and no remedial action is required

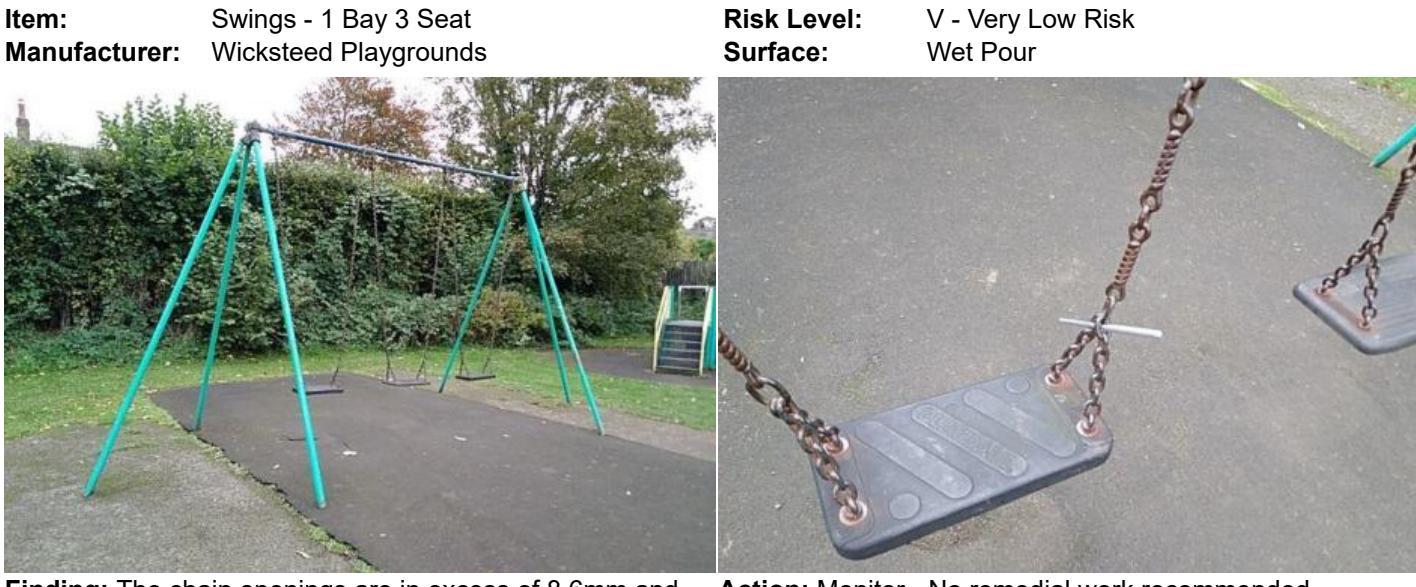
Finding: The chain openings are in excess of 8.6mm and do not meet the recommendations of BS EN 1176 Part 1

Action: Monitor - No remedial work recommended

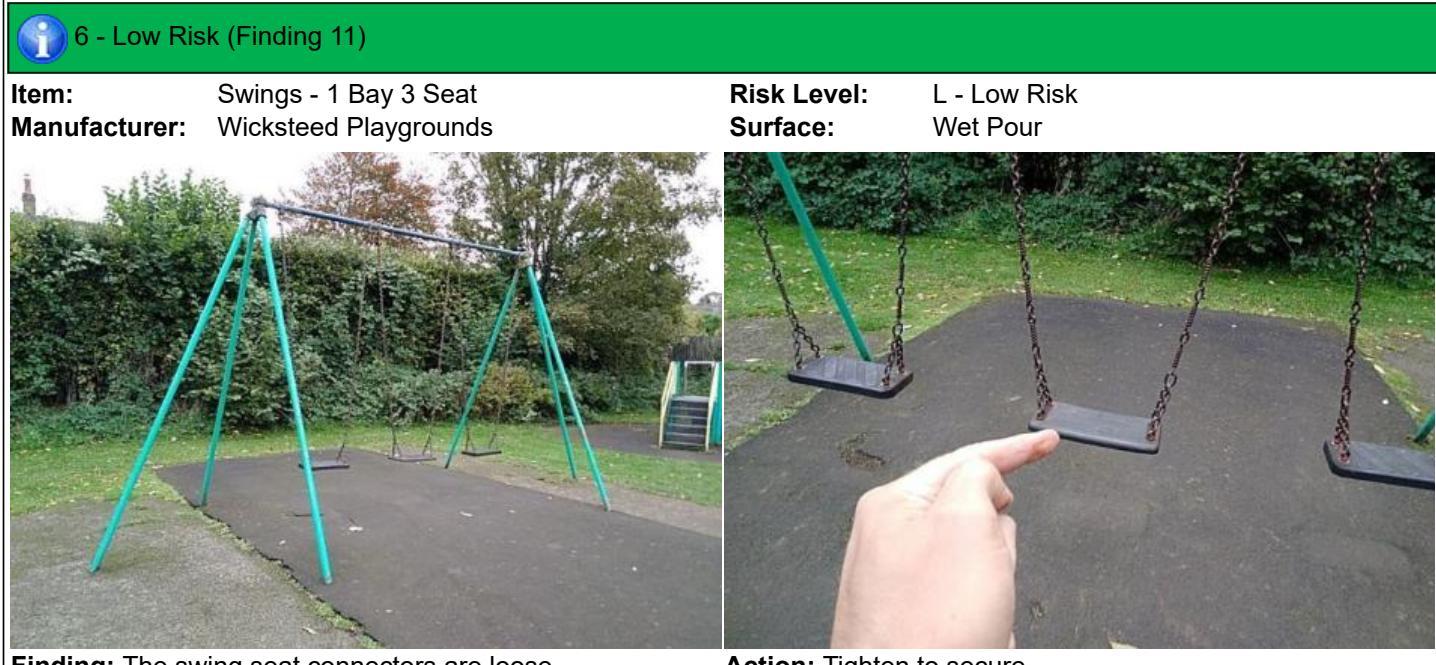
Finding: The swing seat connectors are loose

Action: Tighten to secure

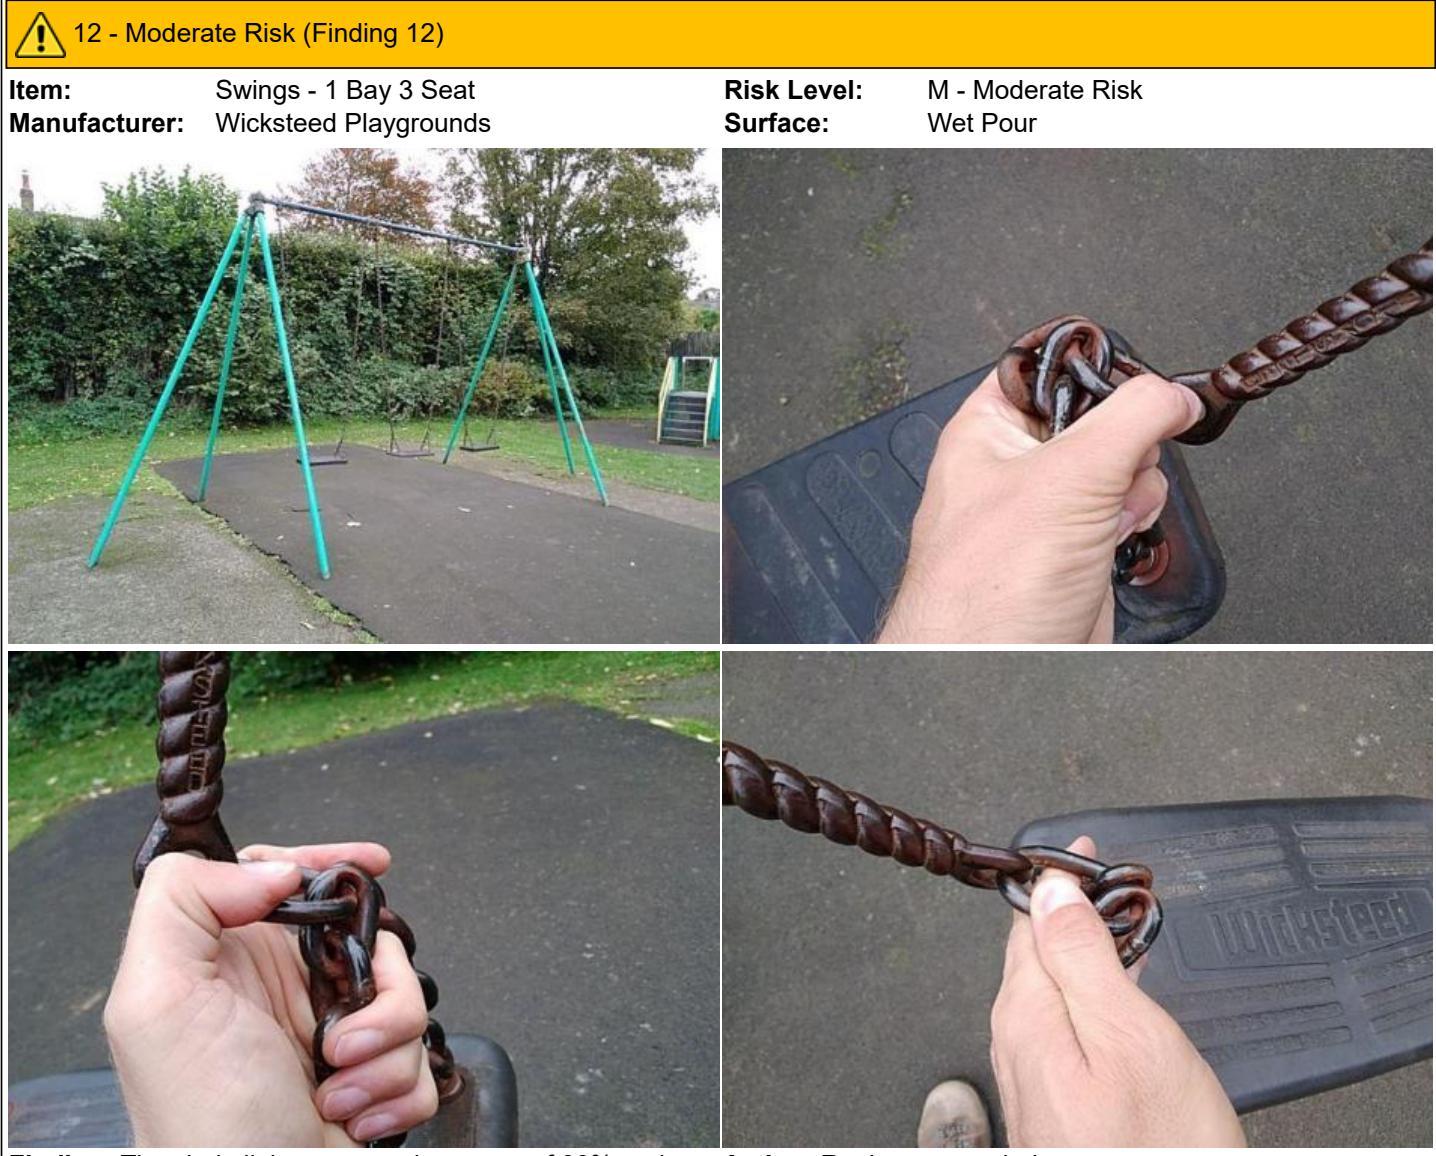
Finding: The chain links are worn in excess of 80% and require renewing

Action: Replace worn chains
