the play inspection company

Annual Inspection

Adderbury Parish Council

Lucy Placket Playing Field

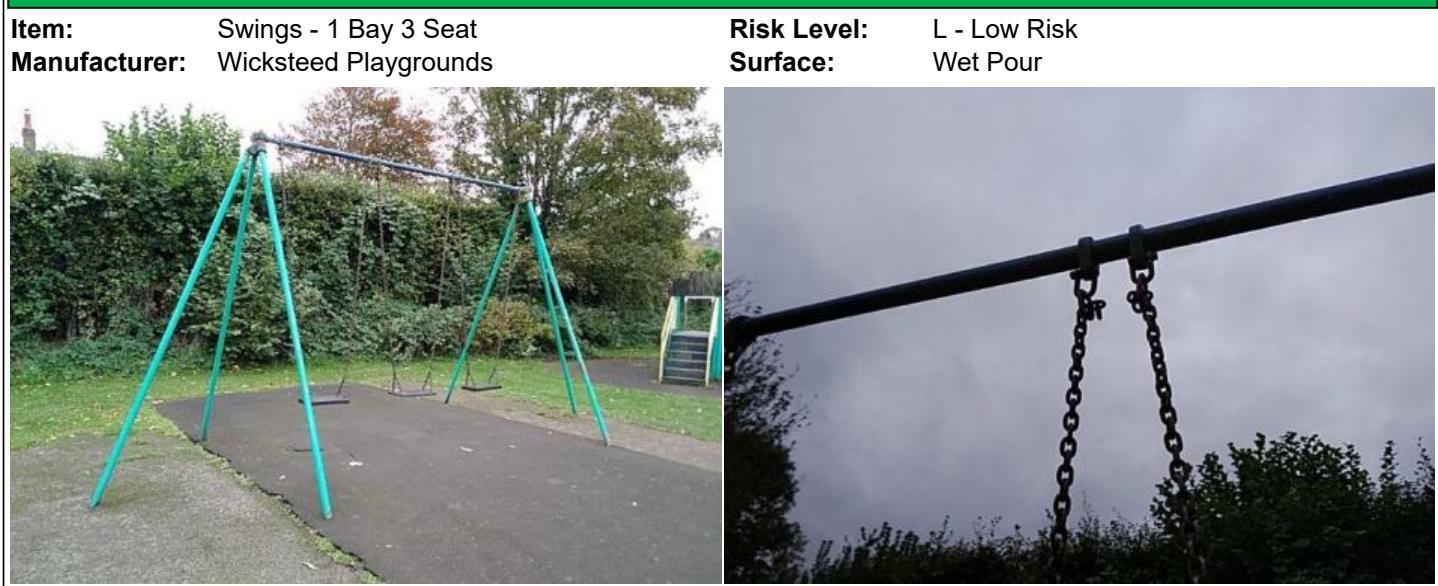
6 - Low Risk (Finding 15)

Finding: There is surface corrosion present on the shackles Action: Consider treating the item

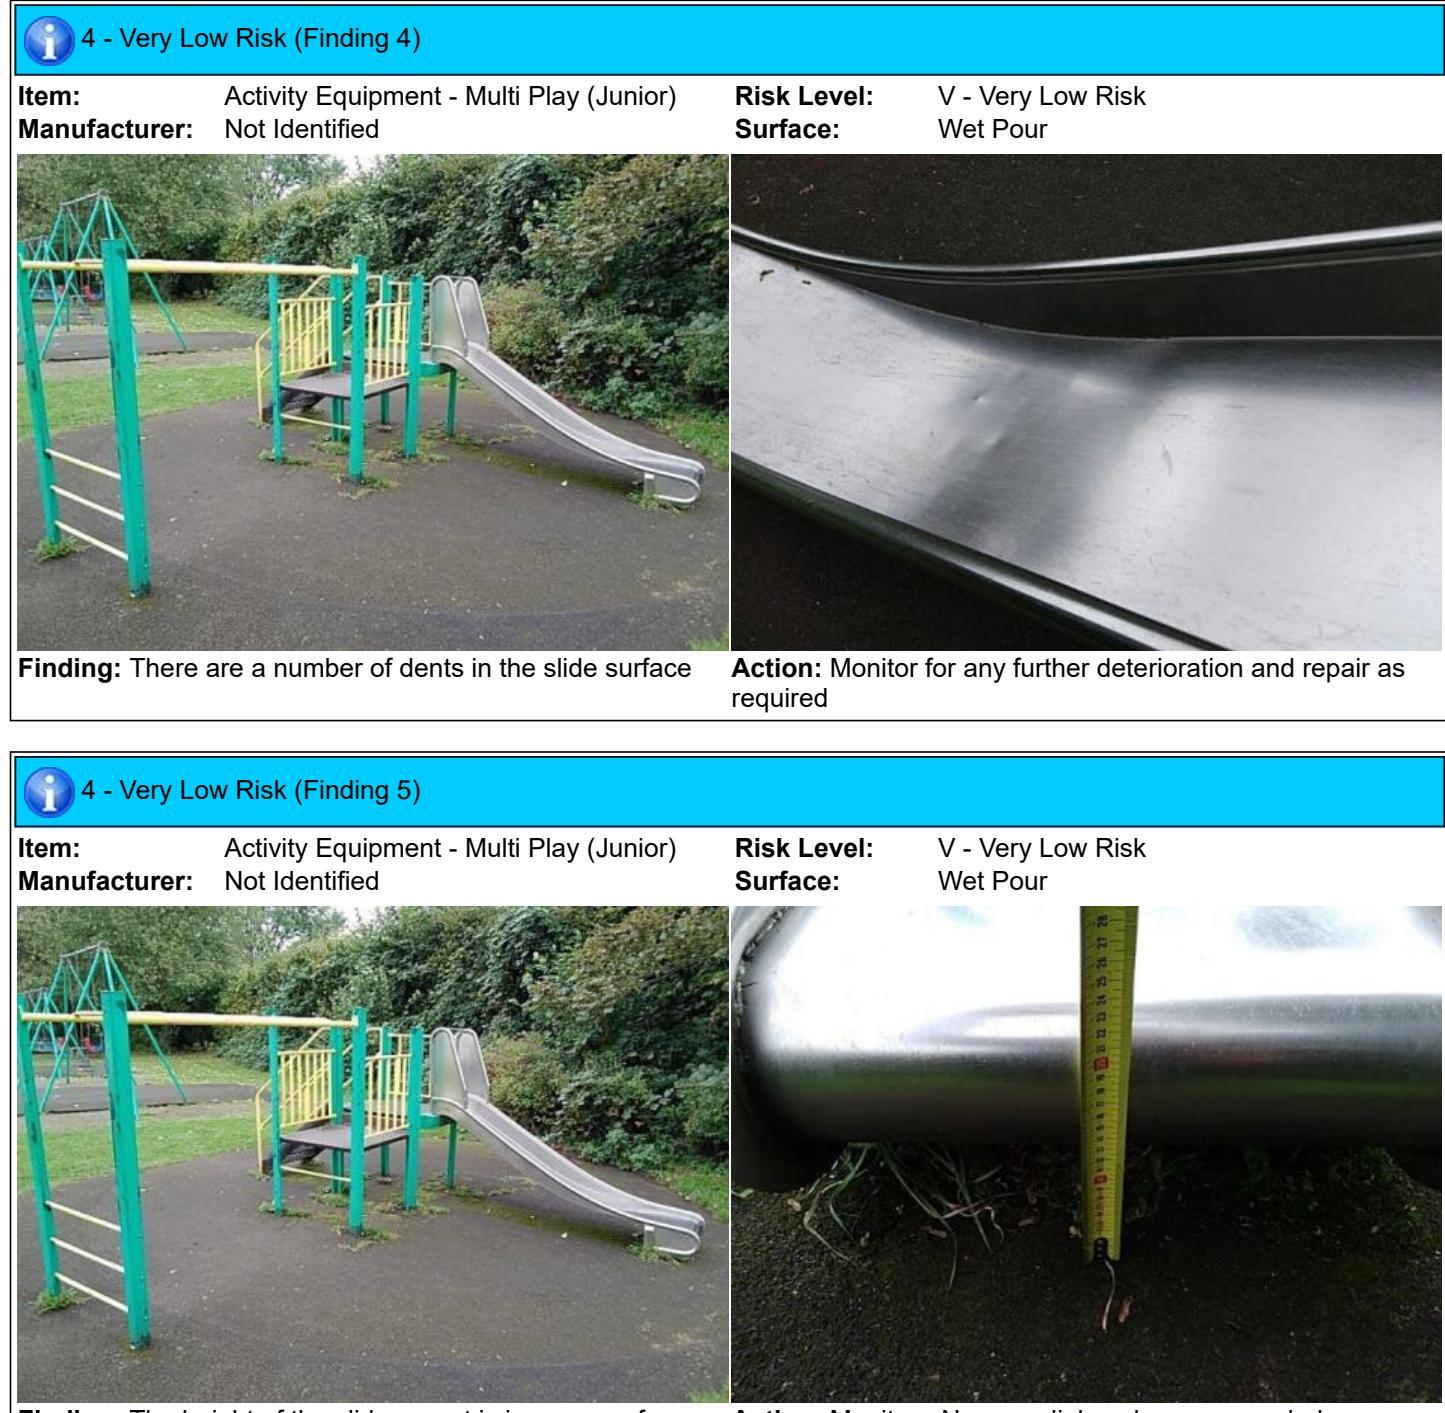
Finding: The height of the slide runout is in excess of 200mm and fails the requirements of BS EN 1176 Part 3

Action: Monitor - No remedial work recommended

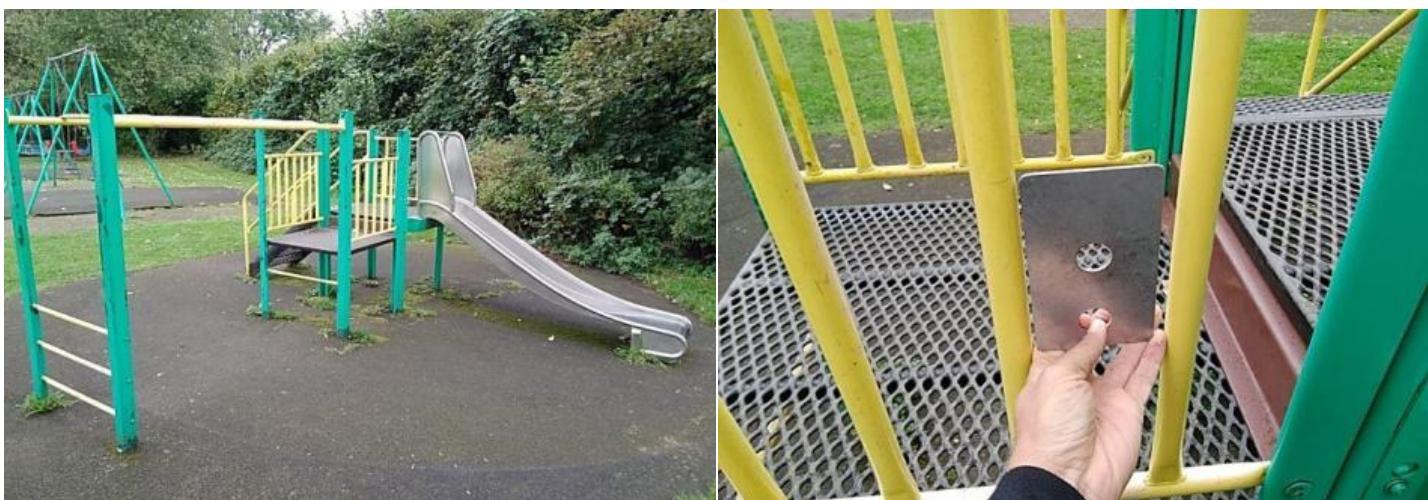
Finding: The item fails to meet the requirements of BS EN 1176 Part 1 4.2.7.2 head and neck entrapment in the barriers and/or steps

Action: Monitor - No remedial work recommended

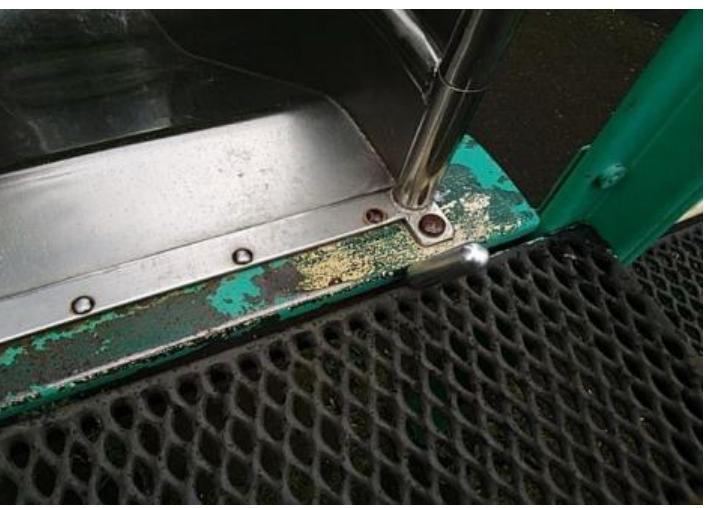
Finding: There is/are finger entrapment/s in the slide and the item fails to meet the requirements of BS EN 1176 Part 1 4.2.7.6 Entrapment of fingers

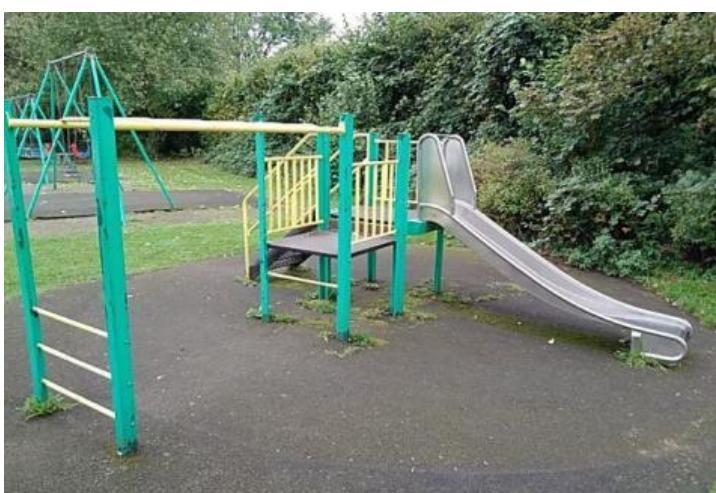
Finding: There is/are finger entrapment/s in the platforms and the item fails to meet the requirements of BS EN 1176 Part 1 4.2.7.6 Entrapment of fingers

Action: Monitor - No remedial work recommended

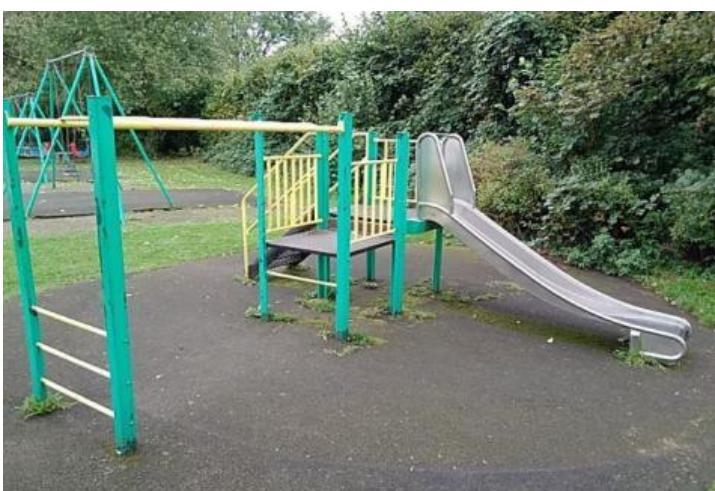
Finding: The item has exposed edges and corners with a radius of less than 3mm due to the damage to the rubber coating and fails the requirements of BS EN 1176

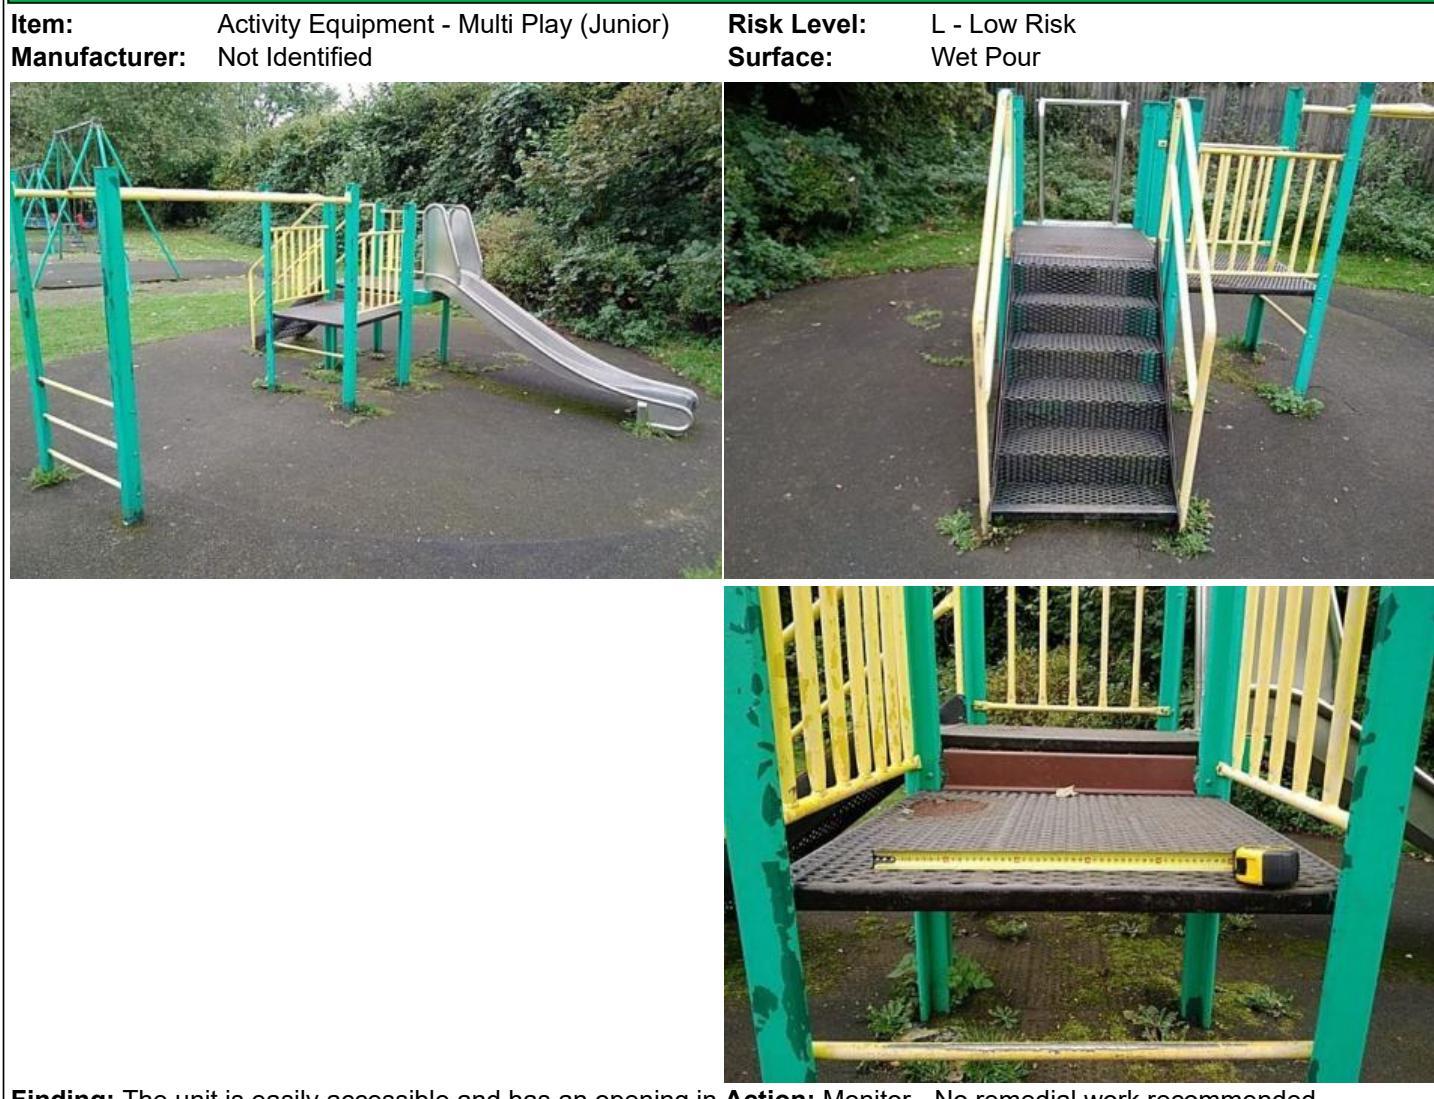
6 - Low Risk (Finding 13)

Finding: The unit is easily accessible and has an opening in **Action:** Monitor - No remedial work recommended the barrier to steep play elements in excess of 500mm in contravention of BS EN 1176 Part 1

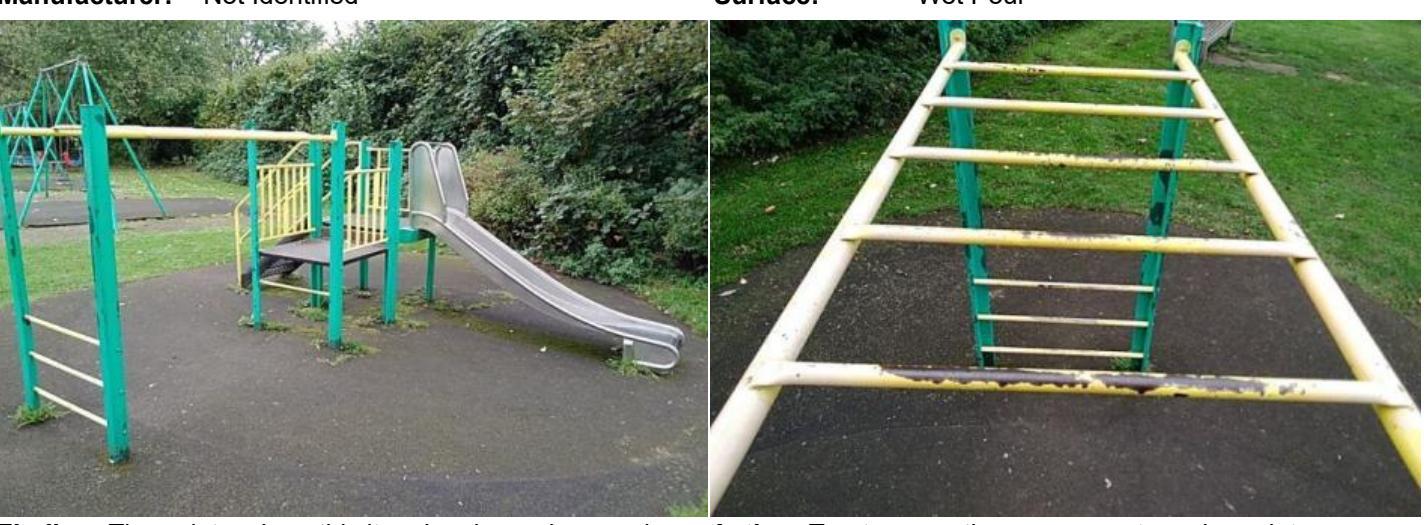
Finding: The paintwork on this item has been damaged or Action: Treat any rusting components and repaint worn exposing the metal underneath which is rusting

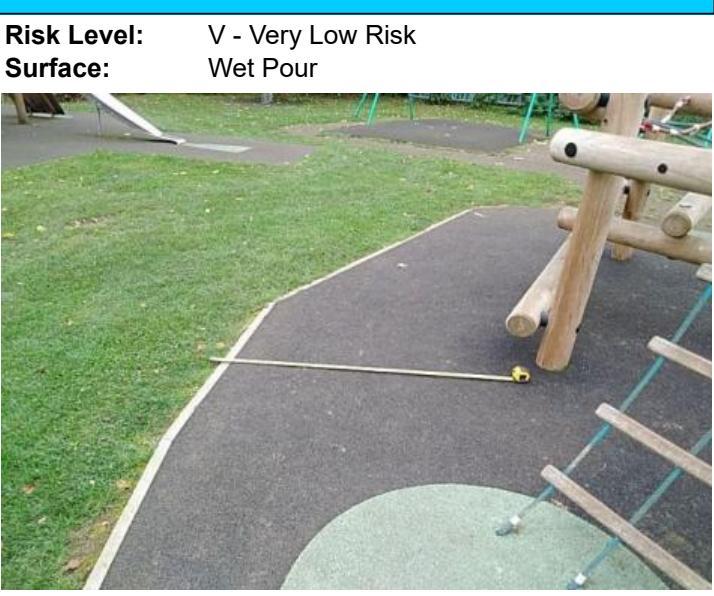
Finding: The surfacing dimensions are short and do not meet with the requirements of the current applicable standard

Action: Monitor - no remedial action recommended

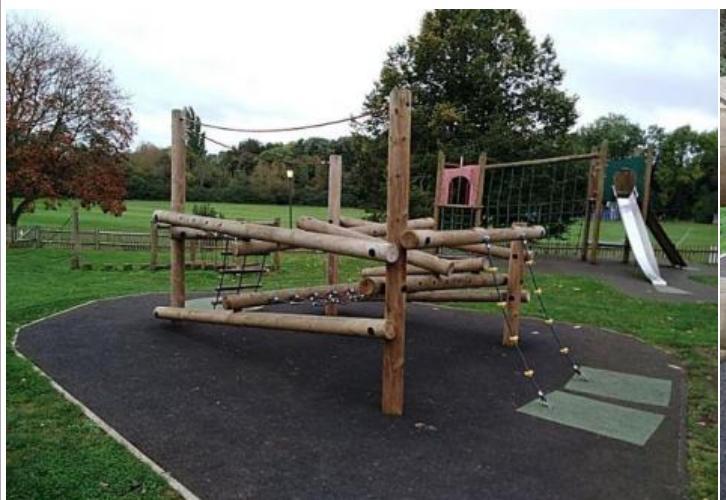
5 - Very Low Risk (Finding 3)

Finding: The connecting links are in excess of 8.6mm and less than 12mm and fail the requirements of BS EN 1176 Part 1; clause 4.2.13, Chains

Action: Monitor use and replace with compliant links at the next maintenance cycle

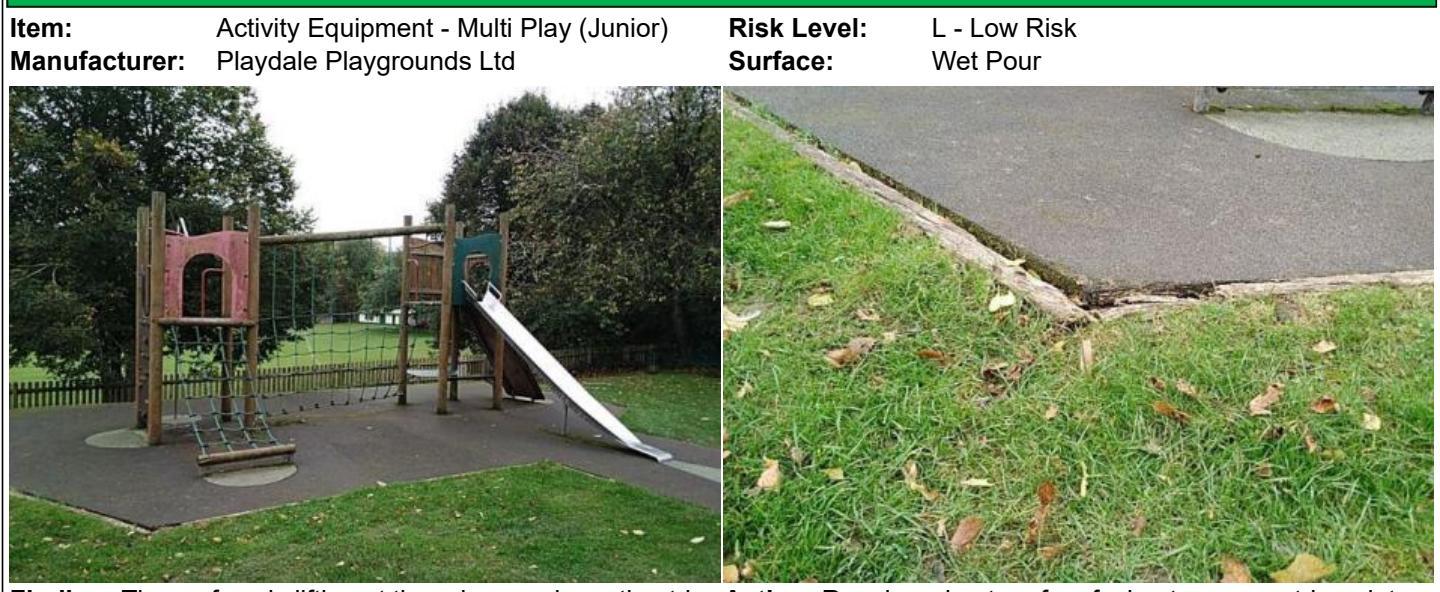
8 - Low Risk (Finding 1)

Finding: The surface is lifting at the edges and creating trip **Action:** Repair perimeter of surfacing to remove trip points points

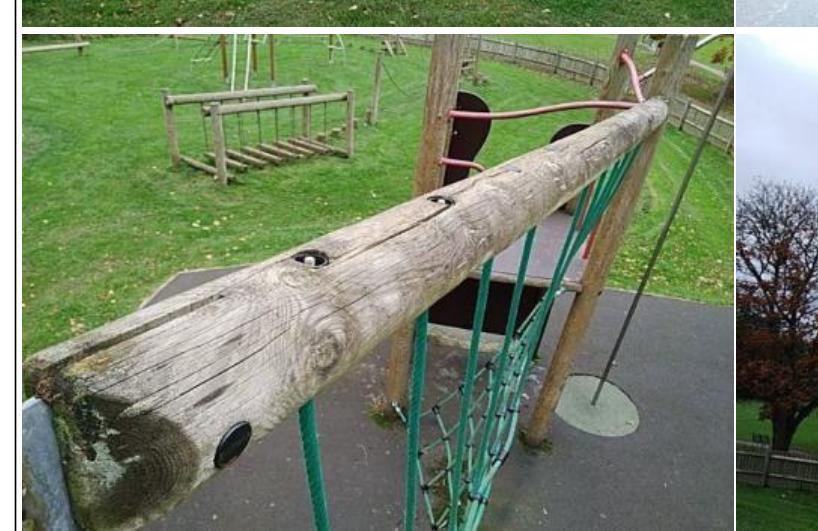
Finding: There is/are bolt cap covers missing or damaged on the item

Action: Replace missing or damaged bolt cap covers

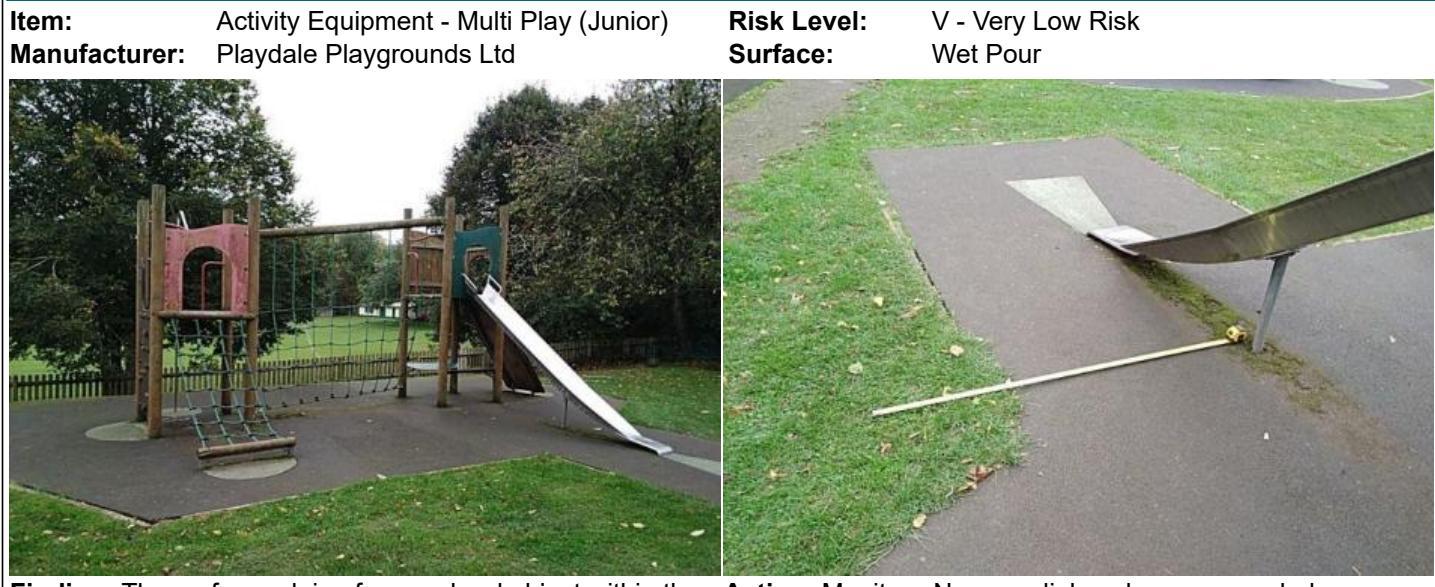
5 - Very Low Risk (Finding 7)

Finding: The surface edging forms a hard object within the **Action:** Monitor - No remedial work recommended impact area of the equipment in contravention of the requirements of BS EN 1176 Part 1

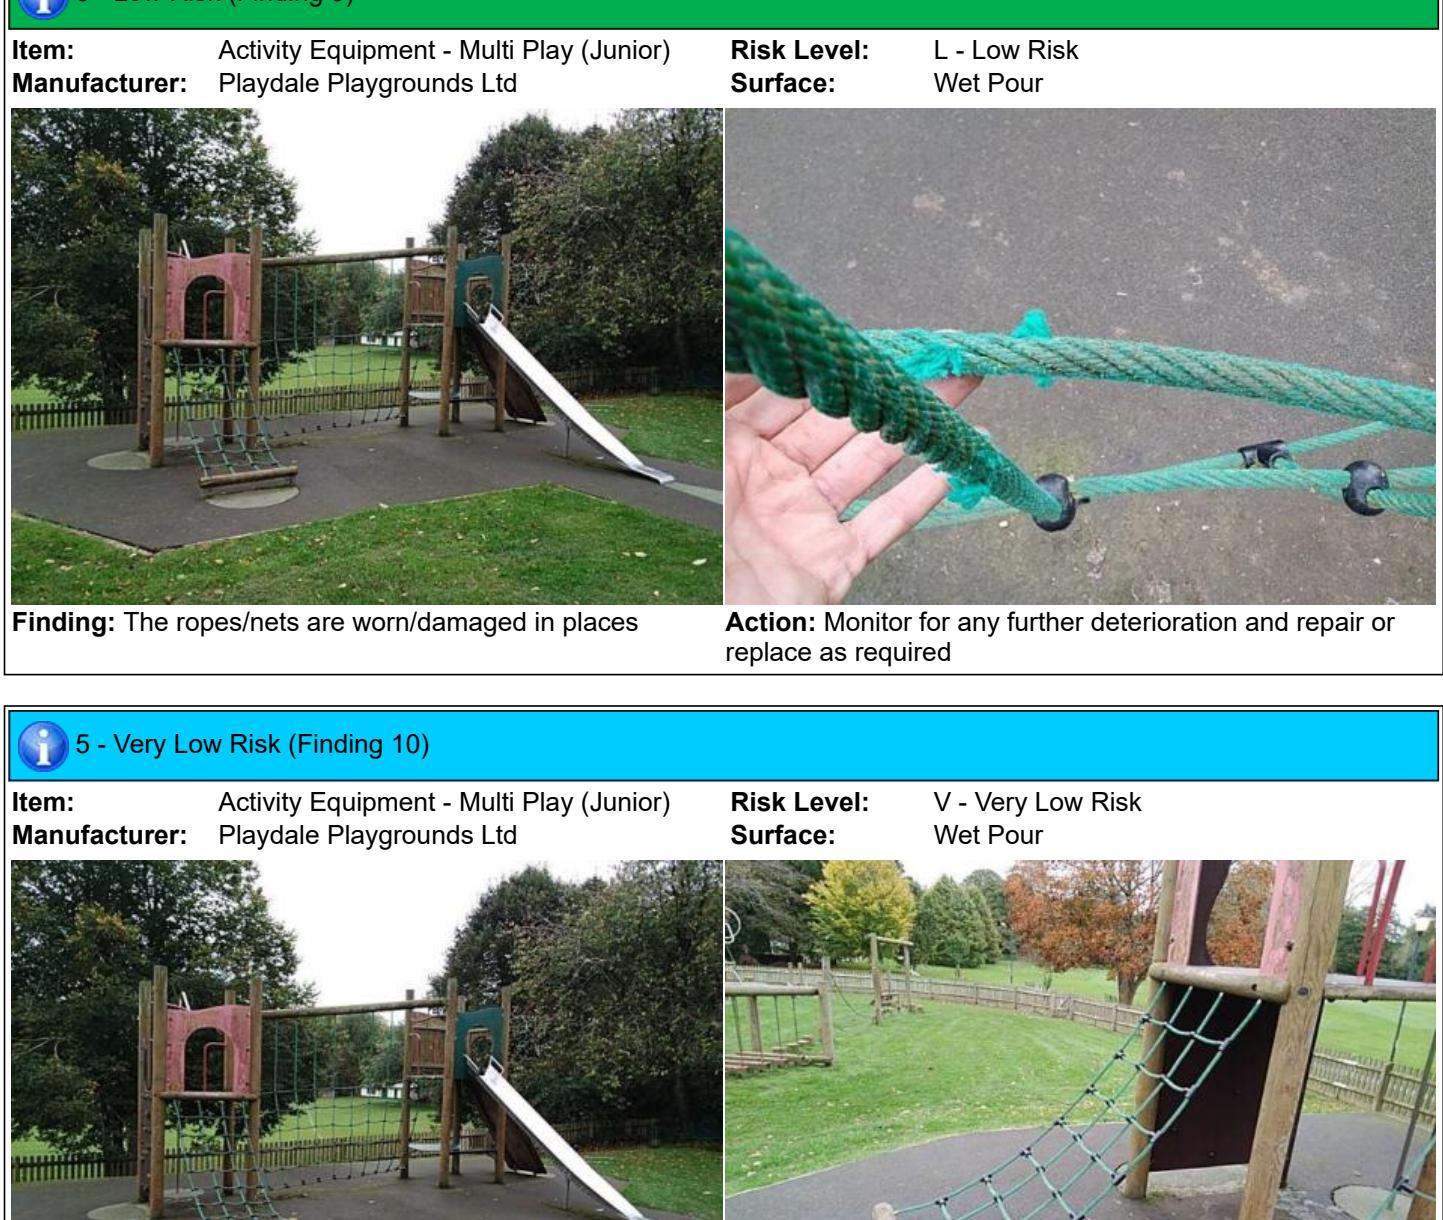
6 - Low Risk (Finding 9)

Finding: The net anchor forms a hard object within the falling space of the equipment in contravention of the requirements of BS EN 1176 Part 1

Action: Monitor - No remedial work recommended

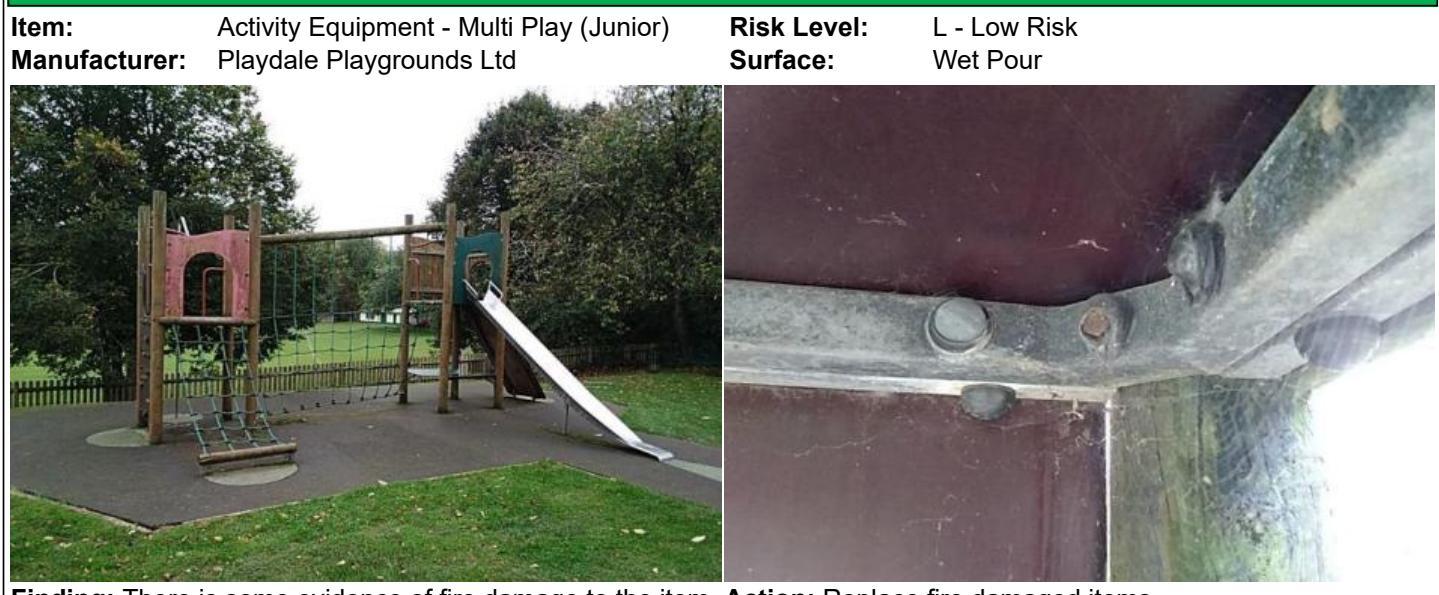
😭 6 - Low Risk (Finding 11)

Finding: There is some evidence of fire damage to the item Action: Replace fire damaged items

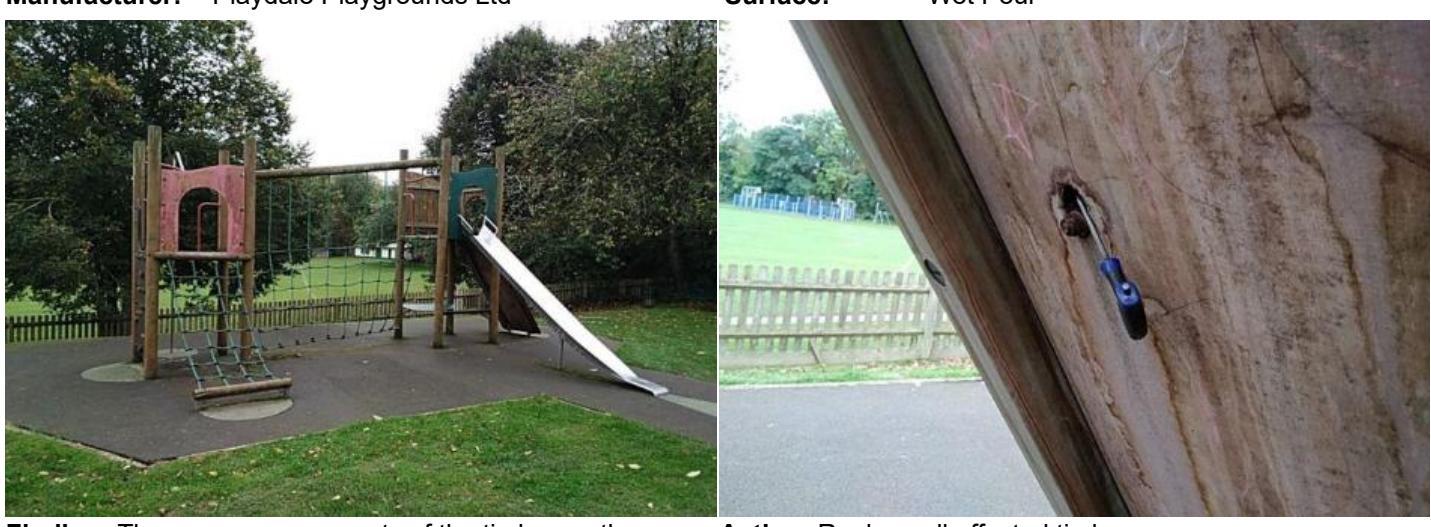
Finding: There are areas or parts of the timber on the ramp **Action:** Replace all affected timbers that have rotted

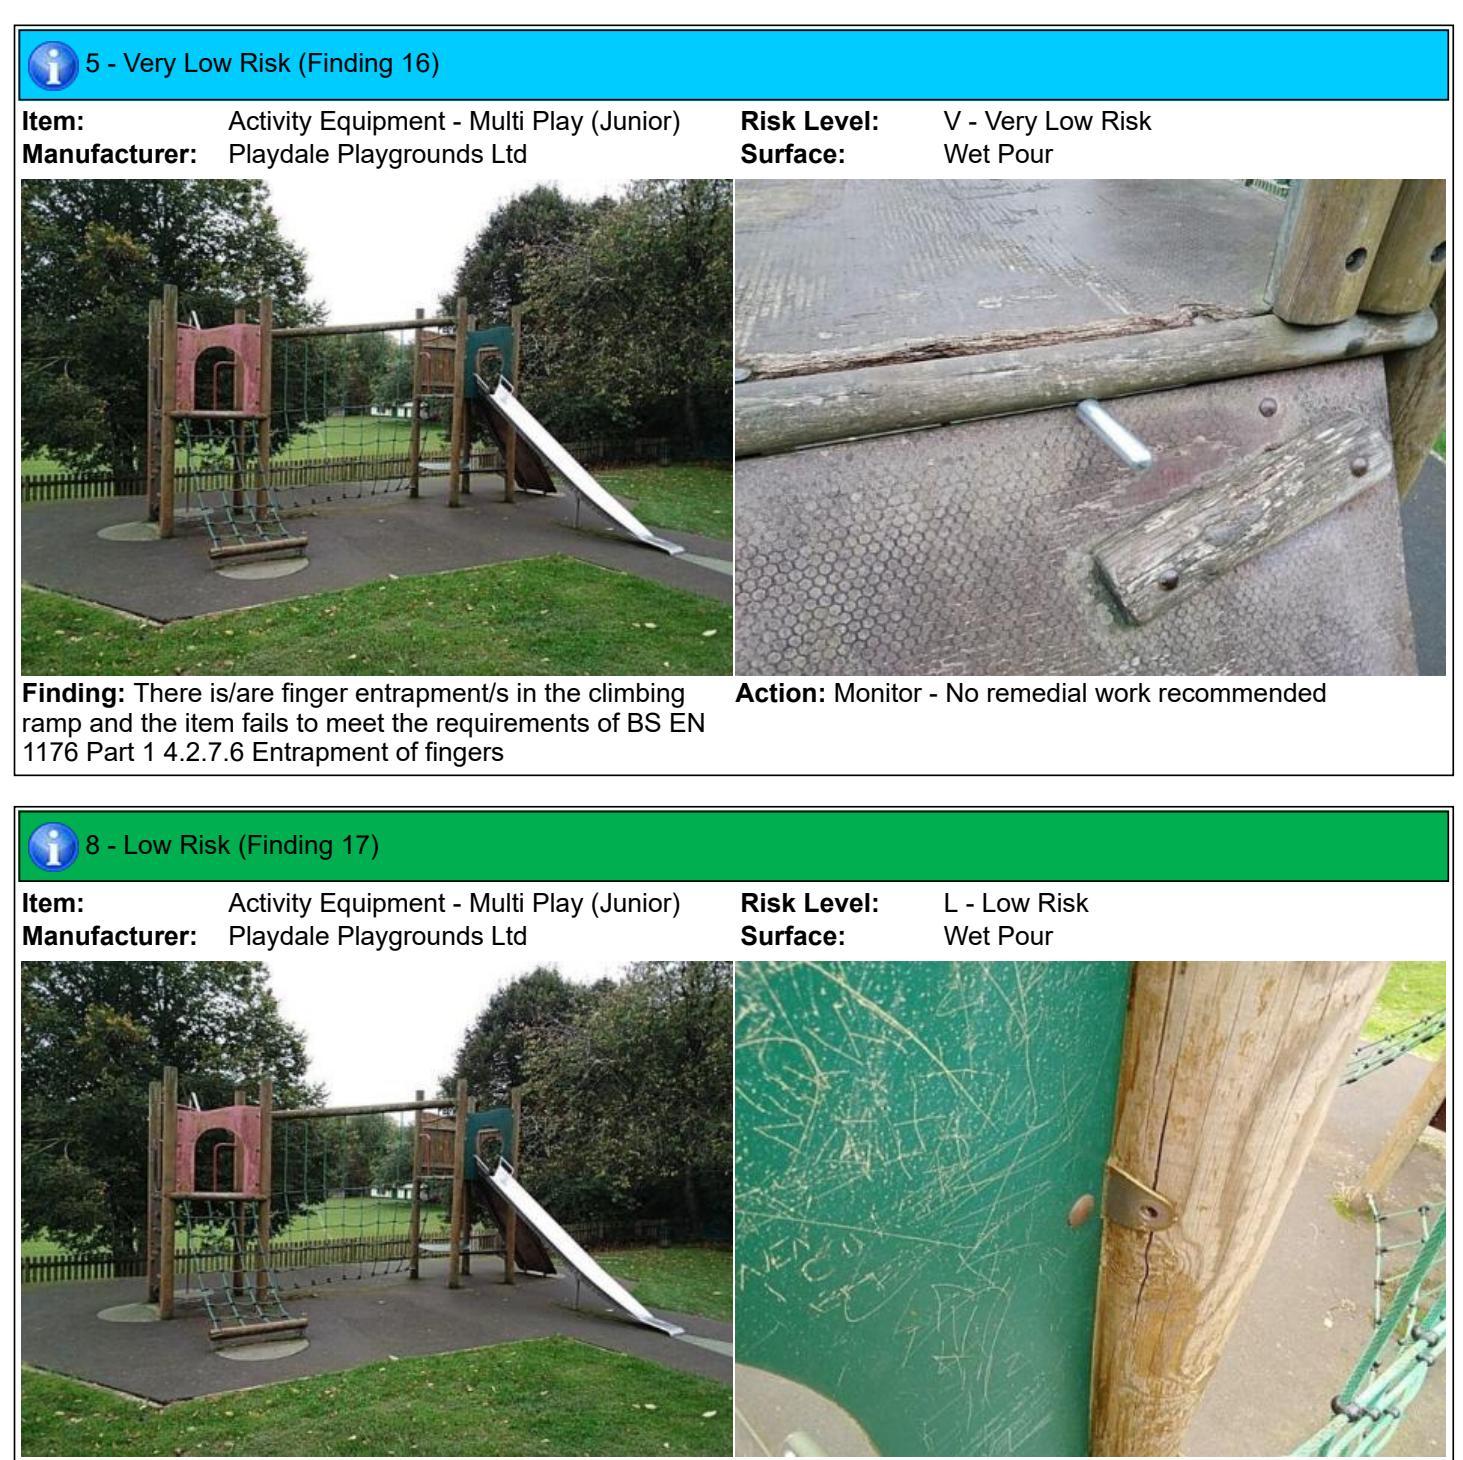
Finding: There is or are fixings missing on the item

Action: Replace all missing fixings

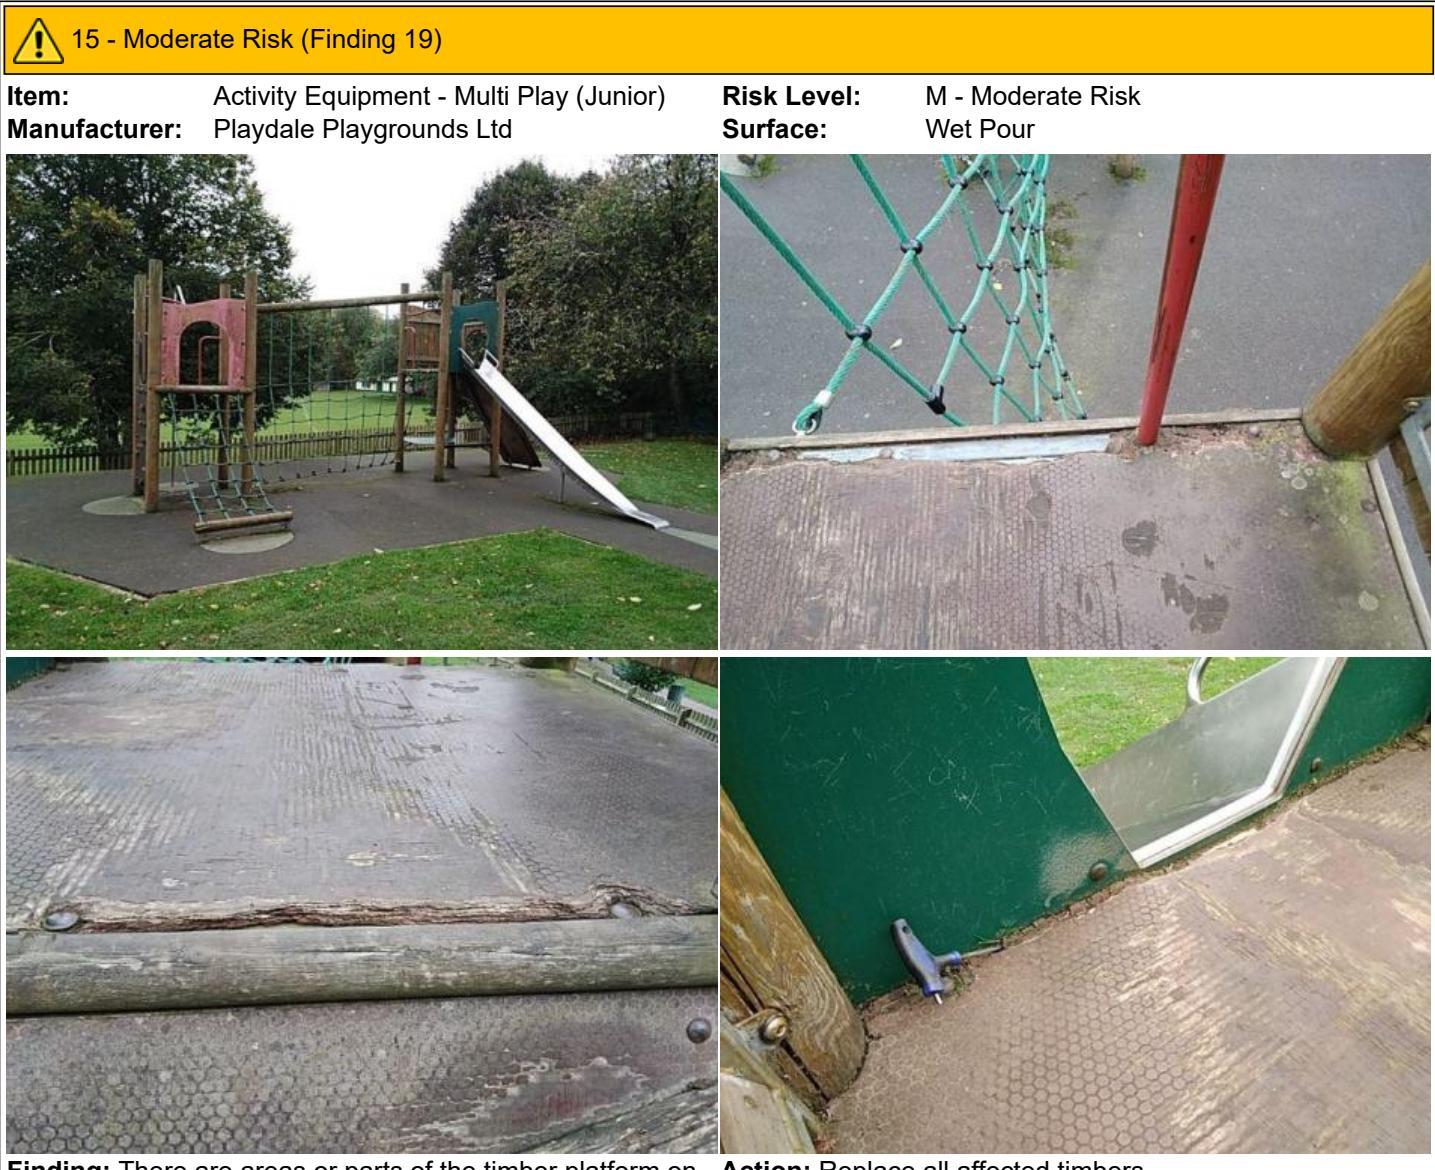
Finding: There are areas or parts of the timber platform on **Action:** Replace all affected timbers the structure that have rotted

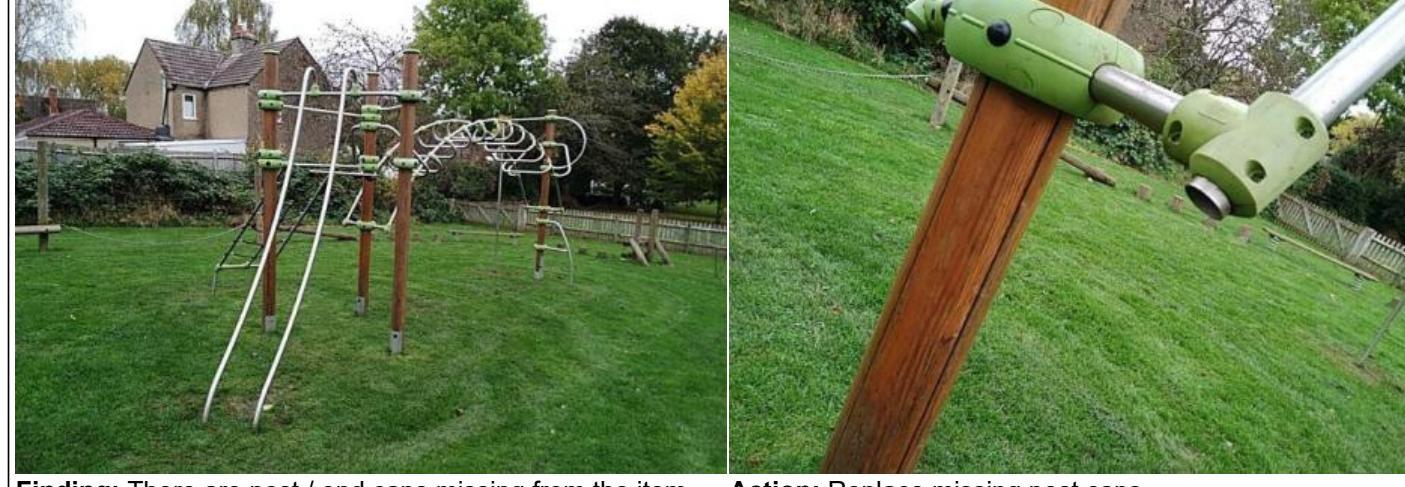
Finding: There are post / end caps missing from the item

Action: Replace missing post caps

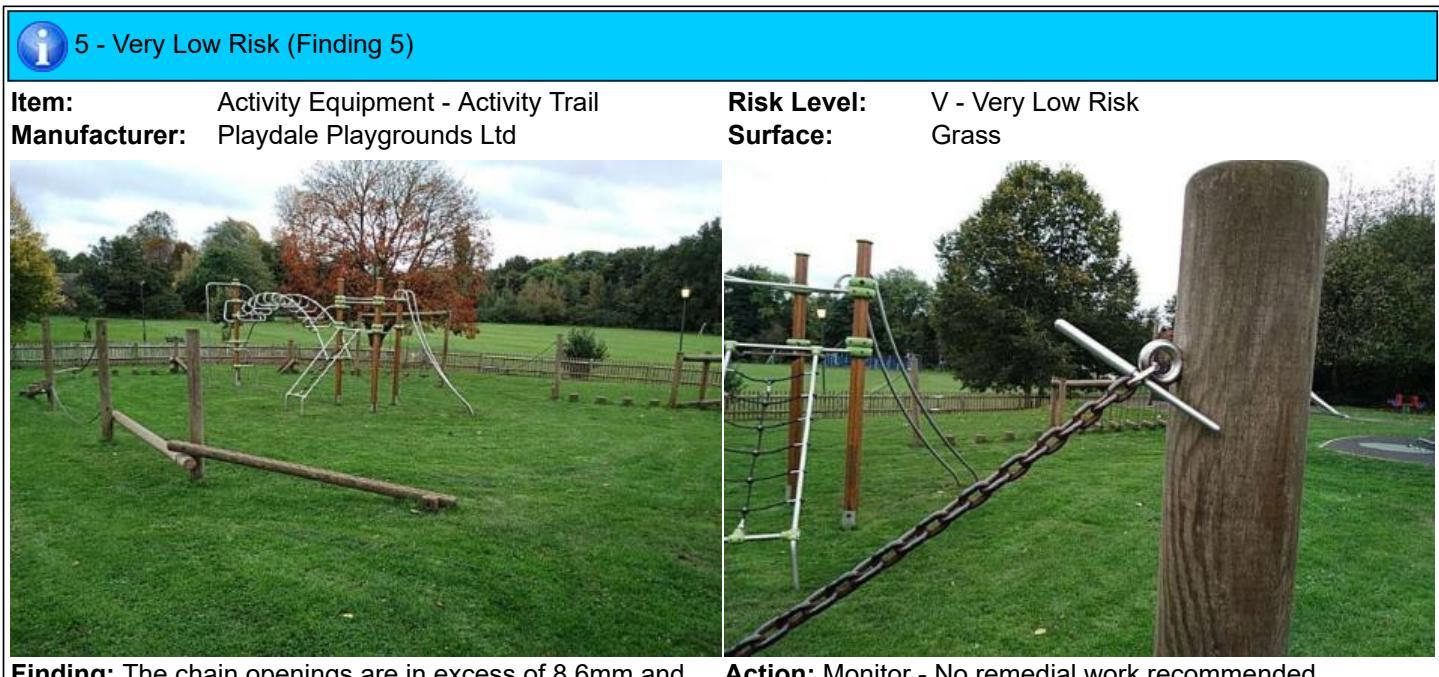
Finding: The chain openings are in excess of 8.6mm and do not meet the recommendations of BS EN 1176 Part 1

Action: Monitor - No remedial work recommended

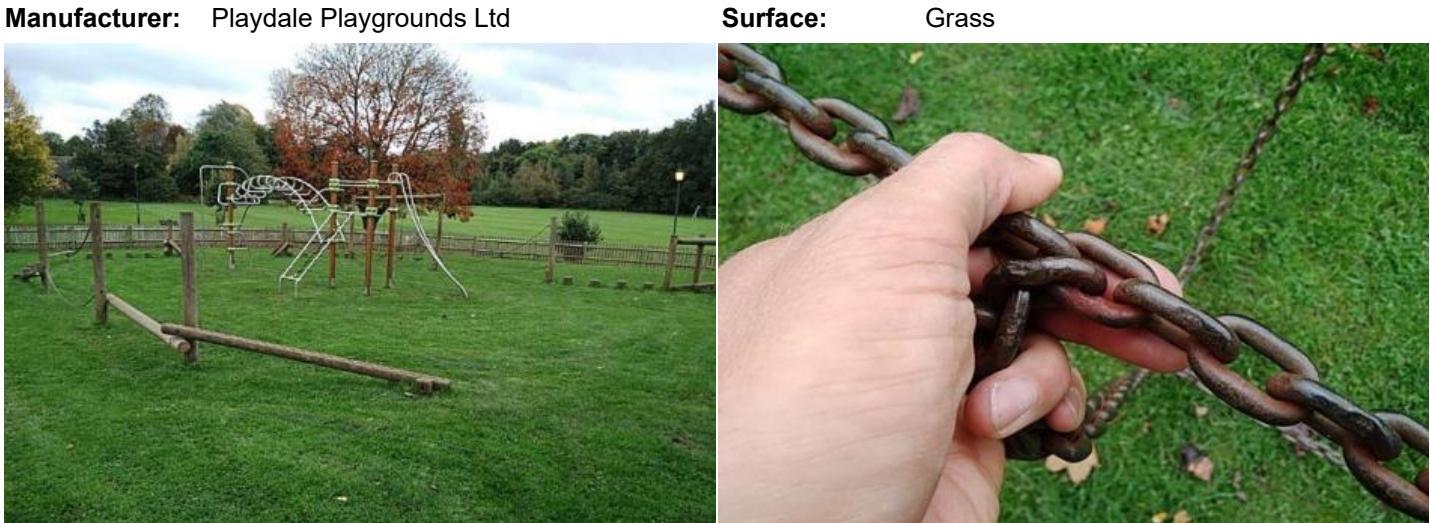
Finding: The chain links are worn in excess of 40% and require renewing

Action: Replace worn chains

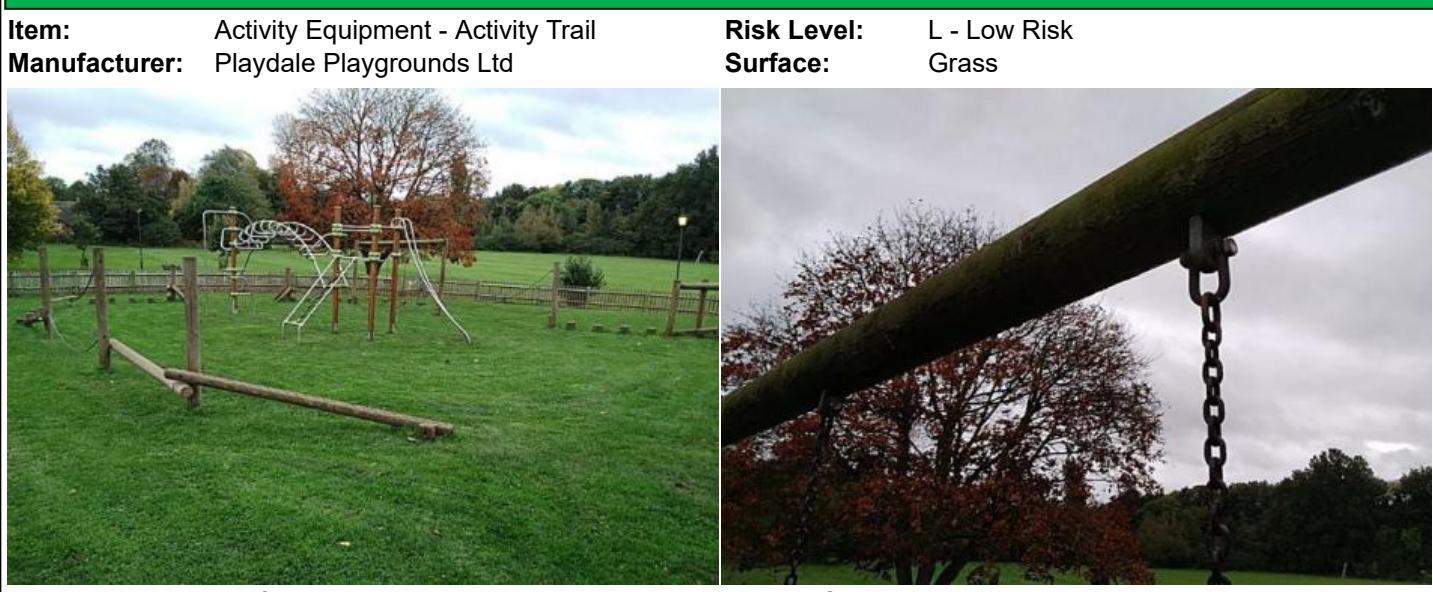
😭 6 - Low Risk (Finding 12)

Finding: There is surface corrosion present on the shackles Action: Consider treating the item

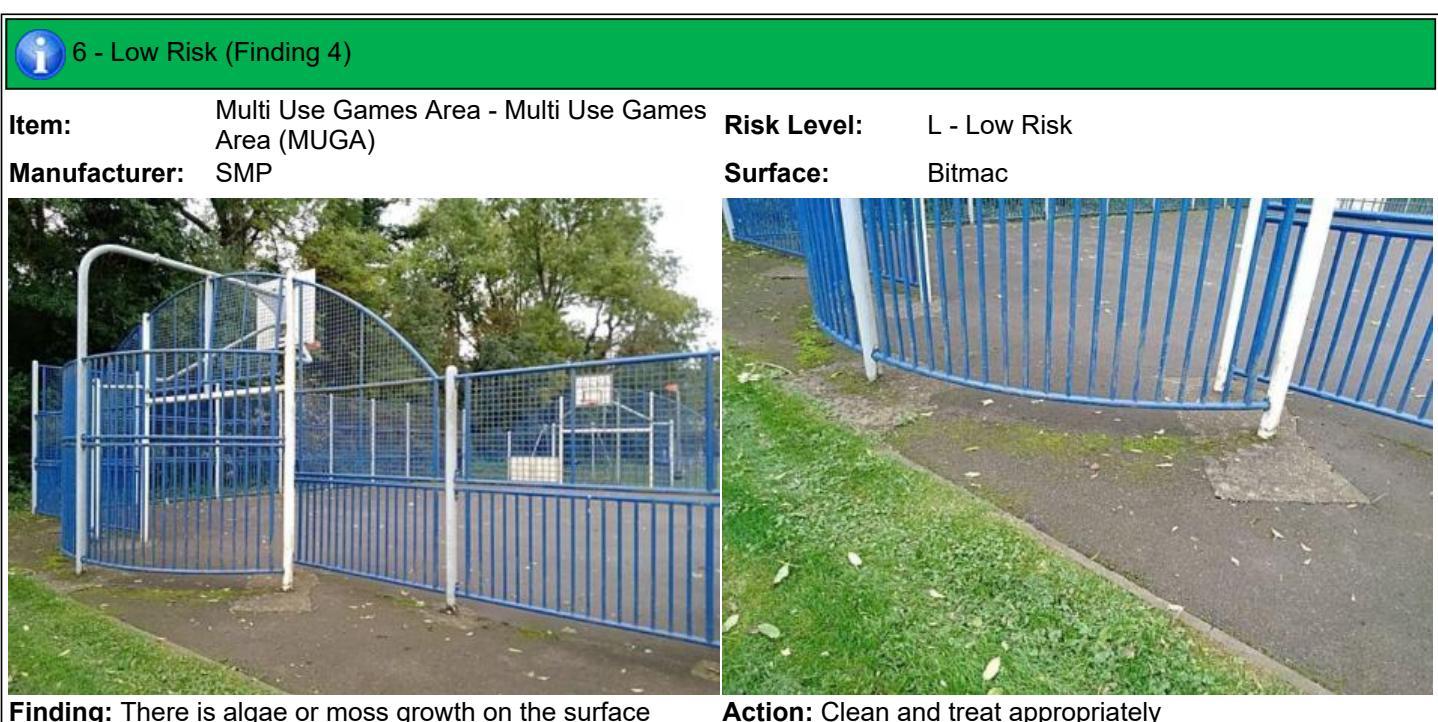
Finding: There is algae or moss growth on the surface resulting in slippery conditions

Action: Clean and treat appropriately

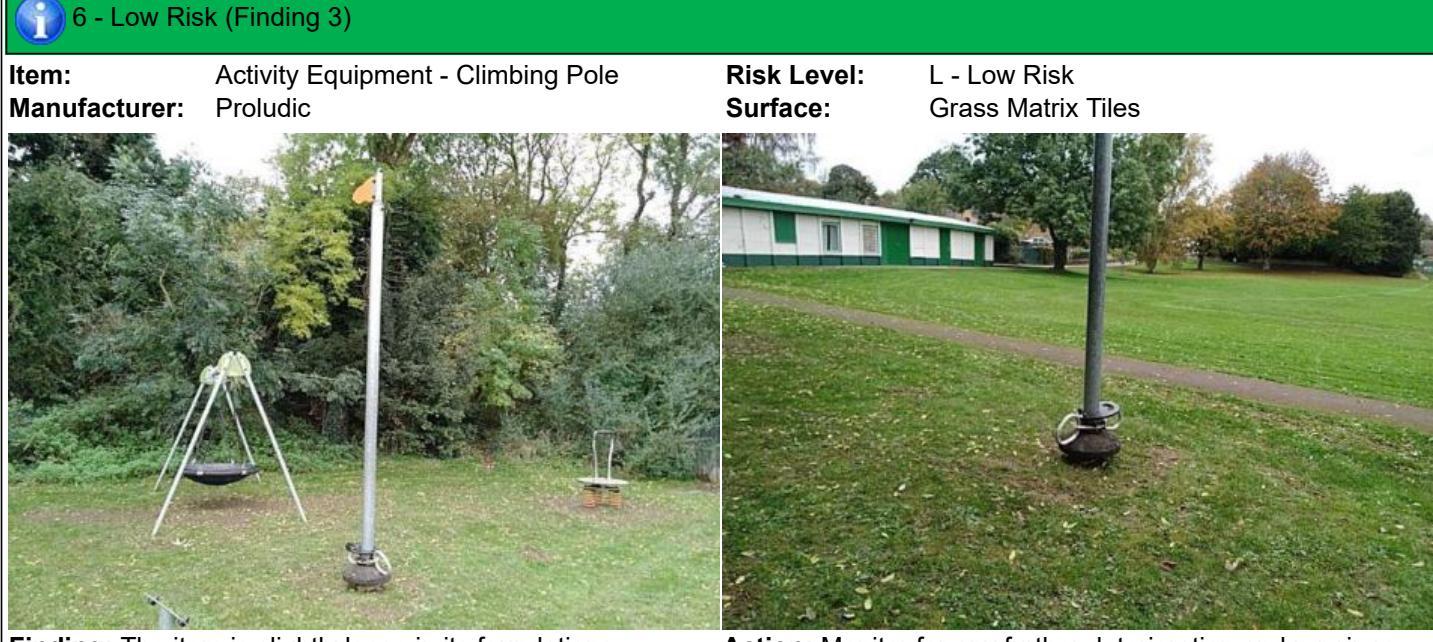
Finding: The item is slightly loose in its foundations

Action: Monitor for any further deterioration and repair as required
