the play inspection company

Annual Inspection

Adderbury Parish Council

Lucy Placket Playing Field

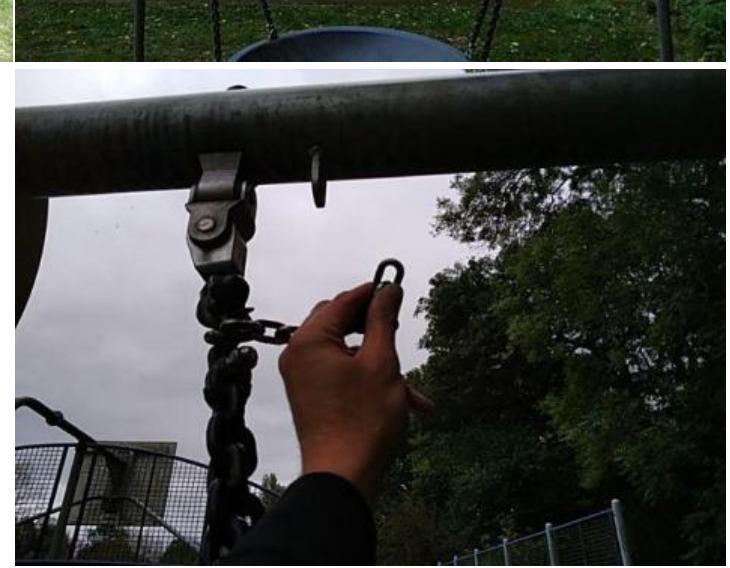
Finding: Swings of this design should have a secondary safety device fitted to prevent collapse of the seat in the event of a joint failure to meet the requirements of BS EN 1176 Part 2

Action: Consider providing a secondary safety device where possible
