the play inspection company

Annual Inspection

Adderbury Parish Council

Lucy Placket Playing Field

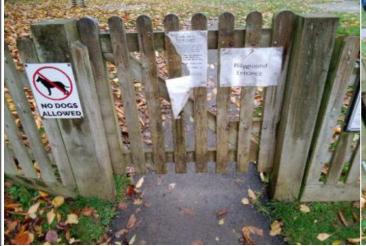
8 - Low Risk (Finding 2)

Item:Ancillary Items - Gate - Self ClosingRisk Level:L - Low RiskManufacturer:Owner/OperatorSurface:Bitmac

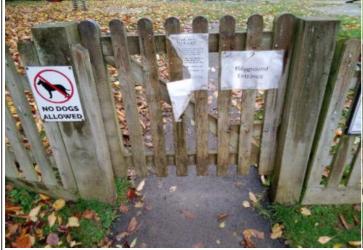
5 - Very Low Risk (Finding 3)

Item:Ancillary Items - Gate - Self ClosingRisk Level:V - Very Low RiskManufacturer:Owner/OperatorSurface:Bitmac

Finding: The gate is snagging on the surrounding surface preventing it from closing correctly

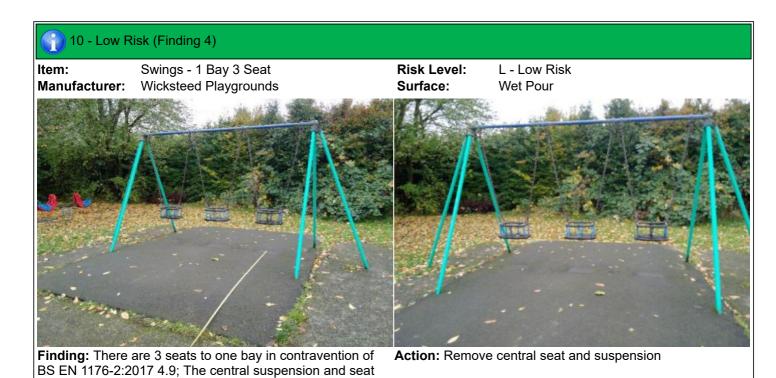
Finding: The surfacing dimensions are significantly short and do not meet with the requirements of the current applicable standard (3163mm required / 2500mm provided)

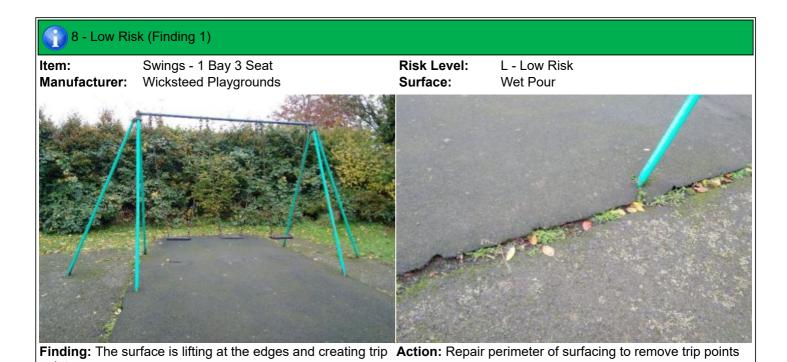
Finding: The seats are too close to each other as defined in **Action:** Monitor - No remedial work recommended BS EN 1176 Part 2; this is a low risk failure and no remedial action is required

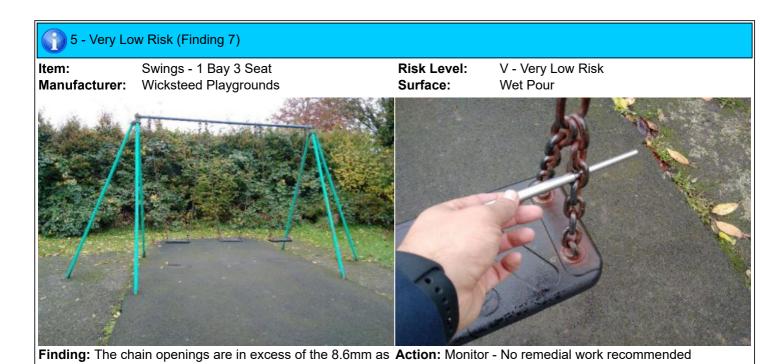
Finding: The seats are too close to the frame as defined in BS EN 1176 Part 2; this is a low risk failure and no remedial action is required

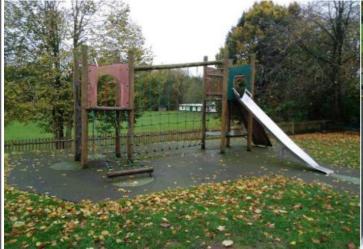
Item: Activity Equipment - Multi Play (Junior) Risk Level: V - Very Low Risk

Manufacturer: Playdale Playgrounds Ltd Surface: Wet Pour

Finding: The surfacing dimensions are short and do not meet with the requirements of the current applicable standard

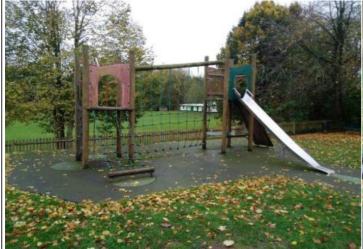
Finding: There is algae or moss on the surface of the equipment

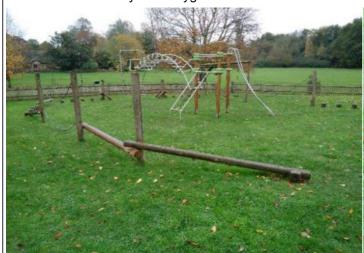
Item: Activity Equipment - Activity Trail

Manufacturer: Playdale Playgrounds Ltd

Risk Level: L - Low Risk Surface: Grass

Finding: The timber has a number of splits/shakes or air **Action:** Monitor to ensure the splits do not cross through cracks and this may affect the stability or allow water ingress fixing points of the structure and/or cause any instability which will accelerate the rotting process

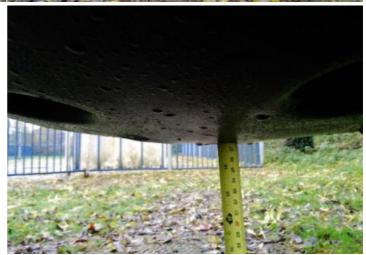
Finding: The seat clearance from finished surface level to the underside of the seat is too low when measured in its most onerous position and does not meet the requirements of BS EN 1176 Part 2

Action: Install seats to a minimum height of 400mm for Group Swing Seats
