Annual Inspection

Adderbury Parish Council

The Rise

Inspection Ref: 1219532

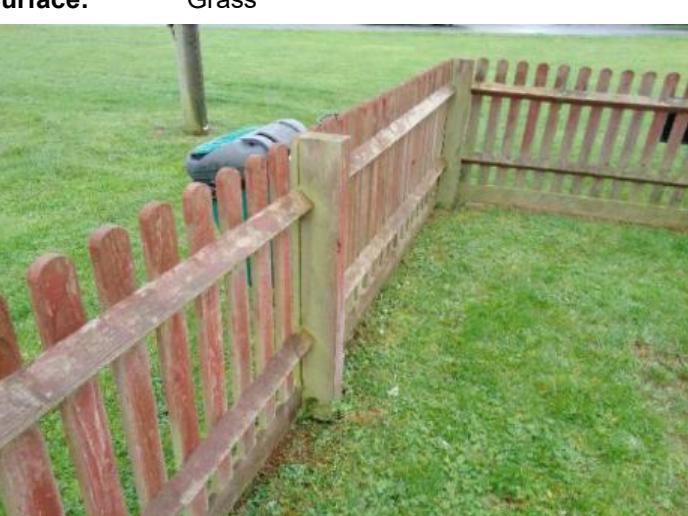
Finding: There are a number of loose posts around the fence

Action: Monitor for any further deterioration and reset as required

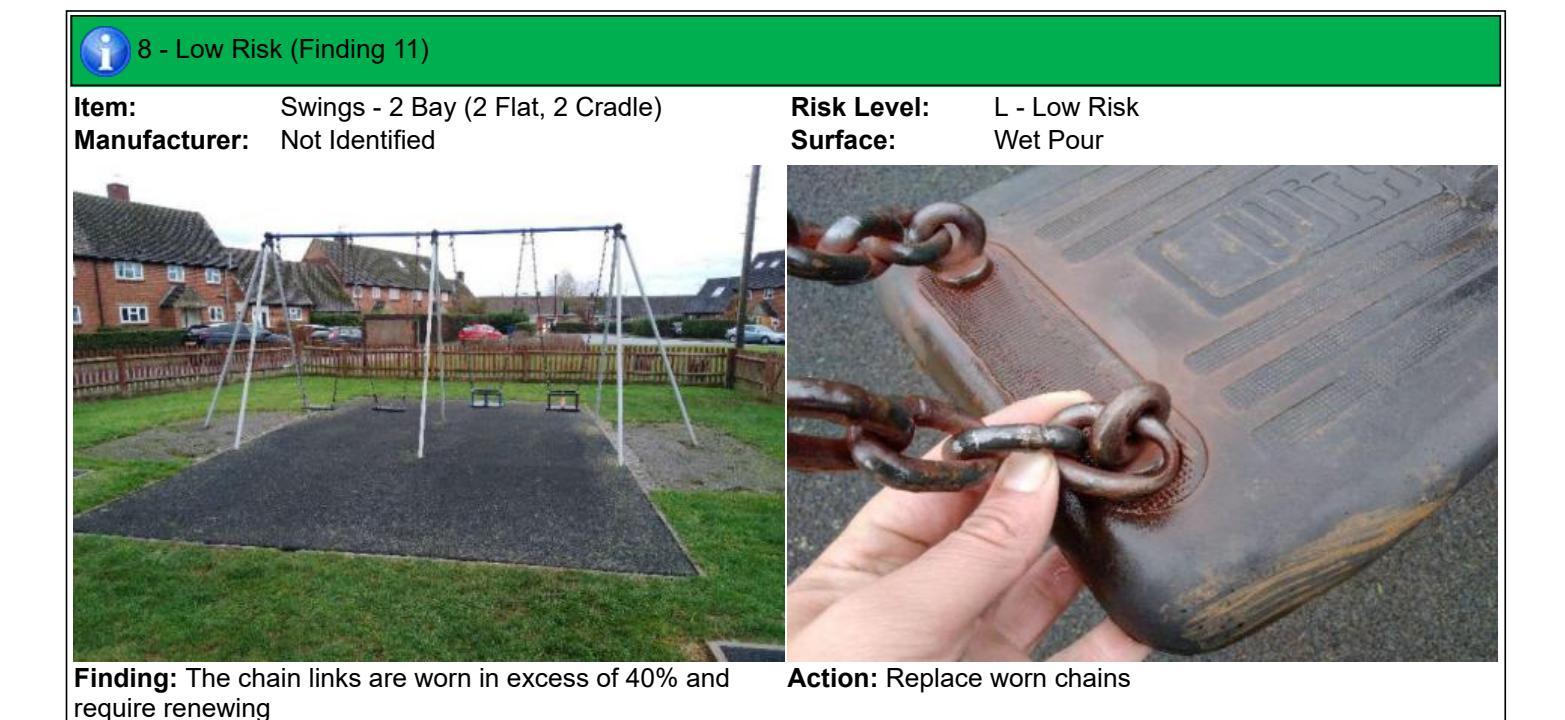
6 - Low Risk (Finding 12) Swings - 2 Bay (2 Flat, 2 Cradle) **Risk Level:** L - Low Risk Item: Manufacturer: Not Identified Surface: Wet Pour IHI mini minin Action: Tighten to secure Finding: The swing seat connectors are loose 1 8 - Low Risk (Finding 13) Swings - 2 Bay (2 Flat, 2 Cradle) Risk Level: L - Low Risk Item: Wet Pour Manufacturer: Not Identified Surface: TH min imen Finding: The suspension elements are corroded Action: Replace
