the play inspection company

Annual Inspection

Adderbury Parish Council

Lucy Placket Playing Field

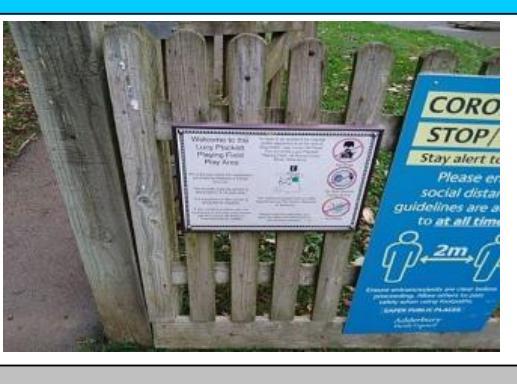
Finding 1 This item is satisfactory - no work required -

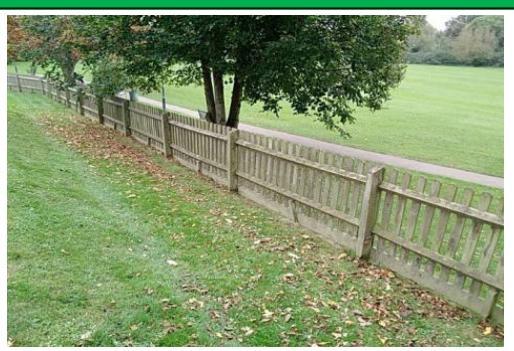
Finding 1	Finding 2
There is some strimmer / machinery damage apparent on the posts, this can penetrate the preservative applied to the timber and accelerate the rotting process - Monitor for any deterioration (rot) and replace as required	There are a number of loose posts around the fence - Monitor for any further deterioration and reset as required
Finding 3	Finding 4
There are areas or parts of the timber on the structure that have rotted - Replace all affected timbers	Parts of the timber are rough or splintered - Remove all rough or sharp edges

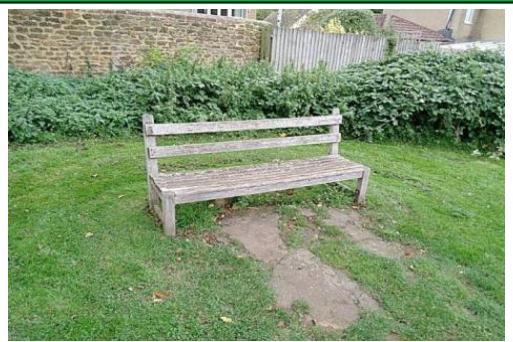
Finding 1	Finding 2
There is moderate damage to the surface - Repair the damaged areas of surfacing	There is some evidence of rot in the timber - Monitor for any further deterioration and replace as required
Finding 3	Finding 4
There is algae or moss on the surface of the equipment - Clean and treat appropriately	There is some strimmer / machinery damage apparent on the posts, this can penetrate the preservative applied to the timber and accelerate the rotting process - Monitor for any deterioration (rot) and replace as required

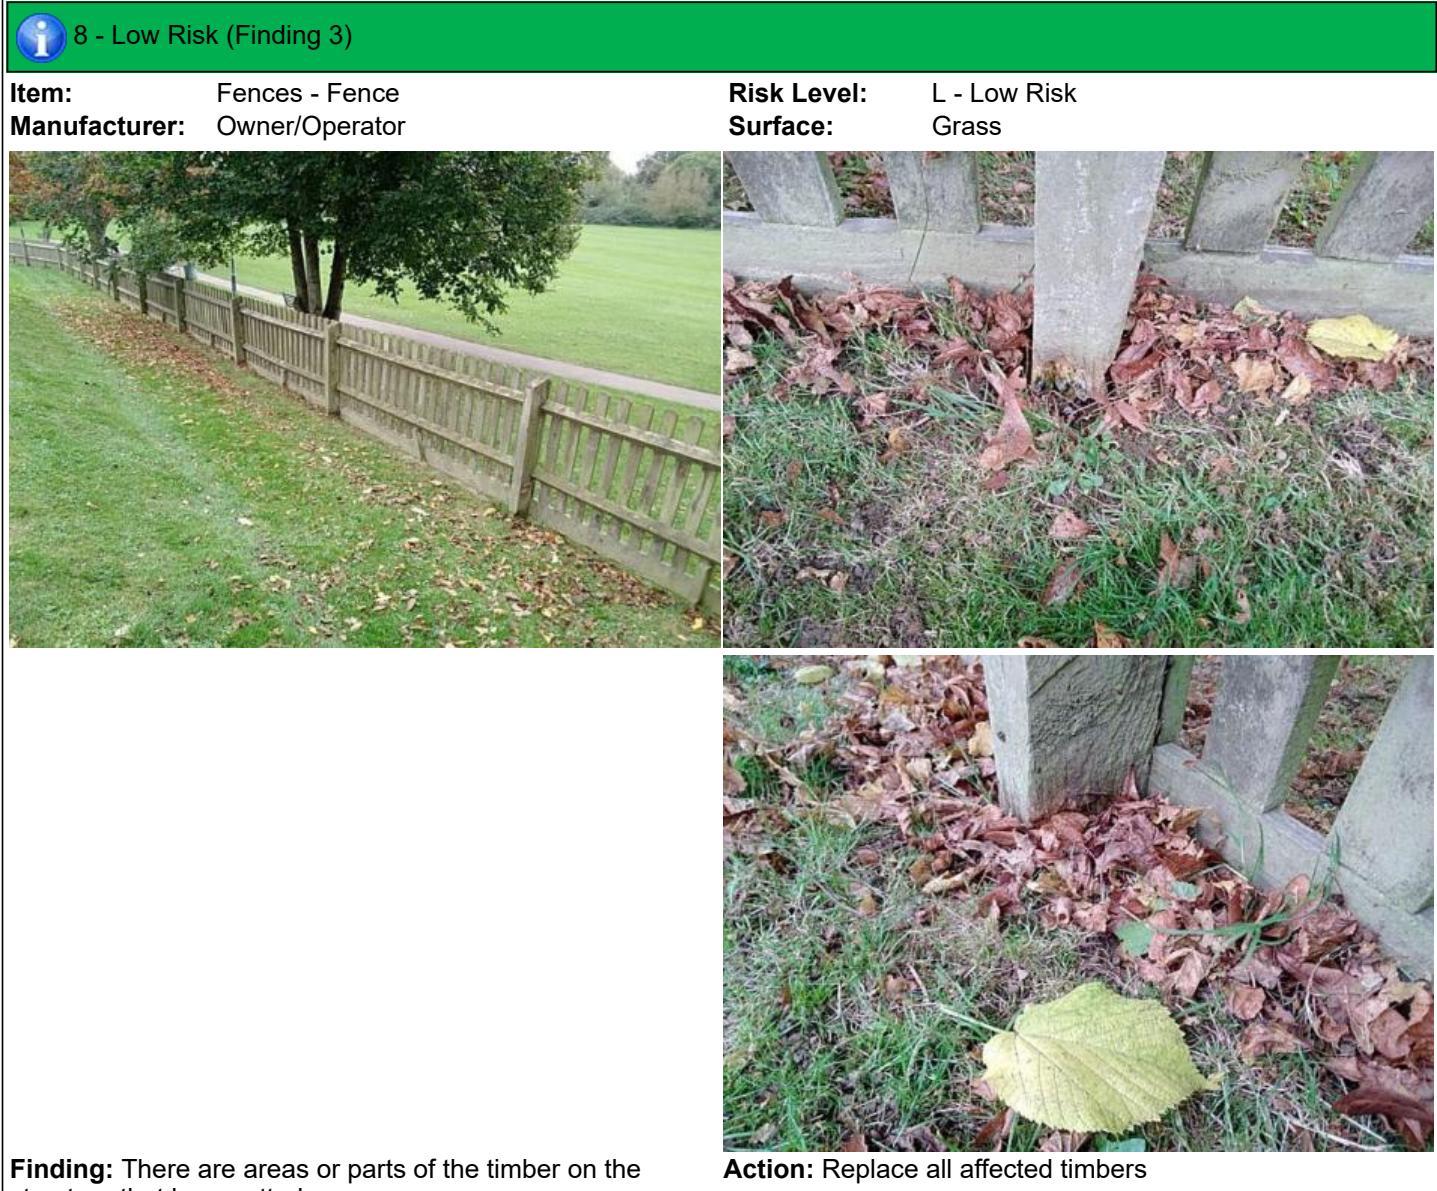
Finding: There are areas or parts of the timber on the structure that have rotted

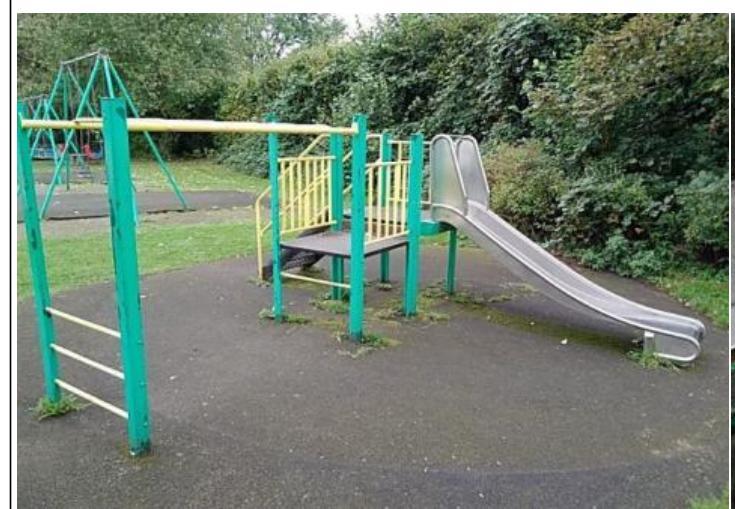
Finding: There is/are finger entrapment/s in the platforms and the item fails to meet the requirements of BS EN 1176 Part 1 4.2.7.6 Entrapment of fingers

Action: Monitor - No remedial work recommended

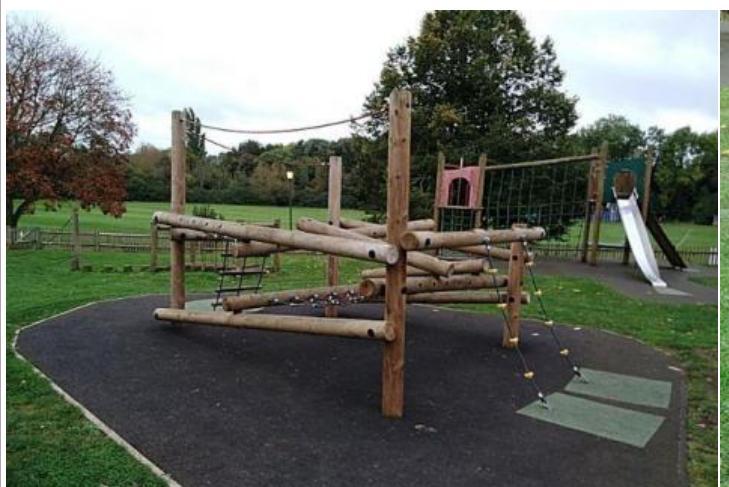
Finding: The surfacing dimensions are short and do not meet with the requirements of the current applicable standard

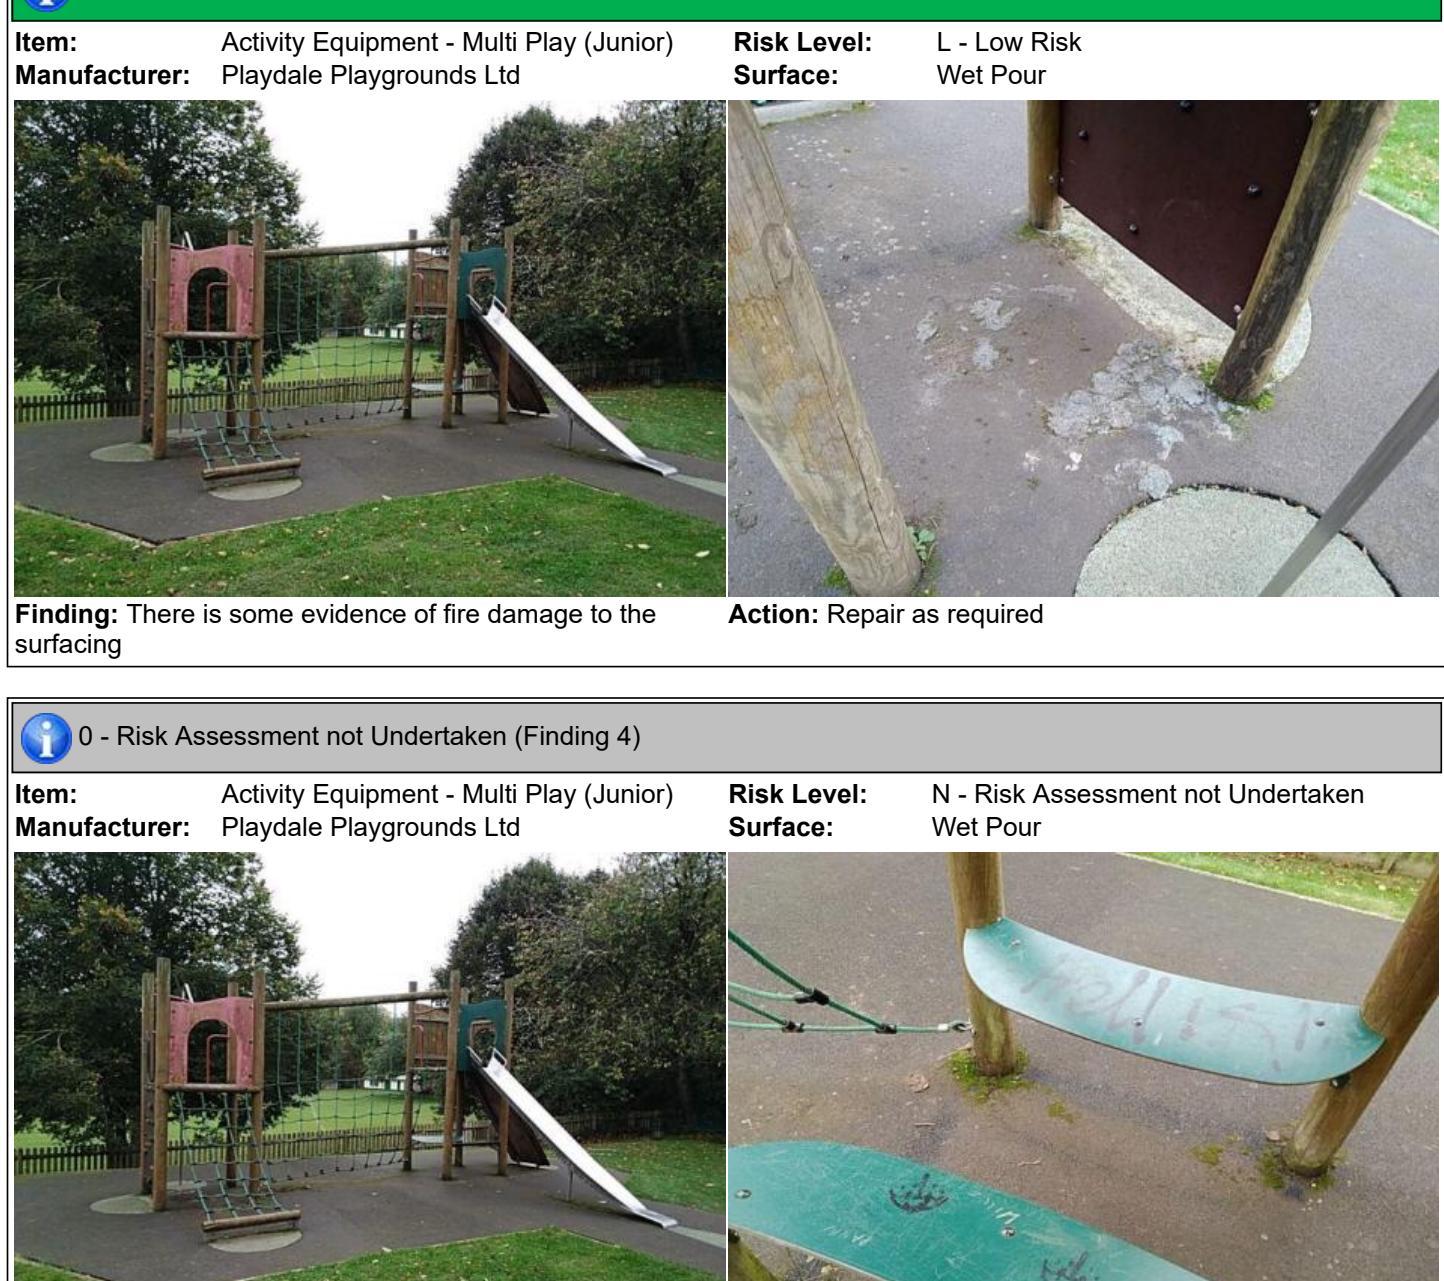
8 - Low Risk (Finding 3)

Finding: There is some graffiti present

Action: Remove the graffiti

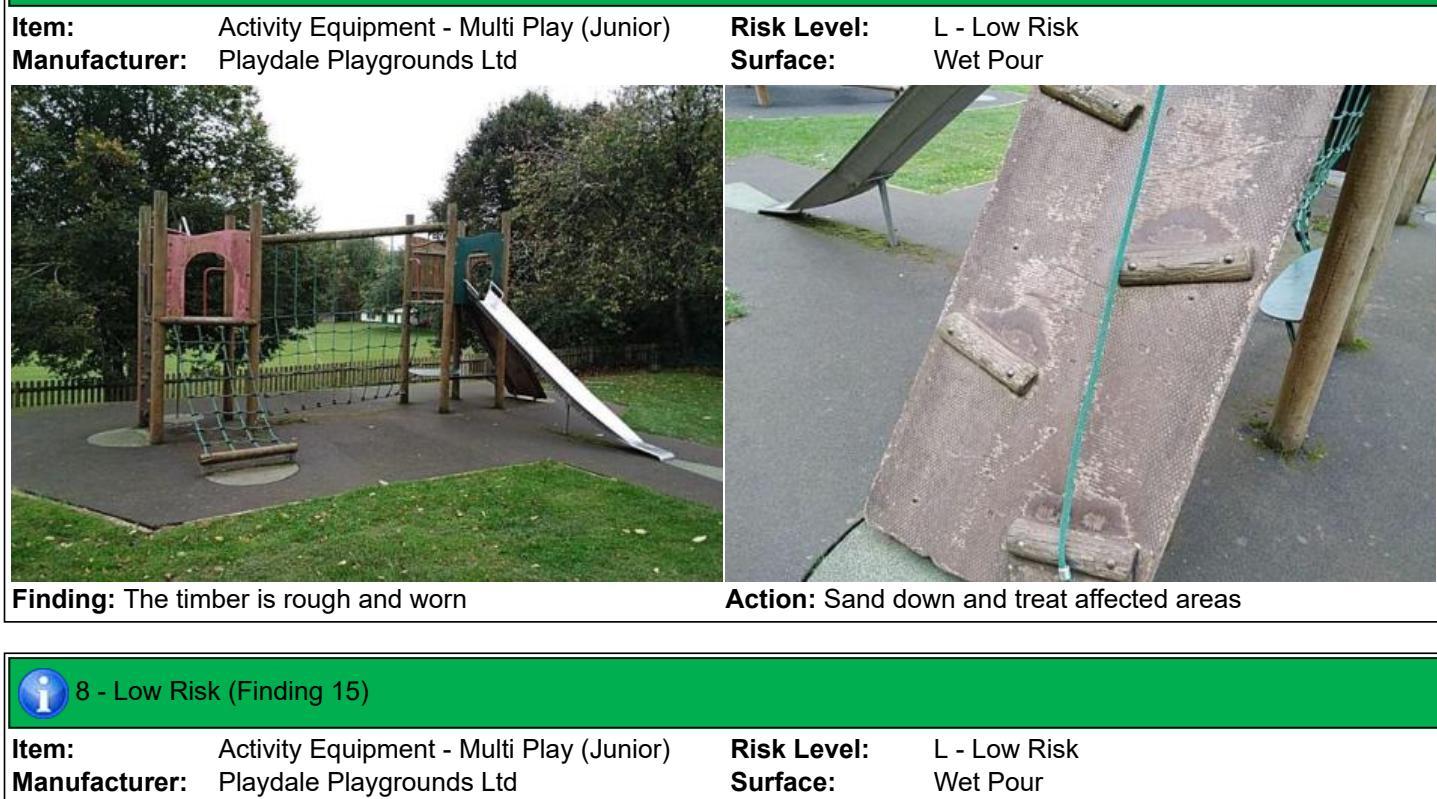
6 - Low Risk (Finding 14)

Finding: There are areas or parts of the timber on the ramp **Action:** Replace all affected timbers that have rotted

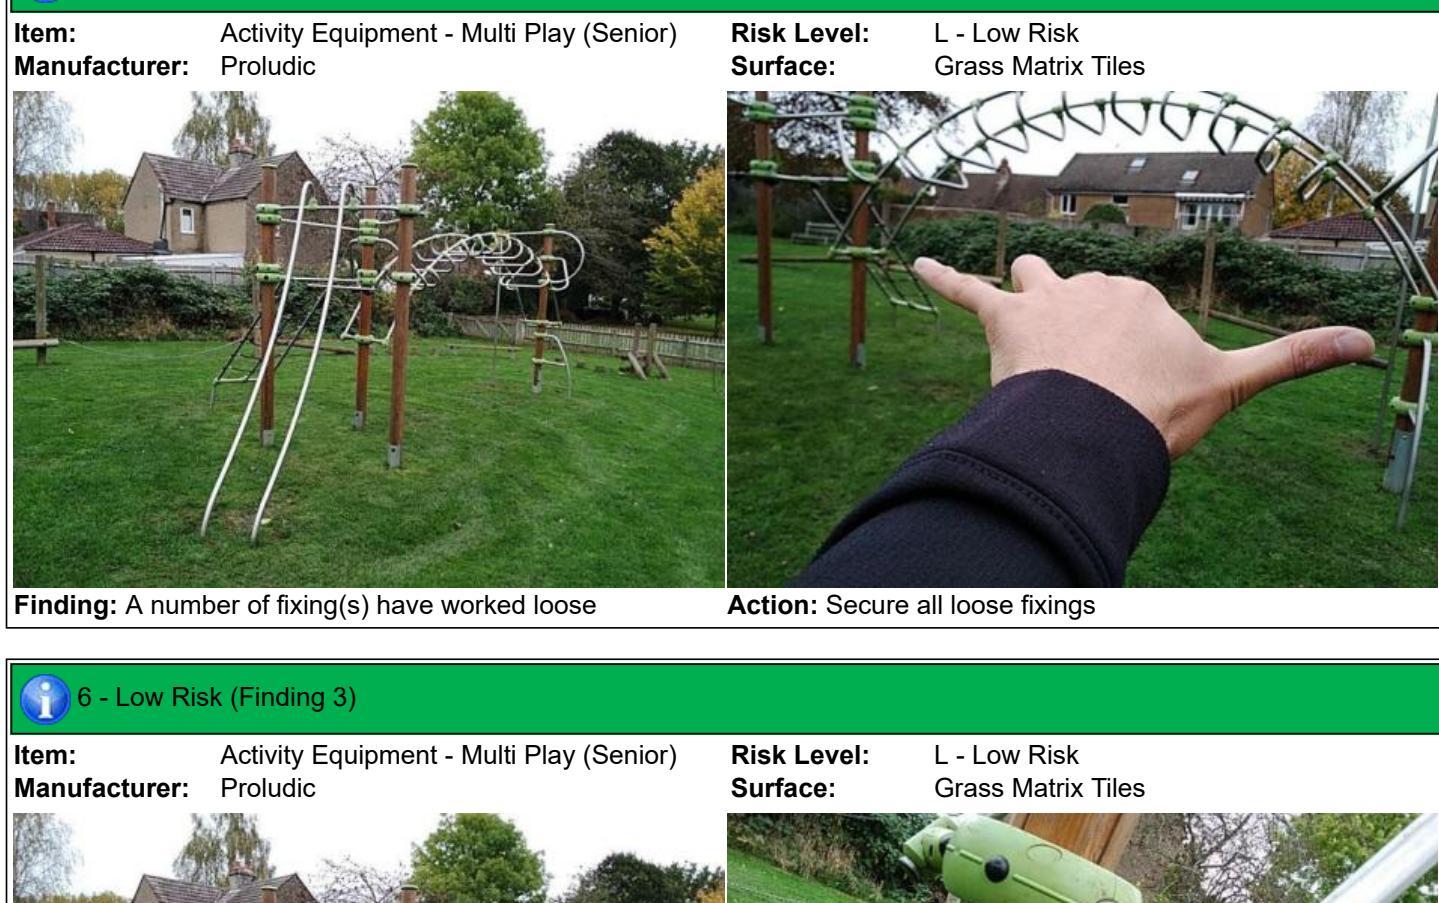
6 - Low Risk (Finding 2)

Finding: There are post / end caps missing from the item

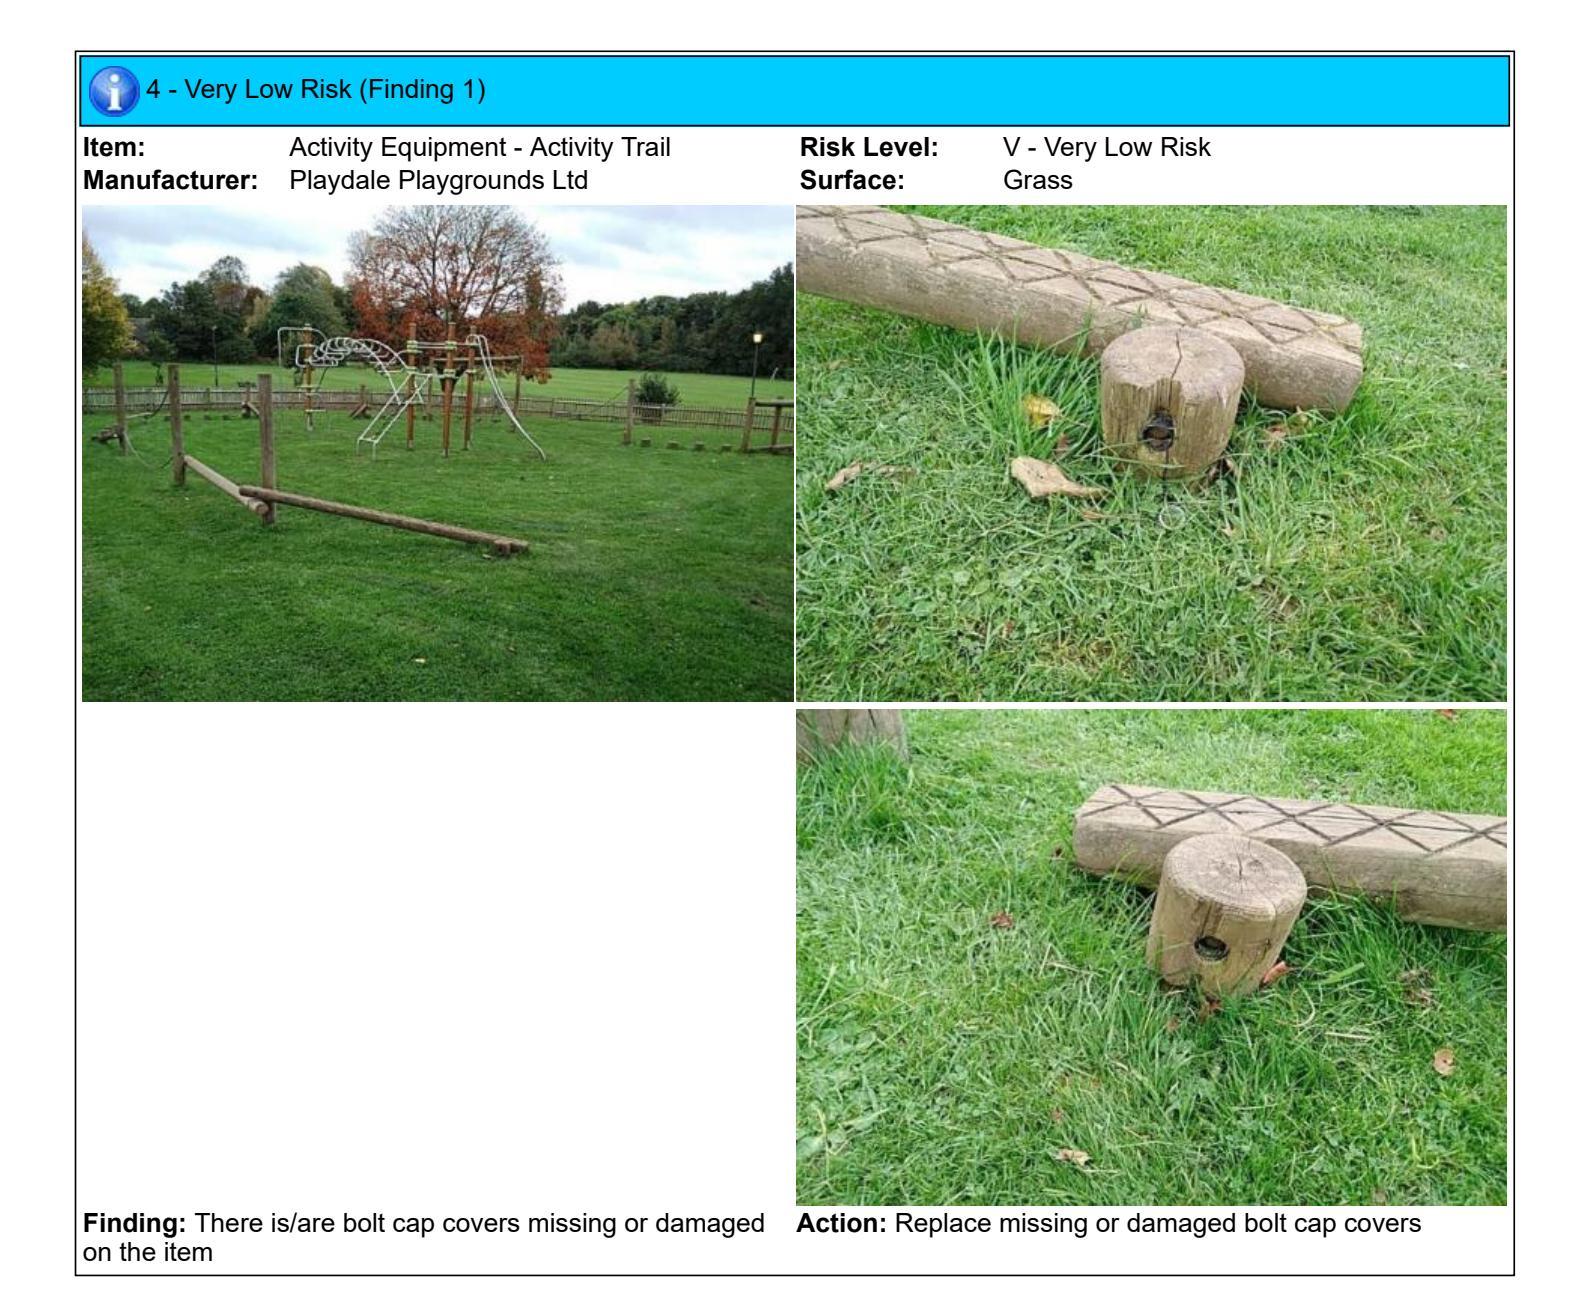
6 - Low Risk (Finding 2) Activity Equipment - Activity Trail **Risk Level:** L - Low Risk Item: Manufacturer: Playdale Playgrounds Ltd Surface: Grass Finding: There is some strimmer / machinery damage Action: Monitor for any deterioration (rot) and replace as

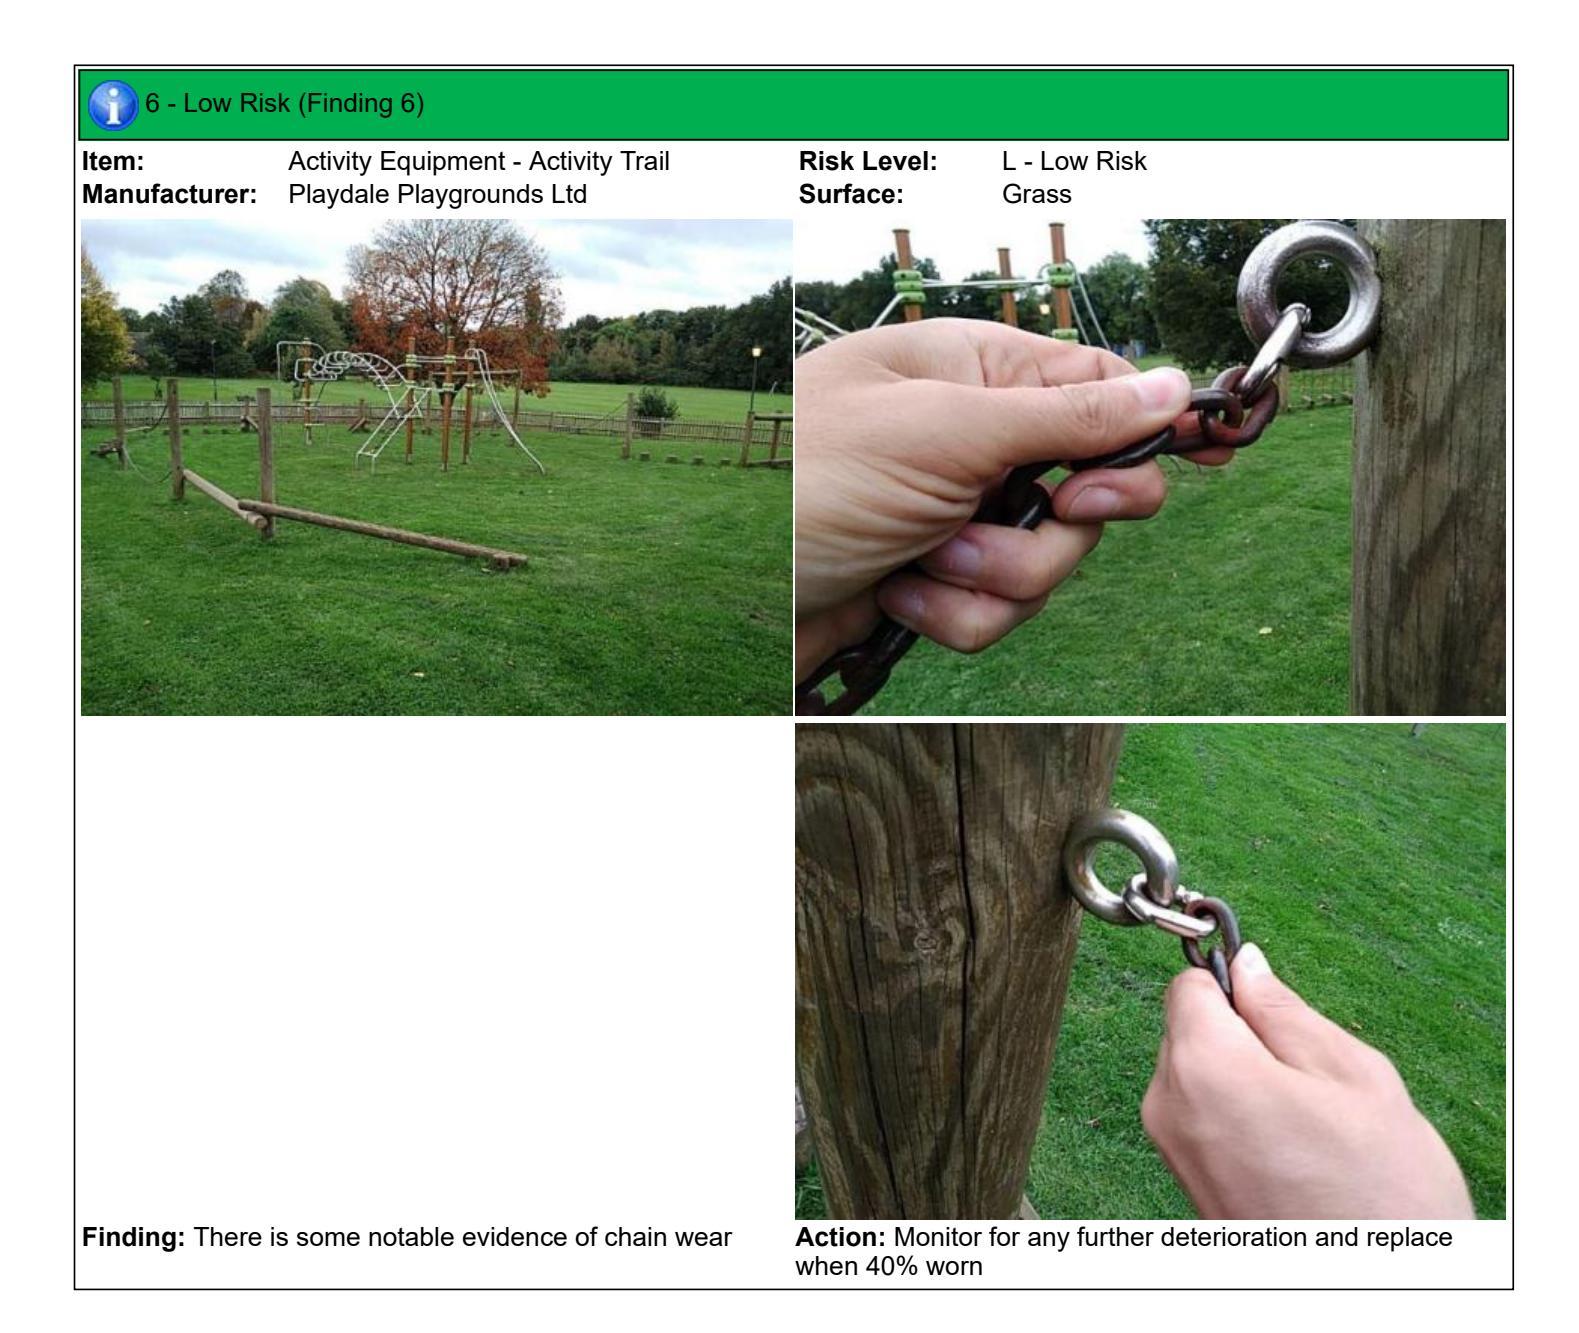
8 - Low Risk (Finding 7) 8 Activity Equipment - Activity Trail Risk Level: L - Low Risk Item: Manufacturer: Playdale Playgrounds Ltd Surface: Grass Finding: There is algae or moss on the surface of the Action: Clean and treat appropriately

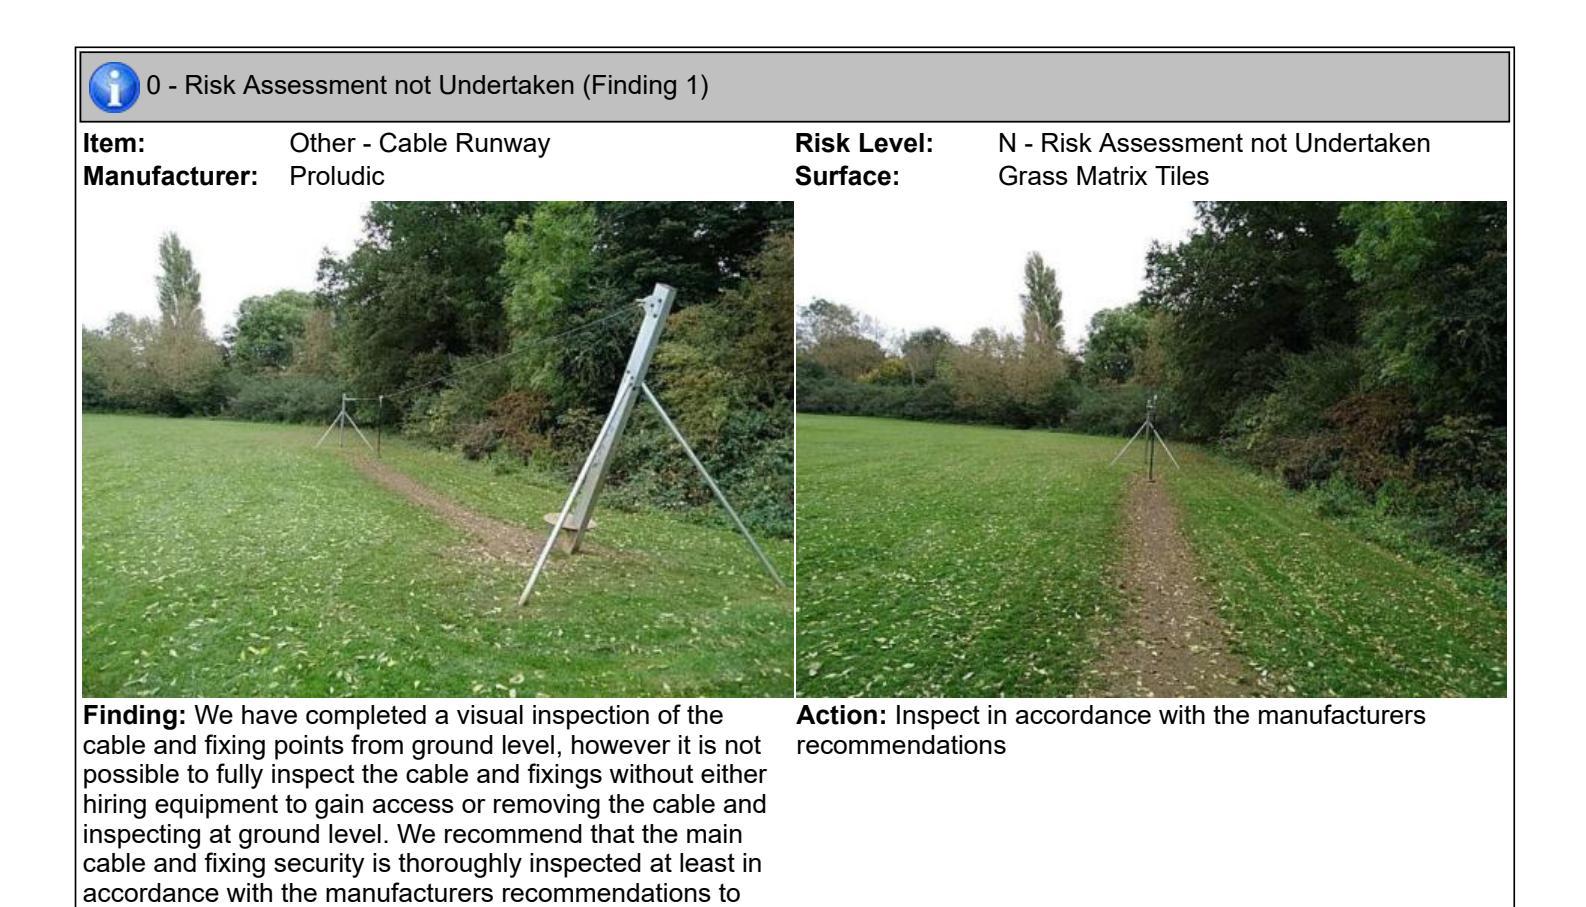
6 - Low Risk (Finding 13) Item: Activity Equipment - Activity Trail Manufacturer: Playdale Playgrounds Ltd Surface: Grass

check for damage, security or internal rusting, this will help

to ensure the continued safe use of the equipment

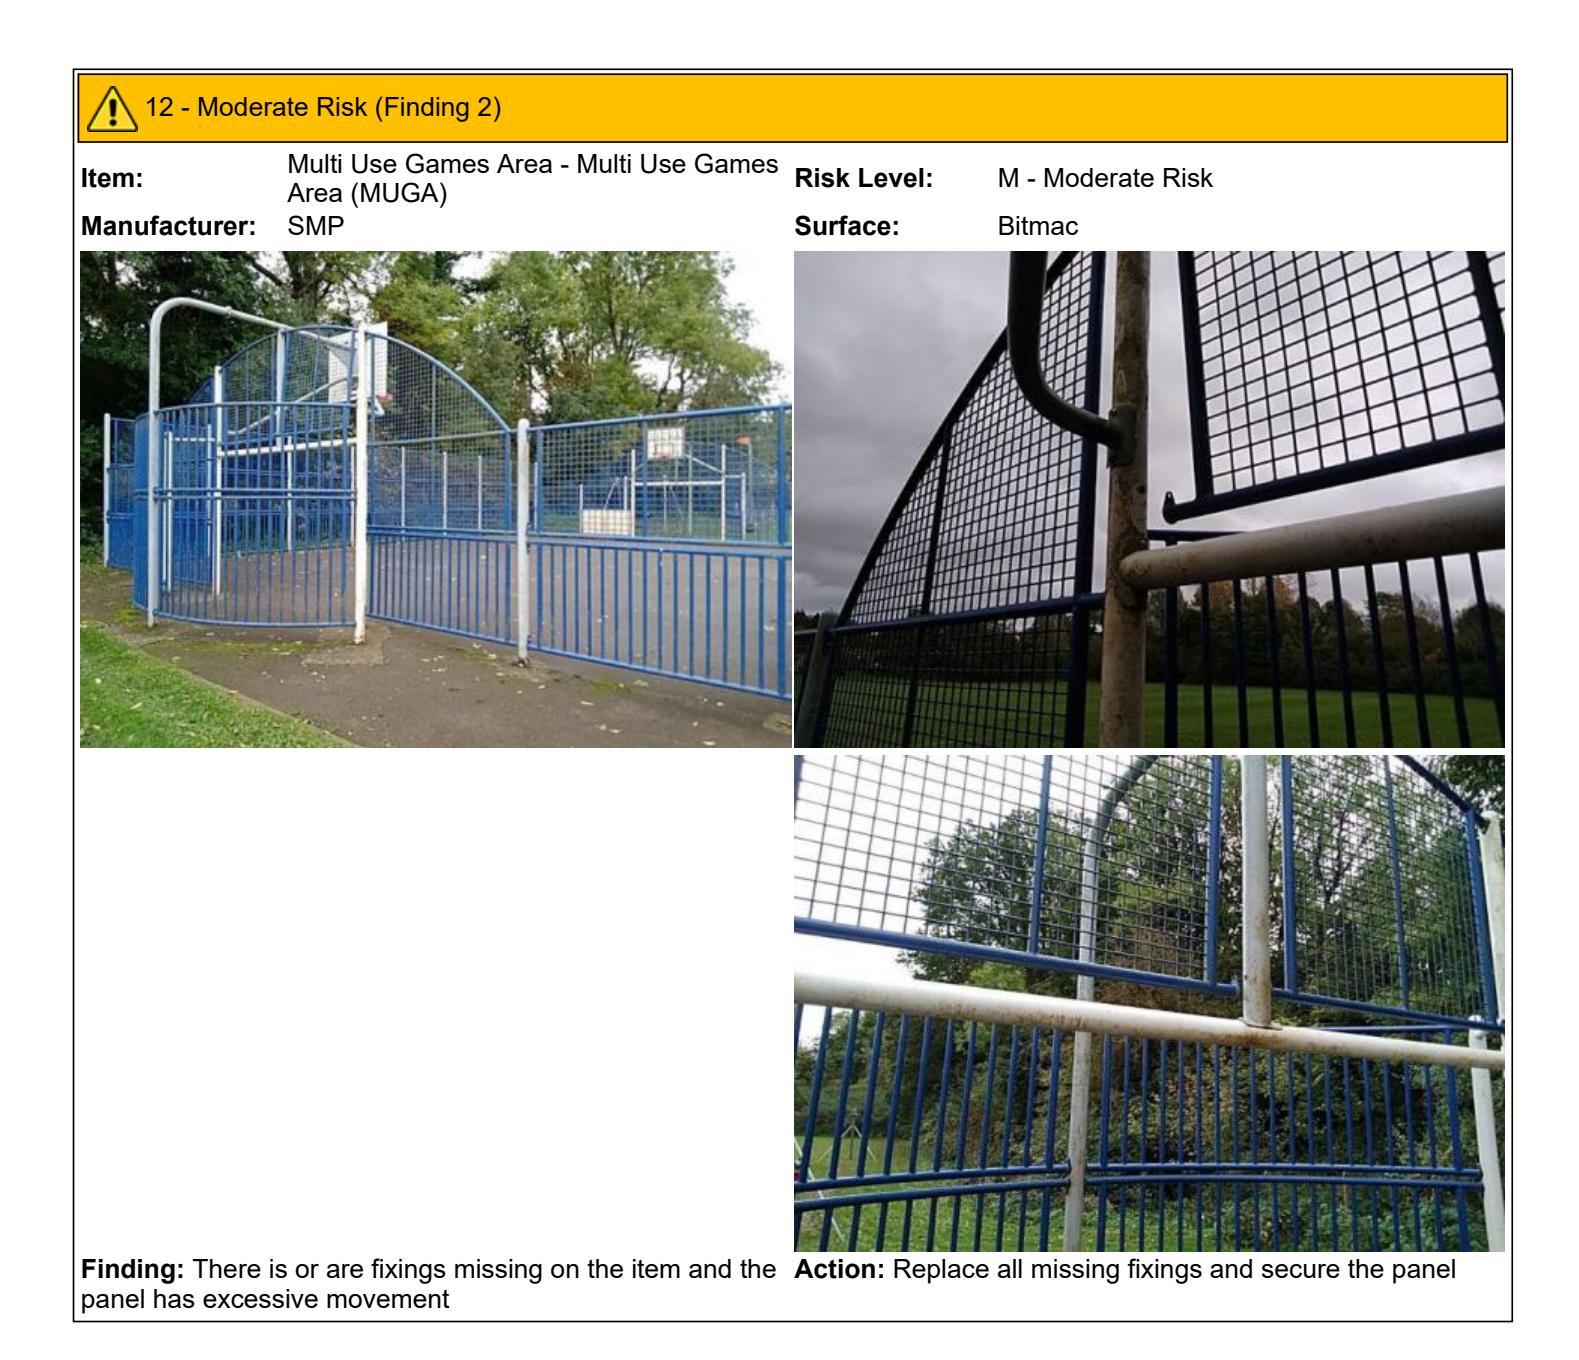
5 - Very Low Risk (Finding 1) Multi Use Games Area - Multi Use Games **Risk Level:** V - Very Low Risk Item: Area (MUGA) SMP Manufacturer: Surface: Bitmac Finding: A clearly visible facility sign should be provided in Action: Provide signage to BS EN 15312 a prominent position with the wording as detailed BS EN 15312- the equipment is not intended for children less than 3 years old- the warning - Do not climb on the framework or nets- the warning - Do not hang on the ring (if provided)- the warning - Do not wear rings or other jewellery- name and telephone number of the administrator- number to call in case of accident

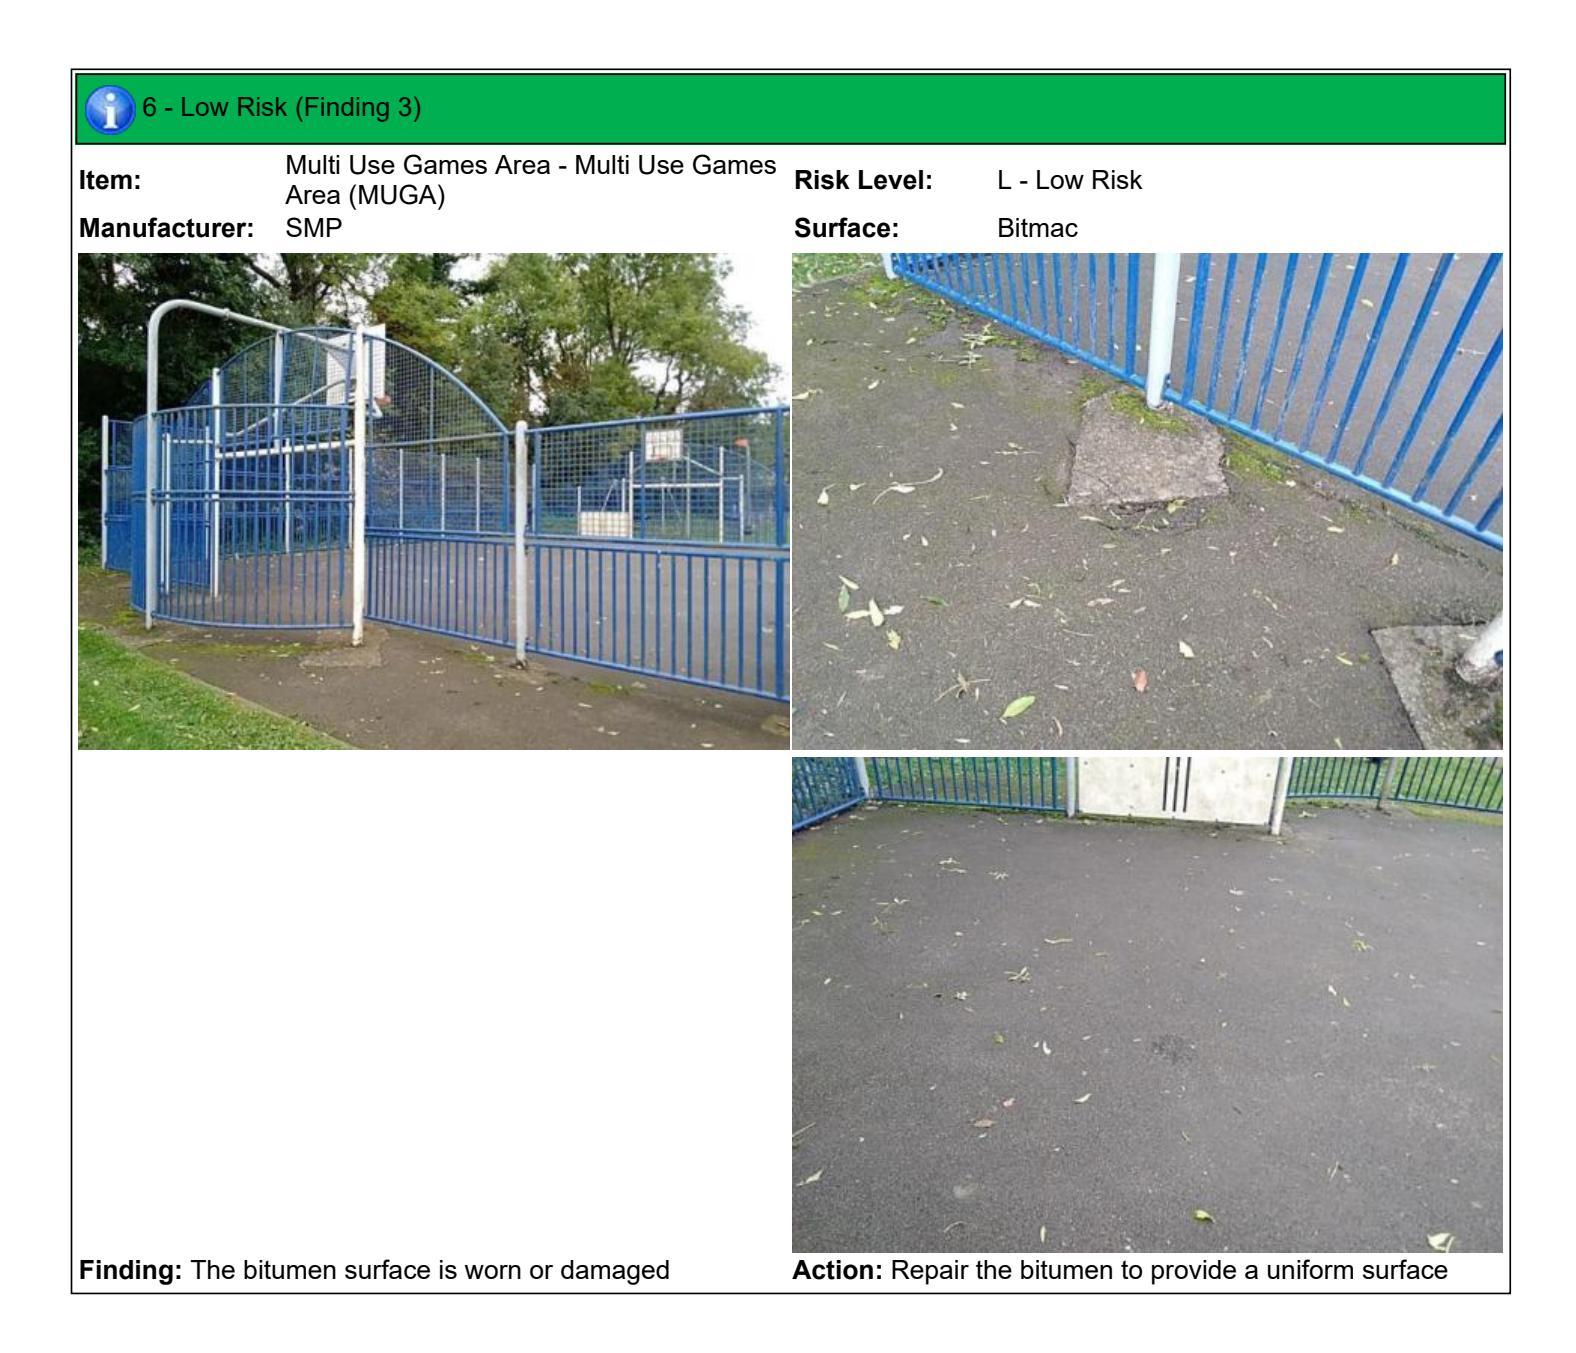
Finding: There is algae or moss growth on the surface resulting in slippery conditions

Action: Clean and treat appropriately

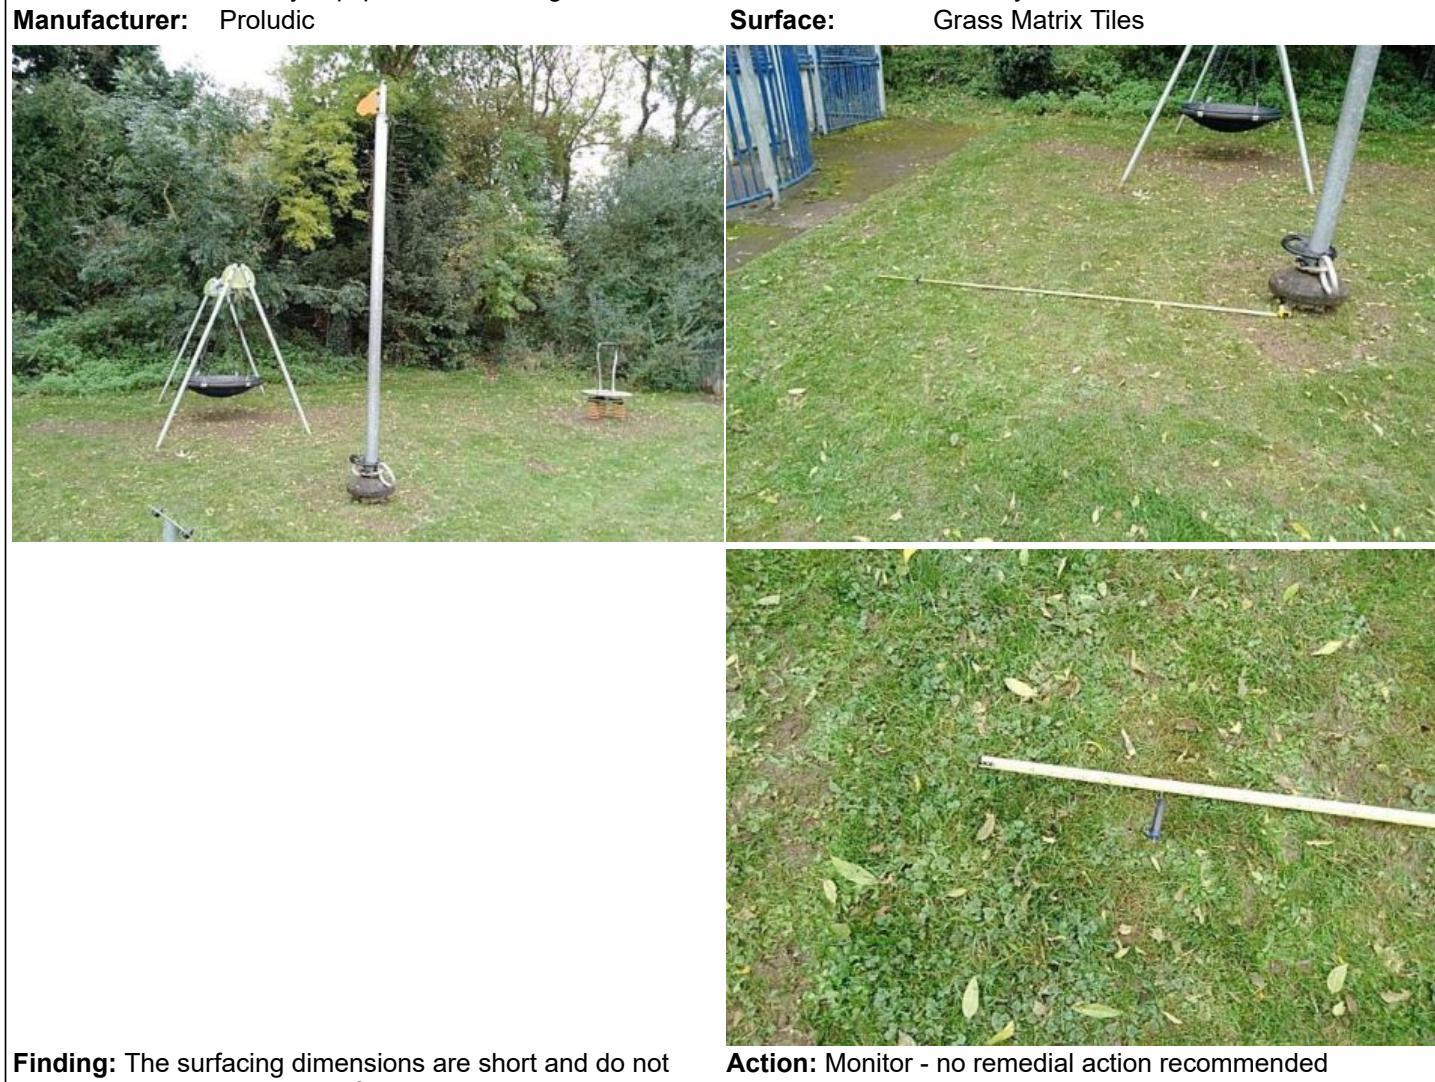
5 - Very Low Risk (Finding 1)

Finding: The surfacing dimensions are short and do not meet with the requirements of the current applicable standard

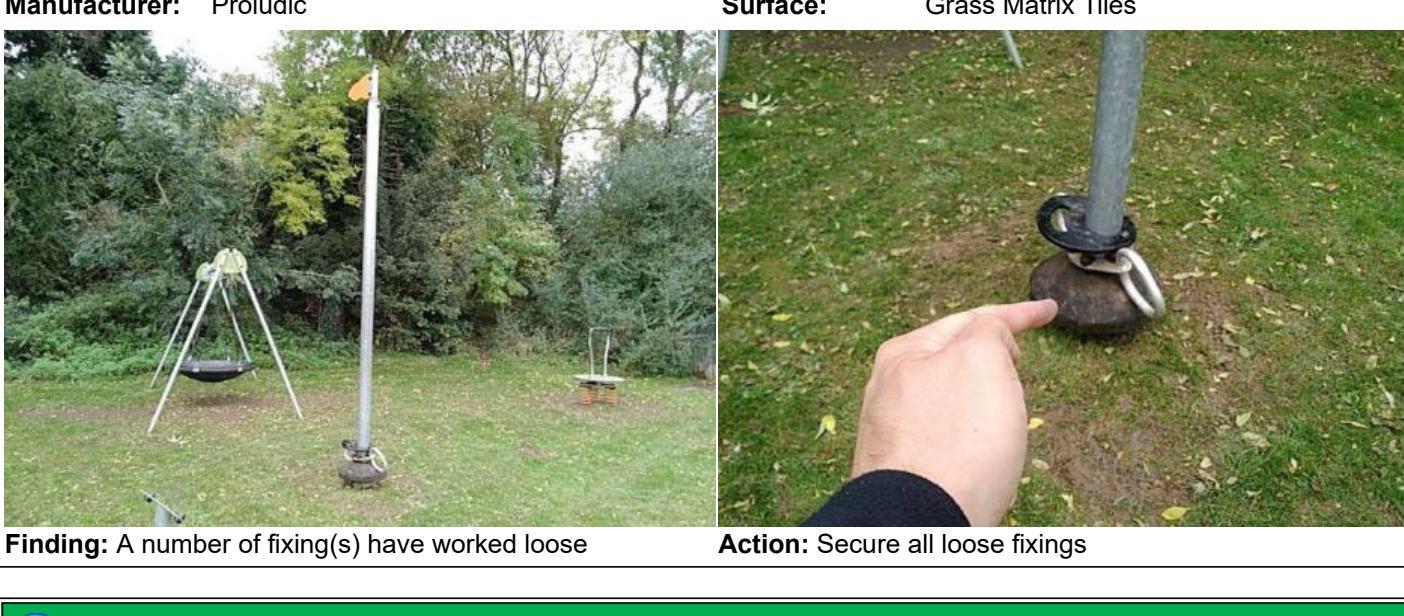
Finding: The item is slightly loose in its foundations

Action: Monitor for any further deterioration and repair as required

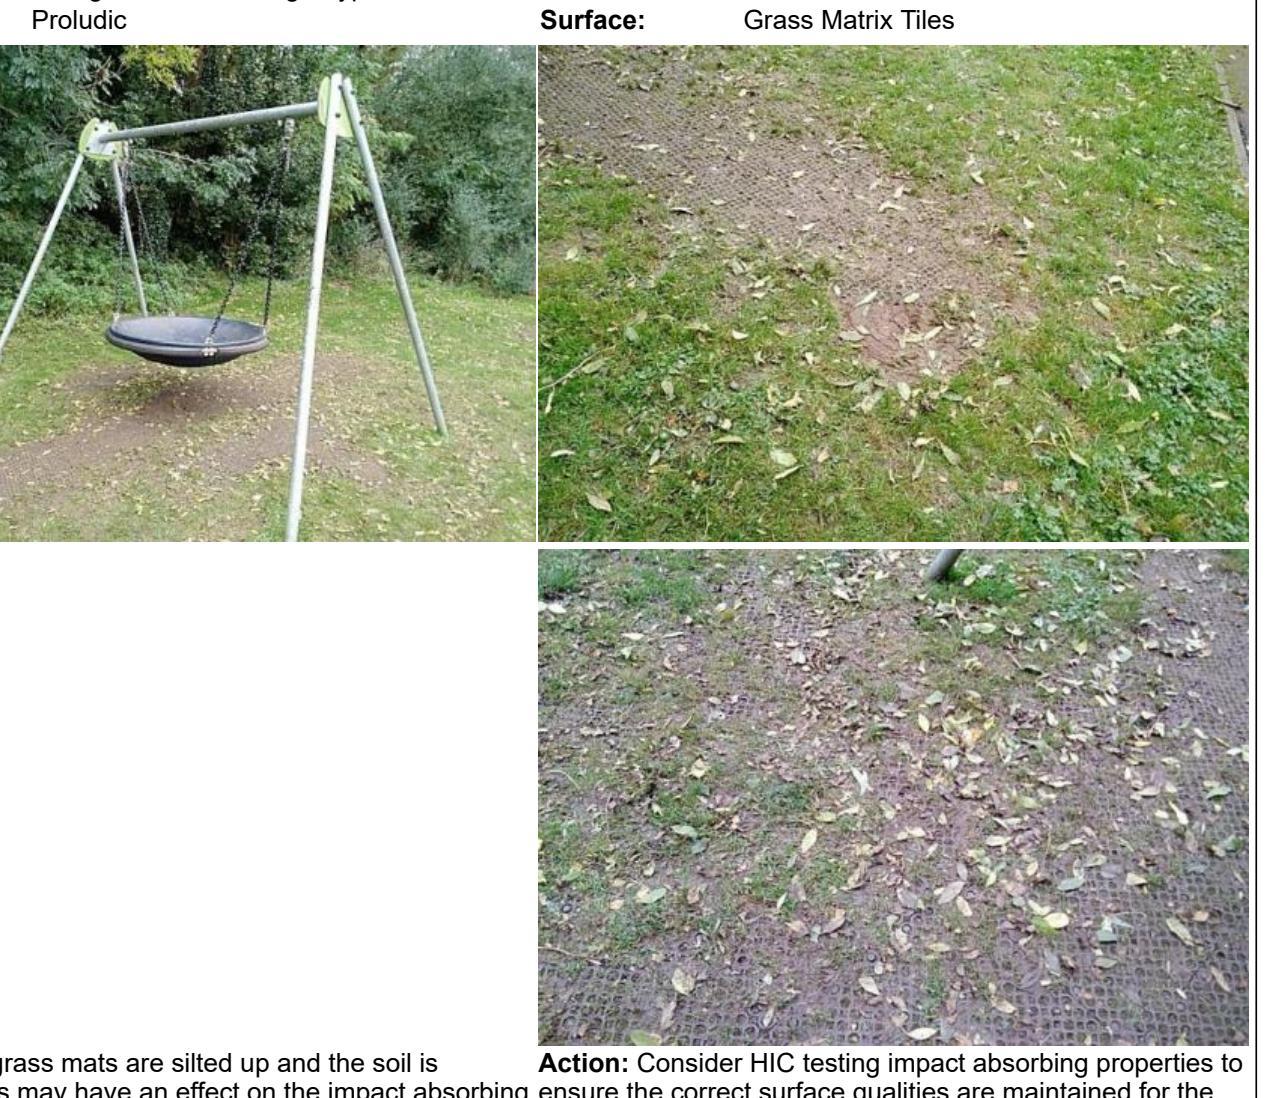
8 - Low Risk (Finding 1)

Finding: The grass mats are silted up and the soil is compacted; this may have an effect on the impact absorbing properties of the surface are maintained for the equipment and replace as required

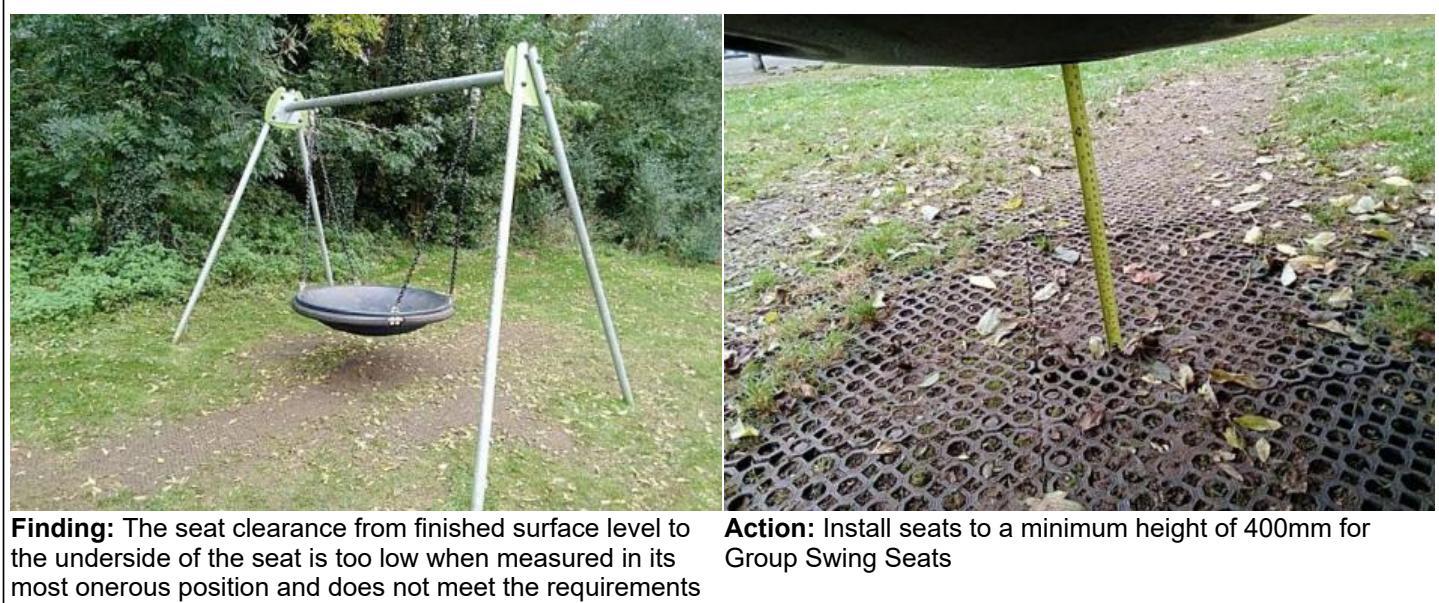
Finding: Swings of this design should have a secondary safety device fitted to prevent collapse of the seat in the event of a joint failure to meet the requirements of BS EN 1176 Part 2

Action: Consider providing a secondary safety device where possible
