the play inspection company

Annual Inspection

Adderbury Parish Council

The Rise

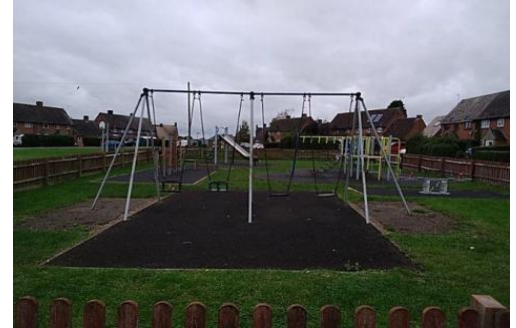
Item: Site General
Manufacturer: Owner/Operator
Surface Type: N/A
Item Quantity: 1
Equipment Compliance: N/A
Surface Area Compliance: N/A

There are trip hazards at the edges of the surface - Reinstate surrounding surface levels to remove the trip points

There are significant gaps (over 30mm) between the surface and the edging or between the joints in the surface; these are large enough for a small foot to enter - Repair surfacing

There are gaps opening between the surfacing and the edging surround or between the joints in the surfacing - Monitor for any further deterioration and repair as required

The surface is lifting at the edges and creating trip points - Repair perimeter of surfacing to remove trip points

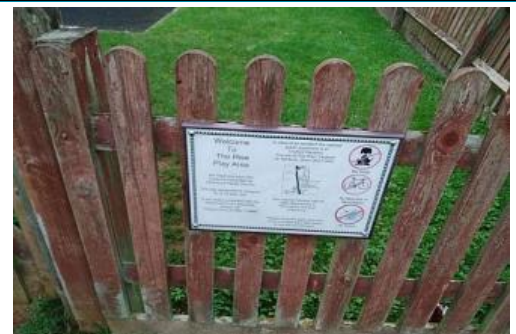
Item: Sign
Manufacturer: Owner/Operator
Surface Type: N/A
Item Quantity: 1
Equipment Compliance: N/A
Surface Area Compliance: N/A

This item is satisfactory - no work required -

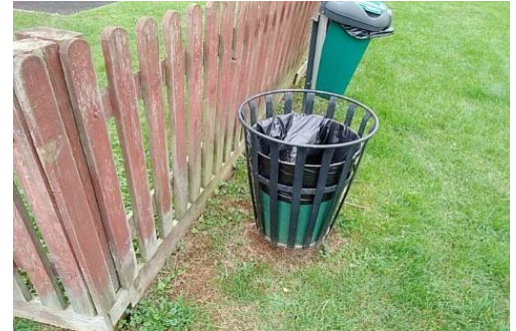
Item: Litter Bin
Manufacturer: Owner/Operator
Surface Type: Grass
Item Quantity: 2
Equipment Compliance: N/A
Surface Area Compliance: N/A

The liner of the litter bin is not secured - Ensure the lid/door is kept locked and the liner secured

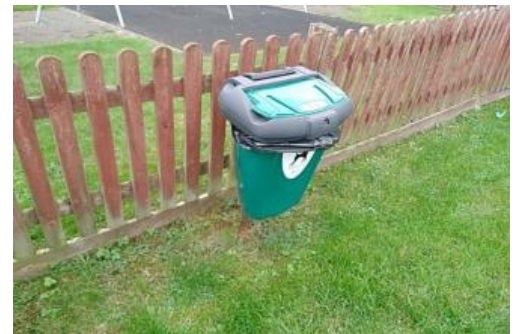
Item: Dog Litter Bin
Manufacturer: Owner/Operator
Surface Type: Grass
Item Quantity: 1
Equipment Compliance: N/A
Surface Area Compliance: N/A

This item is satisfactory - no work required -

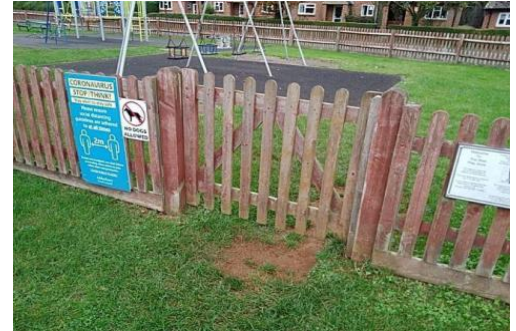
Item: Gate - Self Closing
Manufacturer: Owner/Operator
Surface Type: Grass
Item Quantity: 2
Equipment Compliance: N/A
Surface Area Compliance: N/A

The gate is closing too quickly (less than 4 seconds) - Take corrective action to ensure that the gate closes in 4-8 seconds

There is some evidence of rot in the timber - Monitor for any further deterioration and replace as required

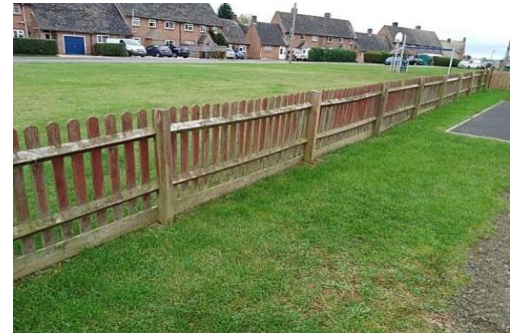
Item: Fence
Manufacturer: Owner/Operator
Surface Type: Grass
Item Quantity: 1
Equipment Compliance: N/A
Surface Area Compliance: N/A

There is some strimmer / machinery damage apparent on the posts, this can penetrate the preservative applied to the timber and accelerate the rotting process - Monitor for any deterioration (rot) and replace as required

There are areas or parts of the timber on the structure that have rotted - Replace all affected timbers

There is or are fixings missing on the item - Replace all missing fixings

There are a number of loose posts around the fence - Monitor for any further deterioration and reset as required

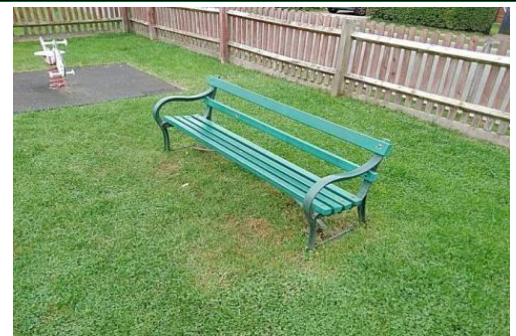
Item: Bench
Manufacturer: Owner/Operator
Surface Type: Grass
Item Quantity: 1
Equipment Compliance: N/A
Surface Area Compliance: N/A

There are projecting bolt thread(s) present - Remove excess thread length and deburr or provide cap

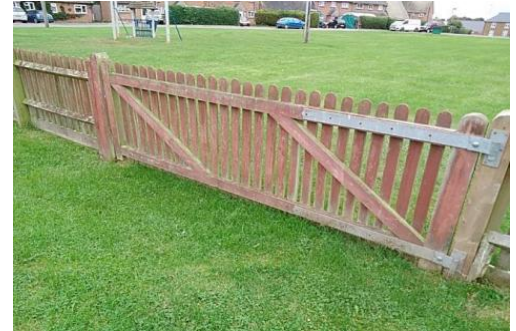
Item: Gate - Maintenance
Manufacturer: Owner/Operator
Surface Type: Grass
Item Quantity: 1
Equipment Compliance: N/A
Surface Area Compliance: N/A

There is no padlock on the maintenance gate - Provide a padlock to secure the gate

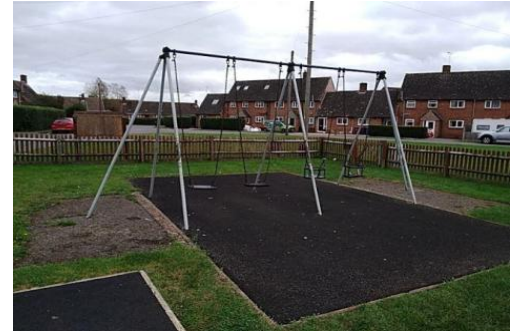
Item: 2 Bay (2 Flat, 2 Cradle)
Manufacturer: Not Identified
Surface Type: Wet Pour
Item Quantity: 1
Equipment Compliance: No
Surface Area Compliance: No

There is some damage to the concrete edging - Monitor for any further deterioration and repair as required

The safety surface around the area is beginning to wear - Monitor for any further deterioration and repair as required

The concrete edging forms a hard object within the impact area of the equipment in contravention of the requirements of BS EN 1176 Part 1 - Monitor - No remedial work recommended

The surfacing width under each seat is less than 1.75 metres and fails the requirements of BS EN 1176 Part 2 - Monitor - No remedial work recommended

The seats are too close to each other as defined in BS EN 1176 Part 2; this is a low risk failure and no remedial action is required - Monitor - No remedial work recommended

The swing seat connectors are loose - Tighten to secure

The seat has minor damage or wear - Monitor for any further deterioration and replace as required

There is some wear to the shackles - Monitor for any further deterioration and replace when 40% worn

There is algae or moss growth on the surface resulting in slippery conditions - Clean and treat appropriately

There is moderate damage to the surface - Repair the damaged areas of surfacing

There is some minor damage to the surface - Monitor for any further deterioration and repair as required

The seats are too close to the frame as defined in BS EN 1176 Part 2; this is a low risk failure and no remedial action is required - Monitor - No remedial work recommended

The chain openings are in excess of 8.6mm and do not meet the recommendations of BS EN 1176 Part 1 - Monitor - No remedial work recommended

The chain links are worn in excess of 60% and require renewing - Replace worn chains

There is some notable evidence of chain wear - Monitor for any further deterioration and replace when 40% worn

The bushes are showing signs of wear - Monitor for any further deterioration and replace as required

There is surface corrosion present on the fixings - Replace all corroded fixings

The connecting links are in excess of 8.6mm and less than 12mm and fail the requirements of BS EN 1176 Part 1; clause 4.2.13, Chains - Monitor use and replace with compliant links at the next maintenance cycle

The seat is severely damaged and requires replacing - Replace damaged seat

The swing seat frames are corroding - Monitor for any further deterioration and replace as required

The paintwork on this item has been damaged or worn exposing the metal underneath which is rusting - Treat any rusting components and repaint

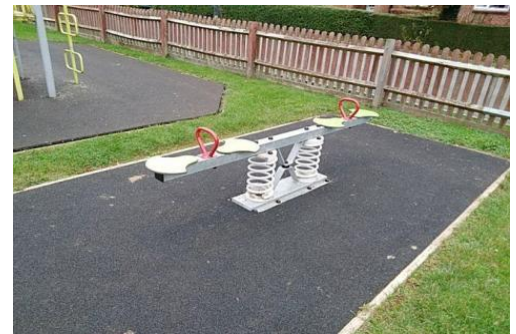
Item: Spring See-Saw
Manufacturer: Proludic
Surface Type: Wet Pour
Item Quantity: 1
Equipment Compliance: Yes
Surface Area Compliance: No

The concrete edging forms a hard object within the impact area of the equipment in contravention of the requirements of BS EN 1176 Part 1 - Monitor - No remedial work recommended

There is some damage to the item - Monitor for any further deterioration and repair as required

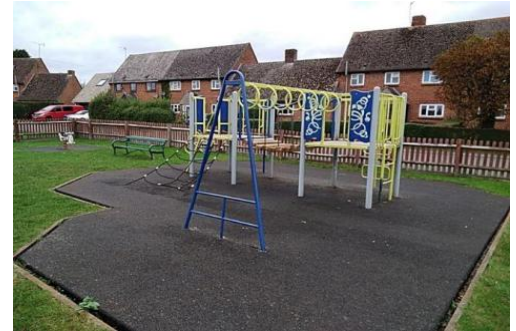
Item: Multi Play (Junior)
Manufacturer: Hags
Surface Type: Wet Pour
Item Quantity: 1
Equipment Compliance: No
Surface Area Compliance: No

There is some damage to the concrete edging - Replace all affected areas

There is some minor damage to the surface - Monitor for any further deterioration and repair as required

The concrete edging forms a hard object within the impact area of the equipment in contravention of the requirements of BS EN 1176 Part 1 - Monitor - No remedial work recommended

The item fails to meet the requirements of BS EN 1176 Part 1 4.2.7.2 head and neck entrapment in the barriers and/or steps - Monitor - No remedial work recommended

The ropes/nets are worn/damaged in places - Monitor for any further deterioration and repair or replace as required

The unit is easily accessible and has an opening in the barrier to steep play elements in excess of 500mm in contravention of BS EN 1176 Part 1 - Monitor - No remedial work recommended

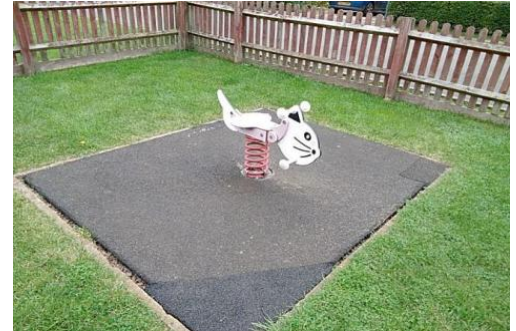
Item: Spring Cat
Manufacturer: SMP
Surface Type: Wet Pour
Item Quantity: 1
Equipment Compliance: Yes
Surface Area Compliance: No

The concrete edging forms a hard object within the impact area of the equipment in contravention of the requirements of BS EN 1176 Part 1 - Monitor - No remedial work recommended

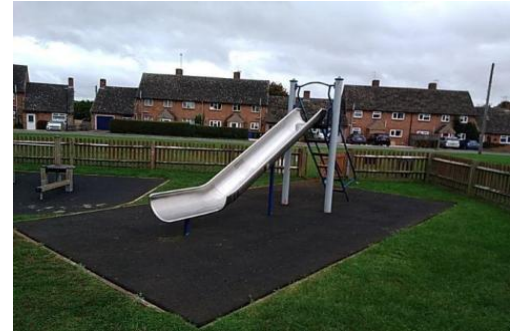
Item: Free Standing Slide
Manufacturer: Not Identified
Surface Type: Wet Pour
Item Quantity: 1
Equipment Compliance: No
Surface Area Compliance: Yes

There is some minor damage to the surface - Monitor for any further deterioration and repair as required

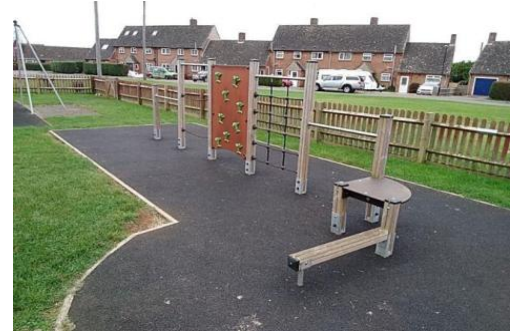
Item: Activity Trail
Manufacturer: Proludic
Surface Type: Wet Pour
Item Quantity: 1
Equipment Compliance: No
Surface Area Compliance: Yes

The item is slightly loose in its foundations - Monitor for any further deterioration and repair as required

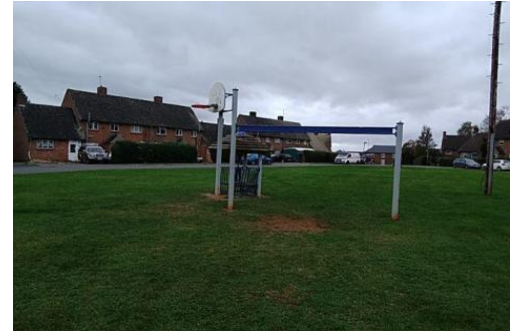
Item: Goalmouth and Basketball Post
Manufacturer: Sutcliffe Play Limited
Surface Type: Grass
Item Quantity: 1
Equipment Compliance: No
Surface Area Compliance: N/A

The surface has eroded in some areas - Reinststate the surface

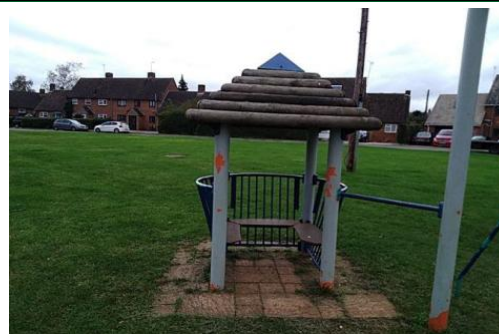
Item: Teenage Shelter
Manufacturer: Sutcliffe Play Limited
Surface Type: Paving Slabs
Item Quantity: 1
Equipment Compliance: N/A
Surface Area Compliance: N/A

There are trip hazards at the edges of the surface - Reinstate surrounding surface levels to remove the trip points

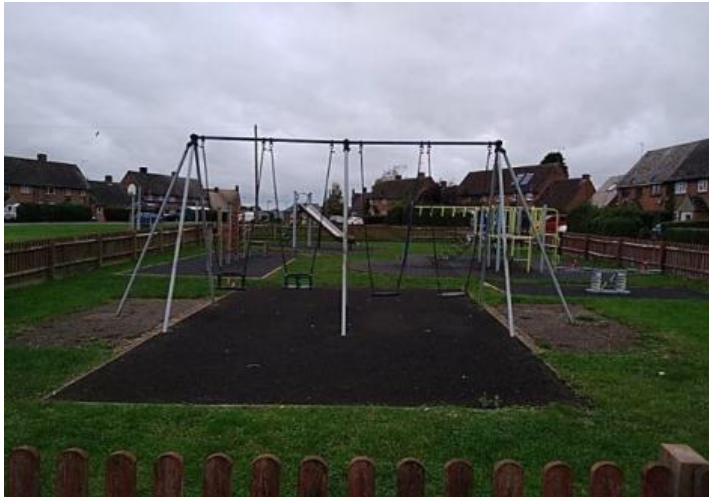
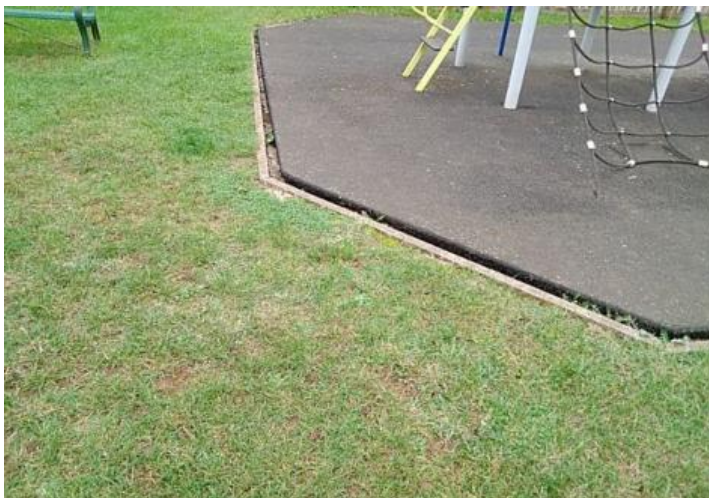
Finding: There are trip hazards at the edges of the surface **Action:** Reinstate surrounding surface levels to remove the trip points

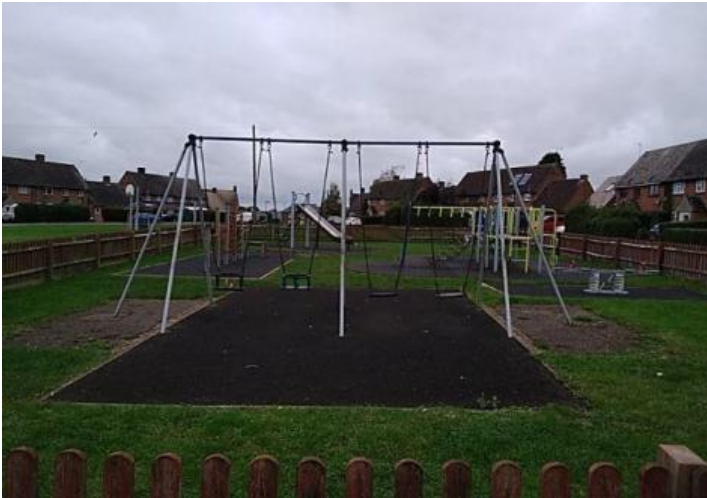
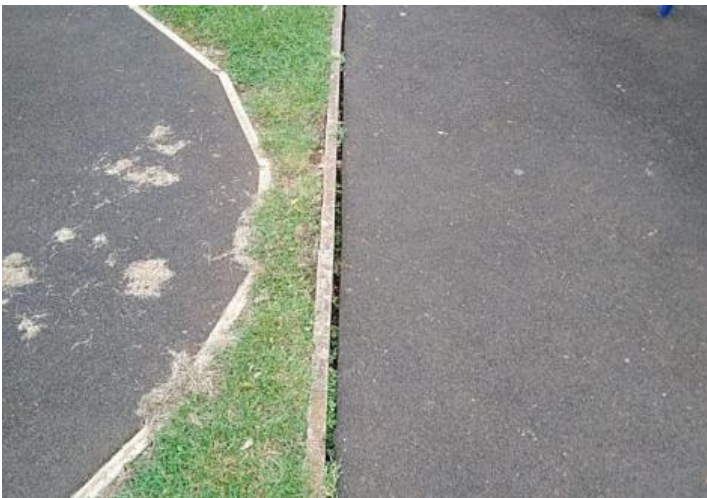
Finding: There are significant gaps (over 30mm) between the surface and the edging or between the joints in the surface; these are large enough for a small foot to enter

Action: Repair surfacing

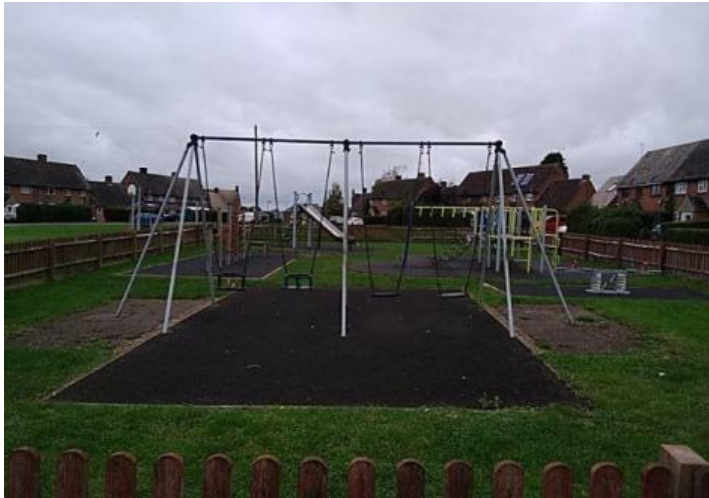
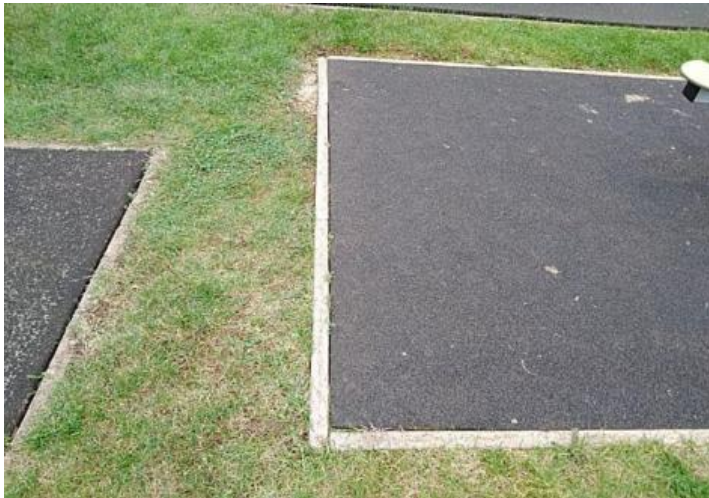
Finding: There are gaps opening between the surfacing and the edging surround or between the joints in the surfacing **Action:** Monitor for any further deterioration and repair as required

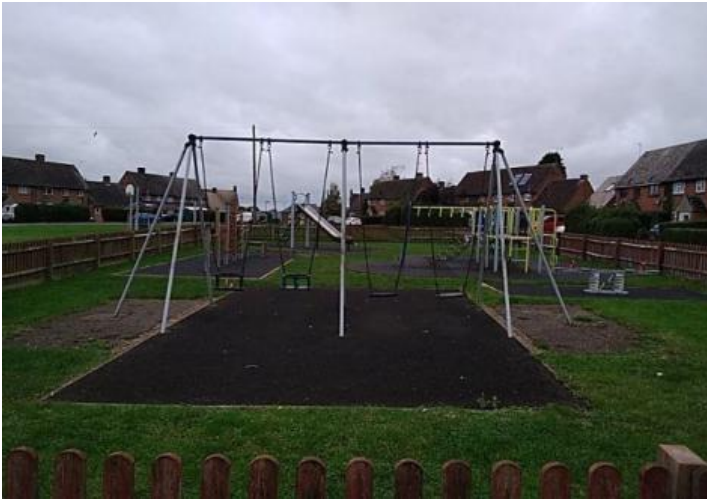
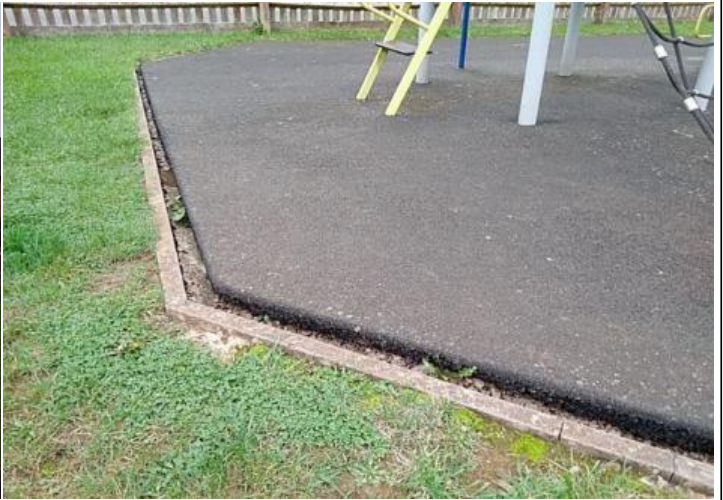
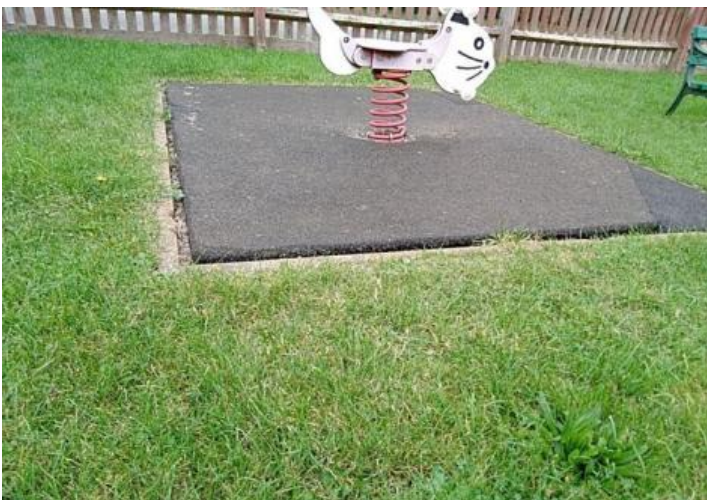
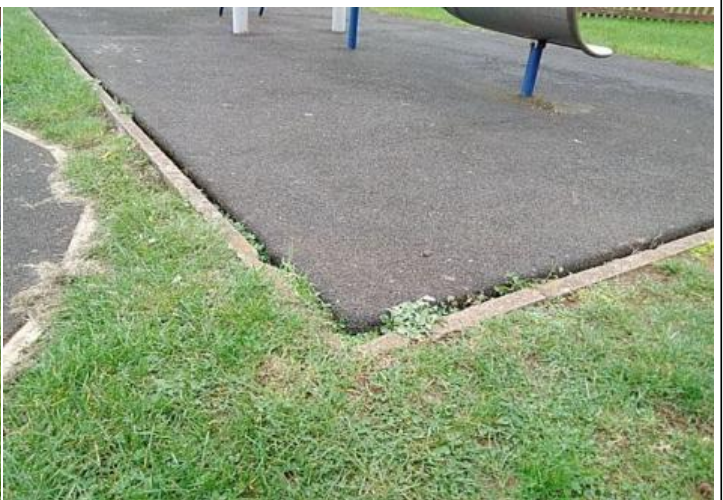
Finding: The surface is lifting at the edges and creating trip points **Action:** Repair perimeter of surfacing to remove trip points

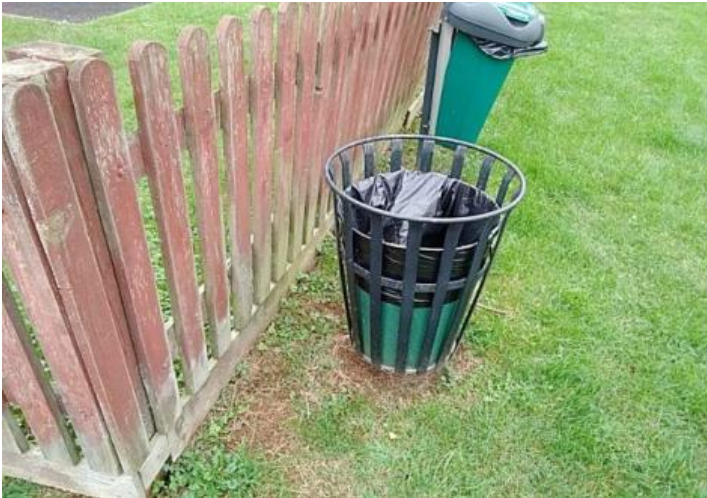
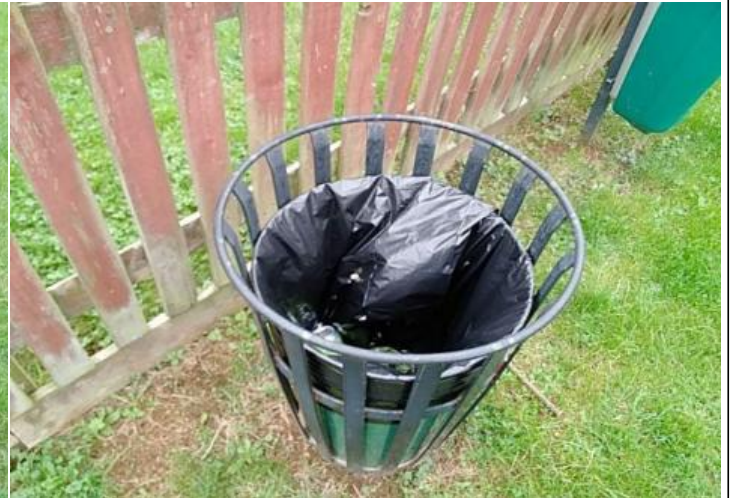
Finding: The liner of the litter bin is not secured

Action: Ensure the lid/door is kept locked and the liner secured

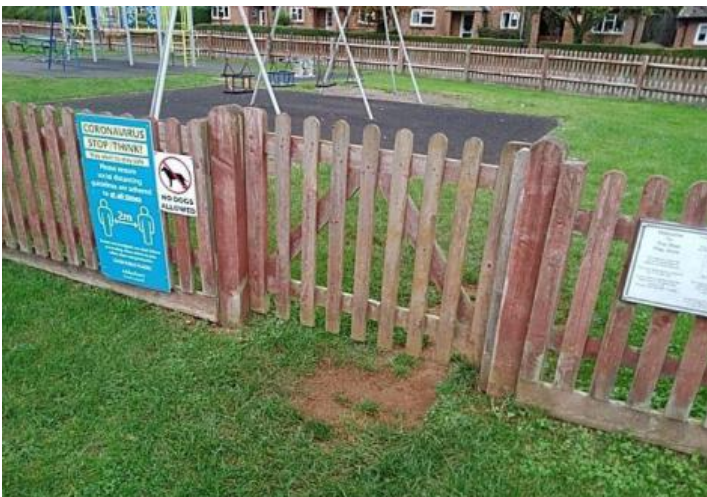
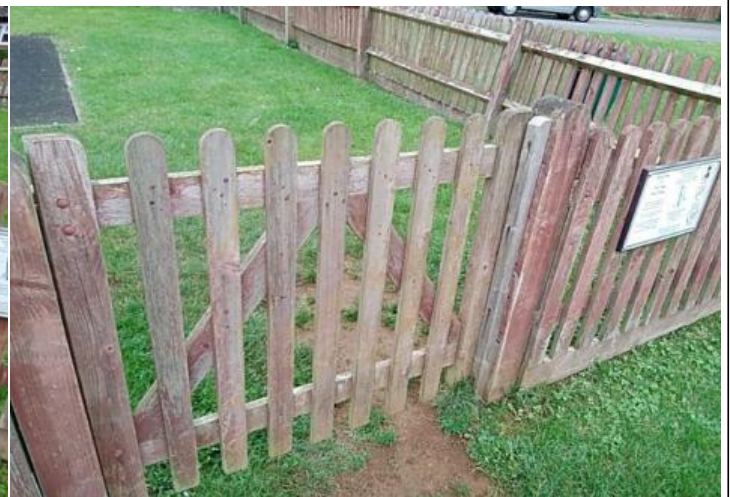
Finding: The gate is closing too quickly (less than 4 seconds)

Action: Take corrective action to ensure that the gate closes in 4-8 seconds

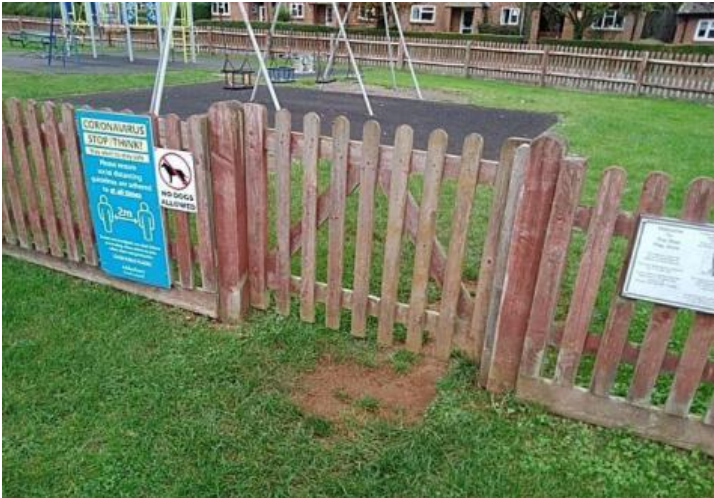
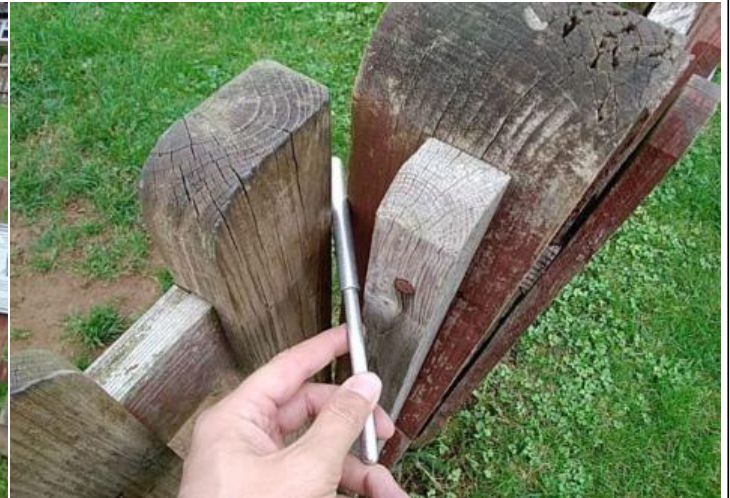
Finding: There are openings that are less than 12mm that could trap or crush fingers

Action: Where possible a 12mm gap should be maintained on both sides or between the gate leaves

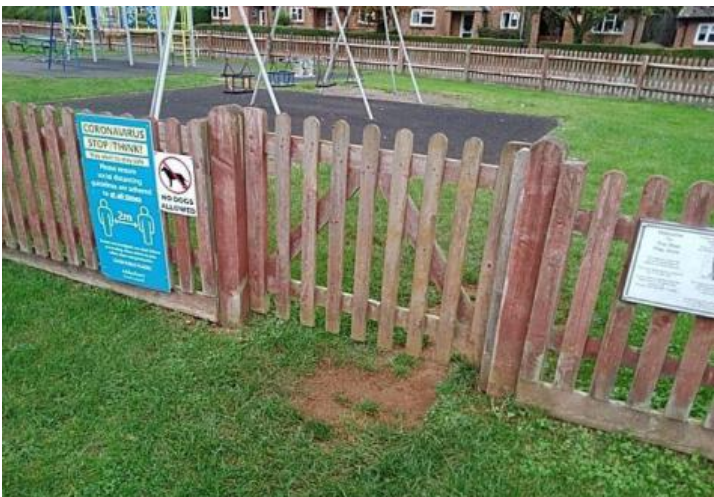
Finding: There is some evidence of rot in the timber

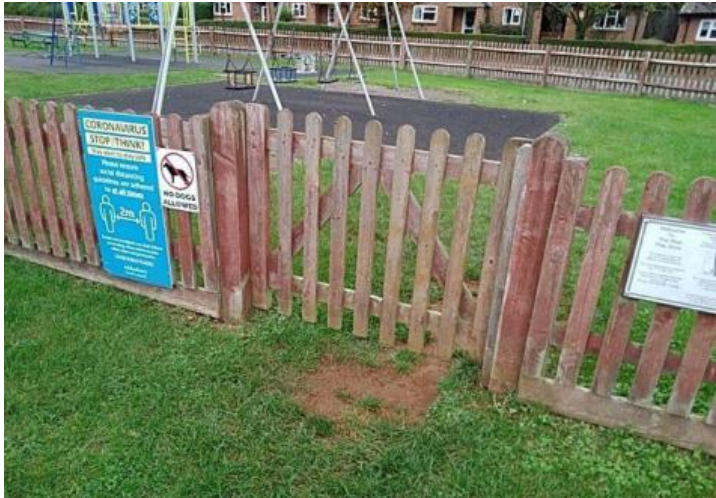
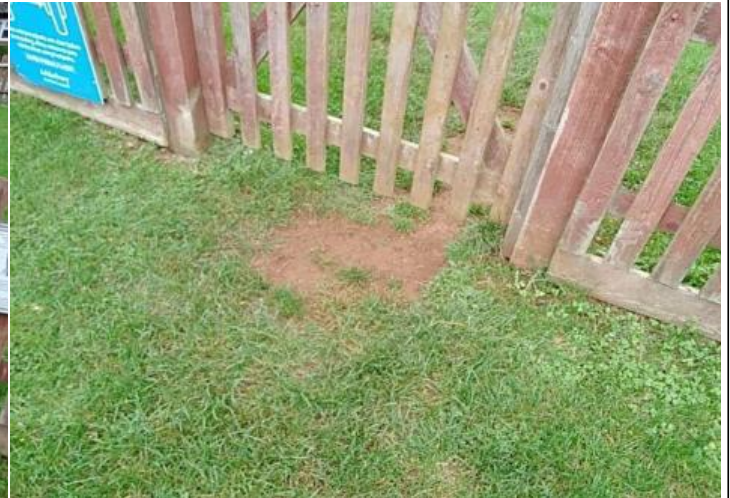
Finding: The area around the item has eroded and may become slippery

Action: Reinststate eroded area

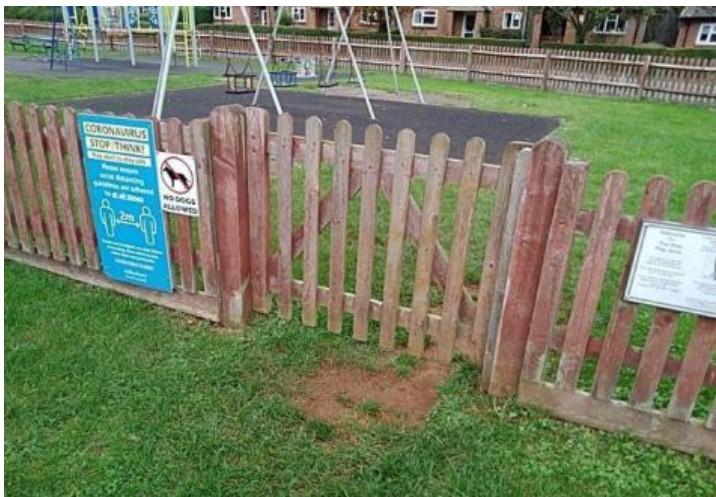
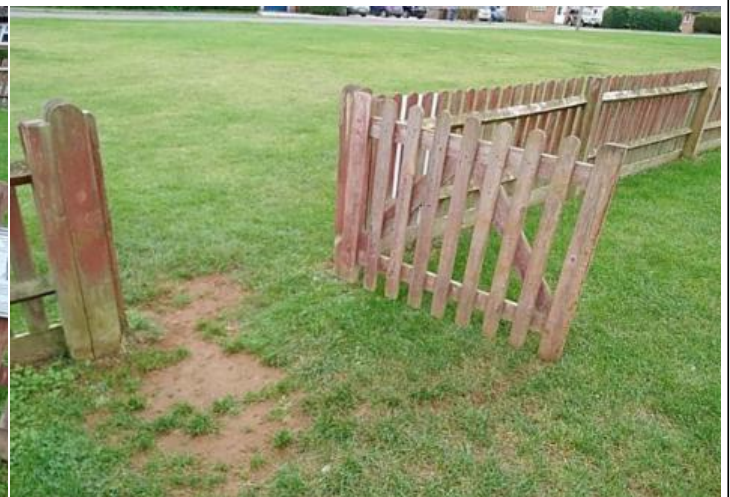
Finding: The gate is snagging on the surrounding surface preventing it from closing correctly

Action: Carry out remedial works to ensure the gate closes correctly

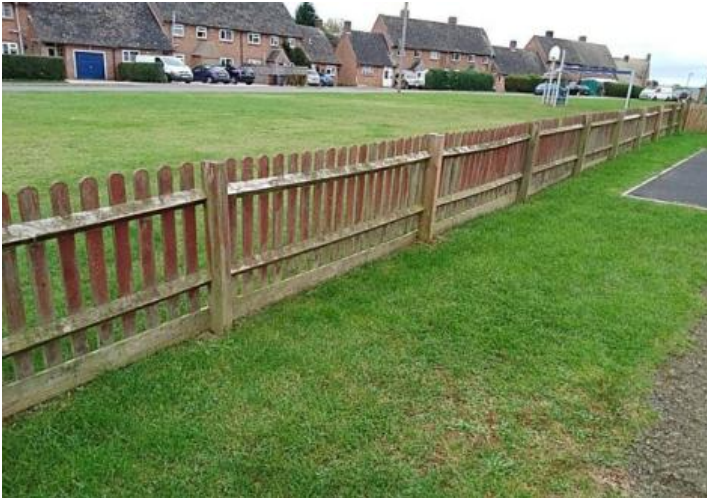
Finding: There is some strimmer / machinery damage apparent on the posts, this can penetrate the preservative applied to the timber and accelerate the rotting process

Action: Monitor for any deterioration (rot) and replace as required

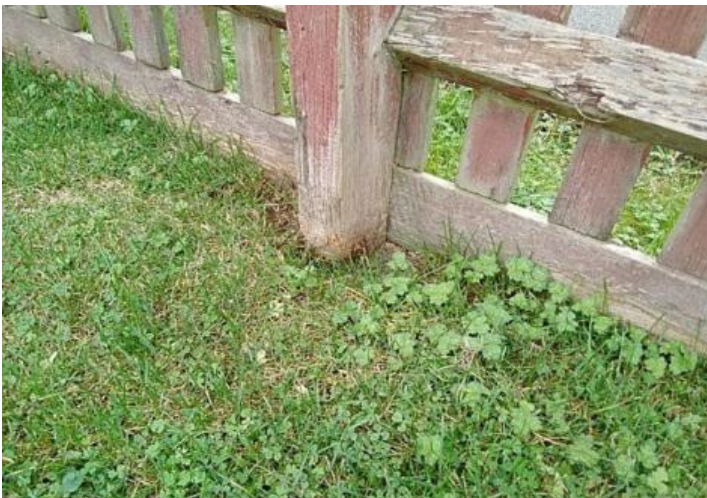
Finding: There are areas or parts of the timber on the structure that have rotted

Action: Replace all affected timbers

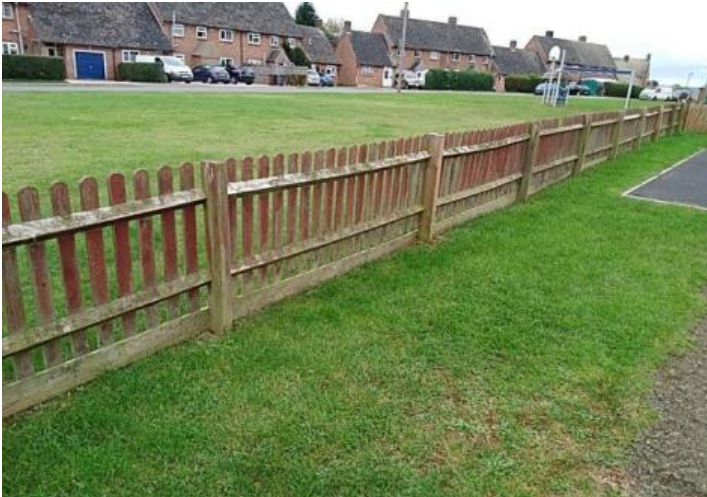
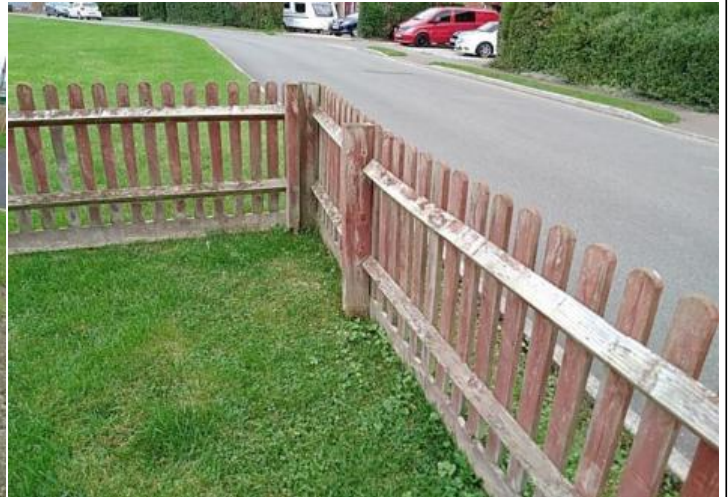
Finding: There are a number of loose posts around the fence

Action: Monitor for any further deterioration and reset as required

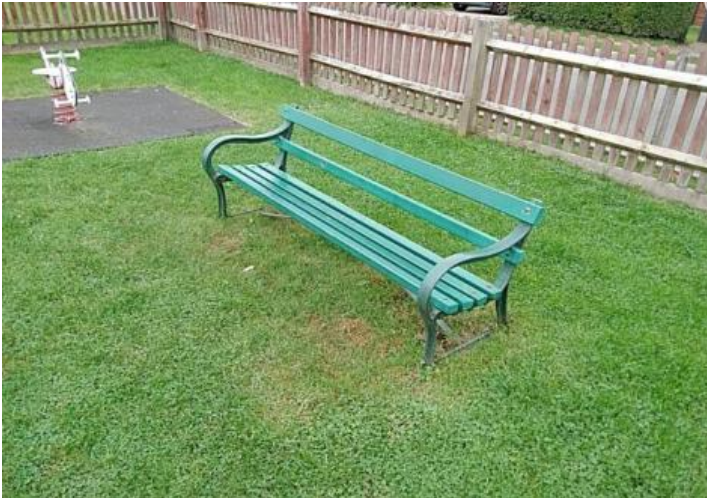
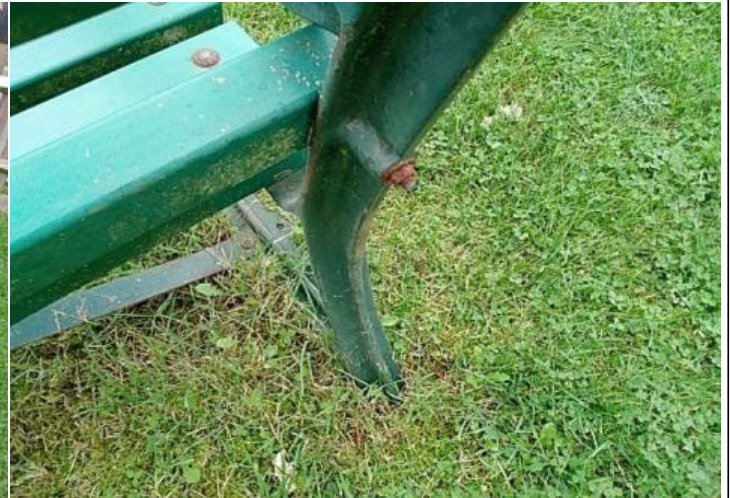
Finding: There are projecting bolt thread(s) present

Action: Remove excess thread length and deburr or provide cap

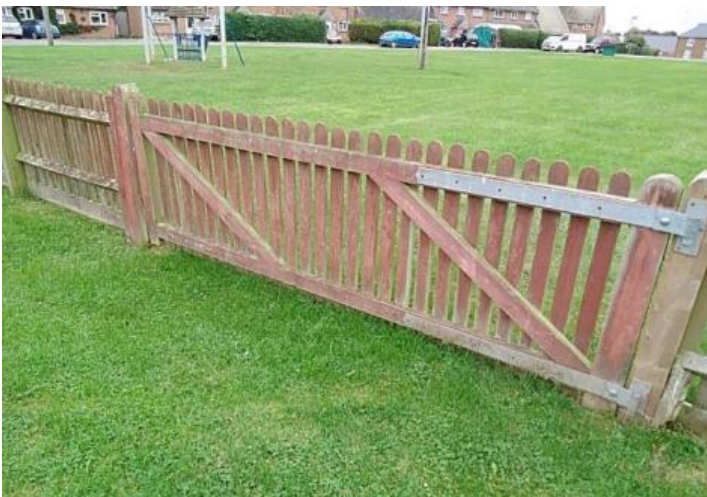
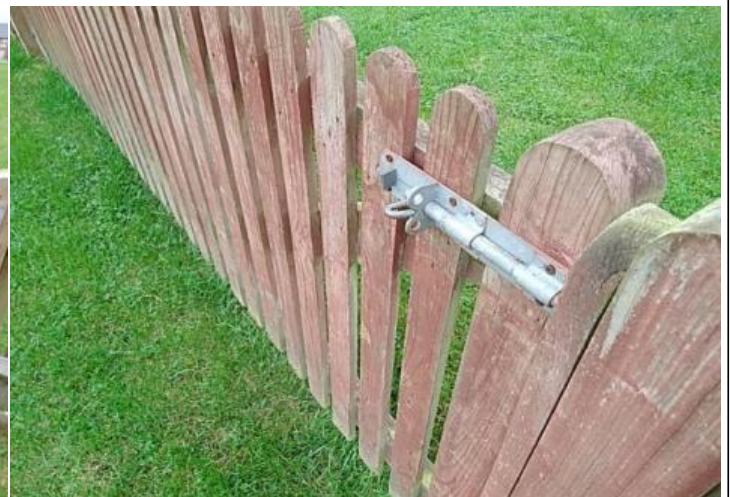
Finding: There is no padlock on the maintenance gate

Action: Provide a padlock to secure the gate

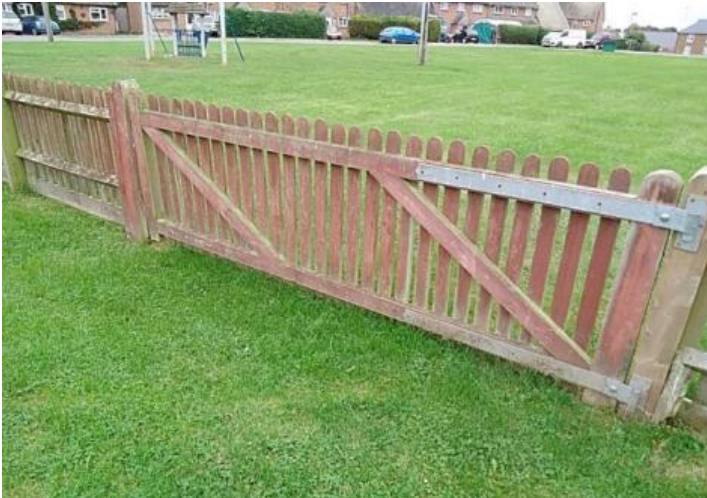
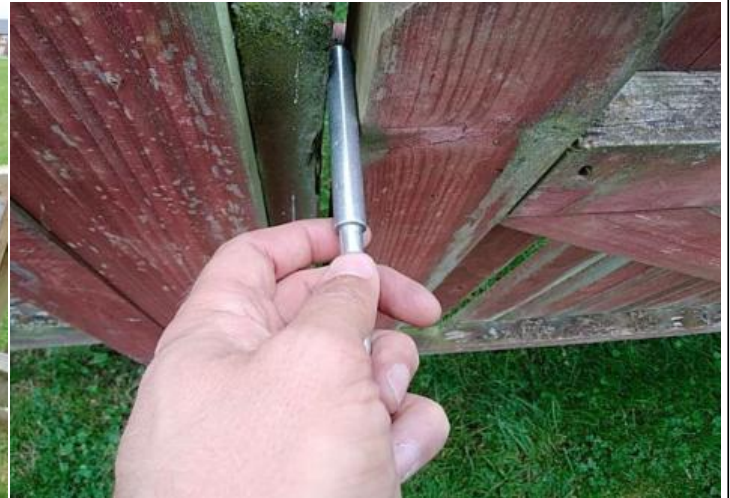
Finding: There are openings that are less than 12mm that could trap or crush fingers

Action: Where possible a 12mm gap should be maintained on both sides or between the gate leafs

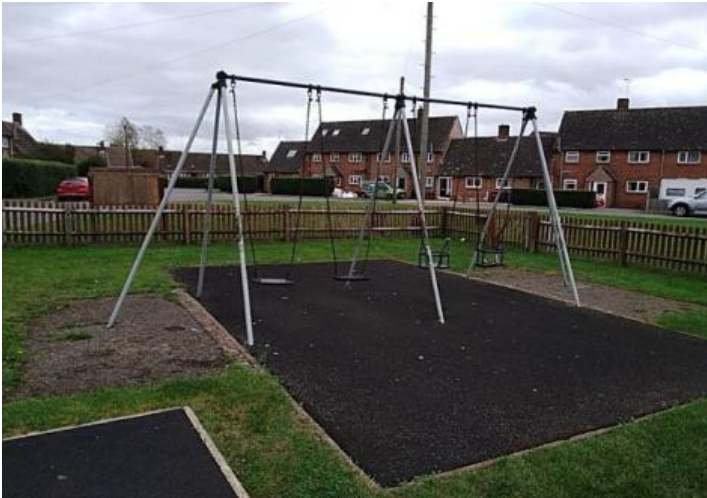
Finding: There is some damage to the concrete edging

Action: Monitor for any further deterioration and repair as required

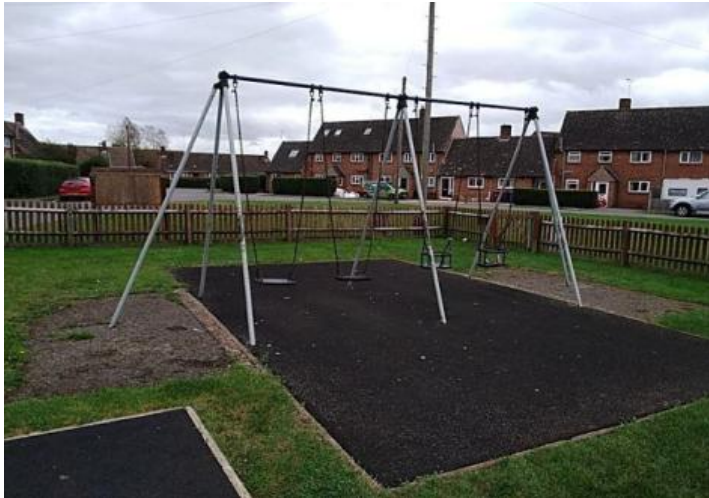
Finding: The safety surface around the area is beginning to wear
Action: Monitor for any further deterioration and repair as required

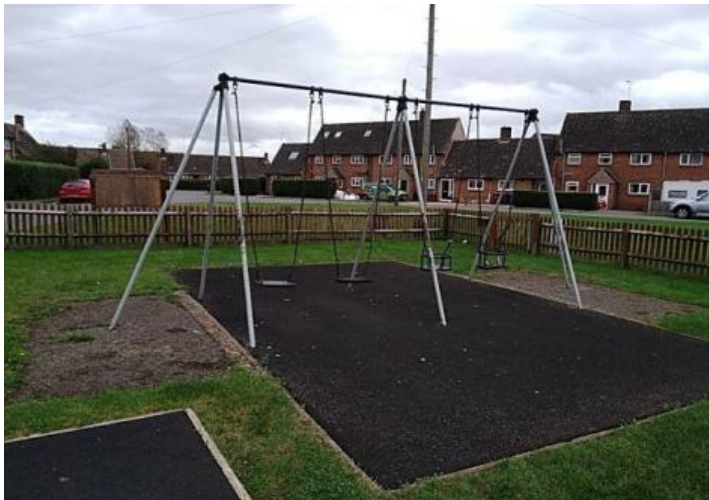
Finding: The surfacing width under each seat is less than 1.75 metres and fails the requirements of BS EN 1176 Part 2

Action: Monitor - No remedial work recommended

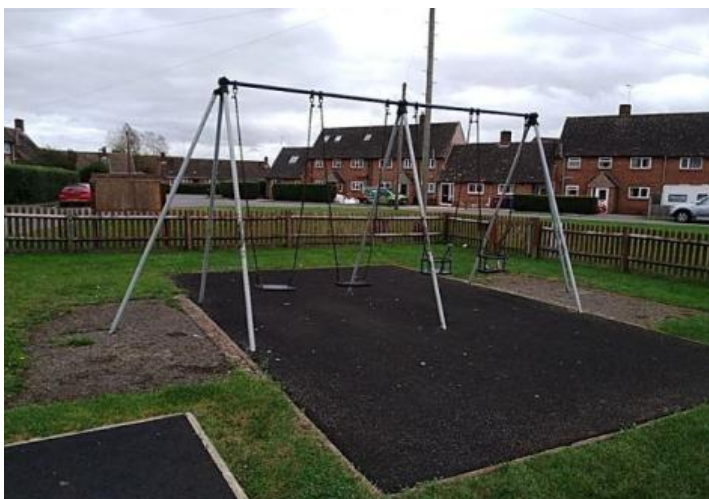
Finding: The seats are too close to the frame as defined in BS EN 1176 Part 2; this is a low risk failure and no remedial action is required

Action: Monitor - No remedial work recommended

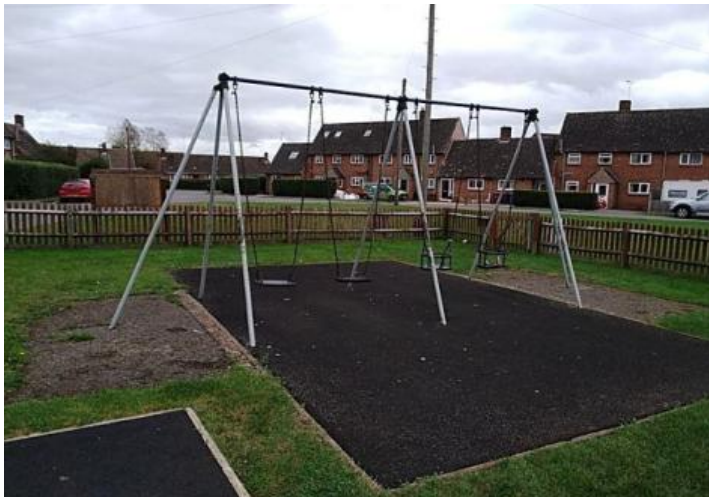
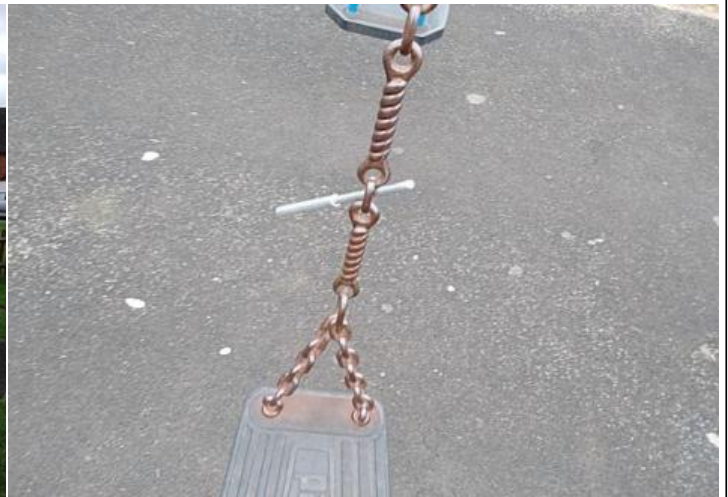
Finding: The chain openings are in excess of 8.6mm and do not meet the recommendations of BS EN 1176 Part 1
Action: Monitor - No remedial work recommended

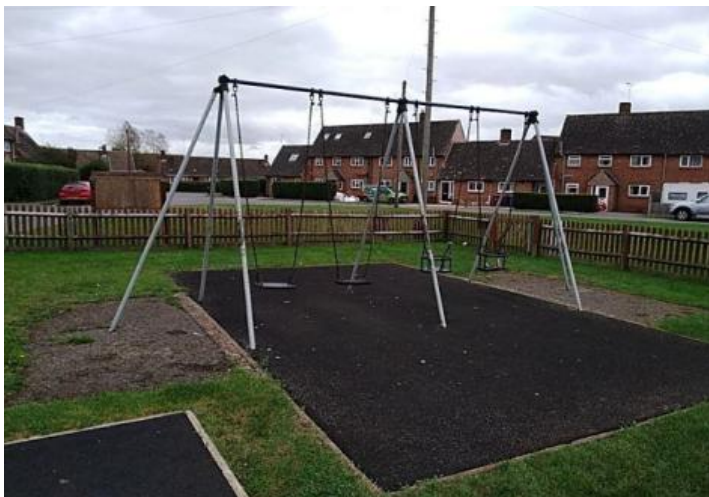
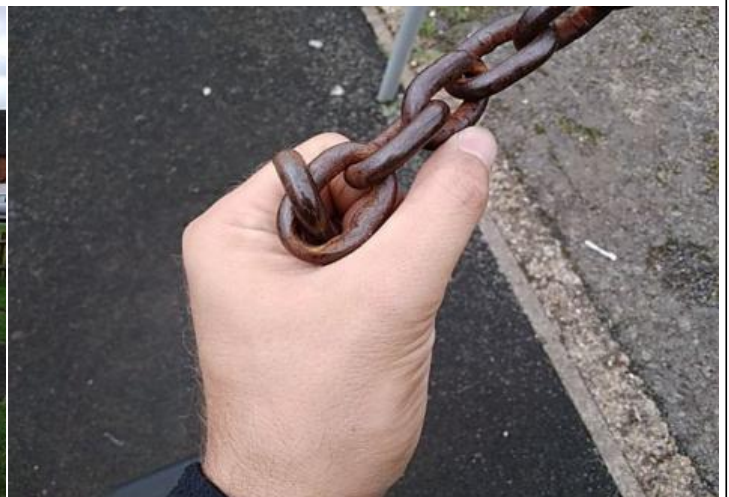
Finding: There is some notable evidence of chain wear

Action: Monitor for any further deterioration and replace when 40% worn

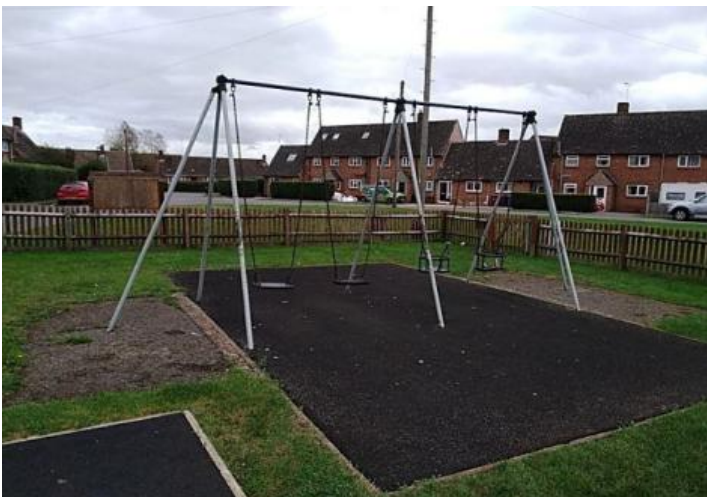
Finding: The bushes are showing signs of wear

Action: Monitor for any further deterioration and replace as required

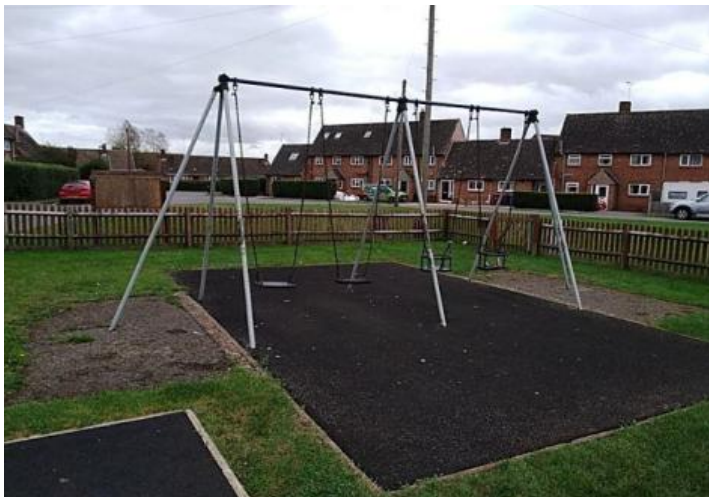
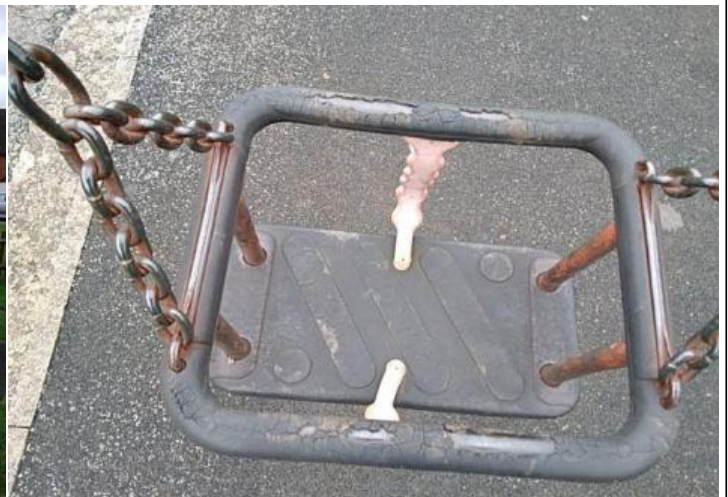
Finding: The swing seat frames are corroding

Action: Monitor for any further deterioration and replace as required

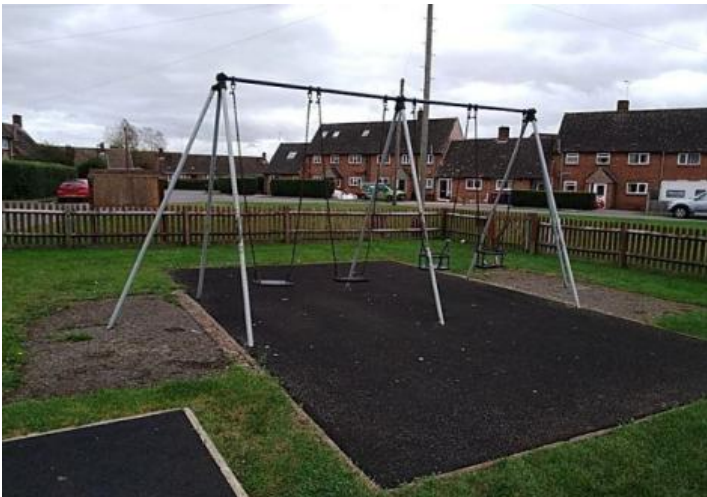
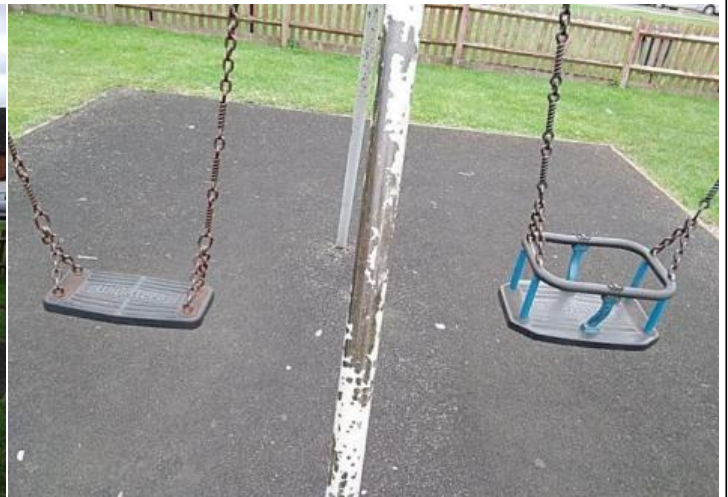
Finding: The paintwork on this item has been damaged or worn exposing the metal underneath which is rusting

Action: Treat any rusting components and repaint

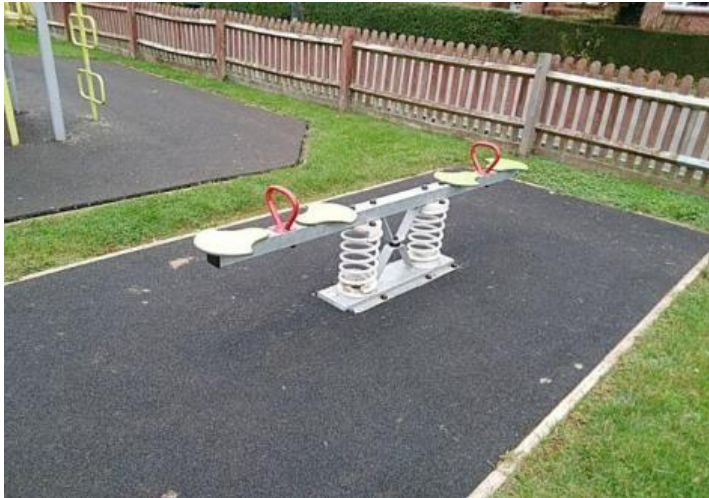
Finding: The concrete edging forms a hard object within the impact area of the equipment in contravention of the requirements of BS EN 1176 Part 1
Action: Monitor - No remedial work recommended

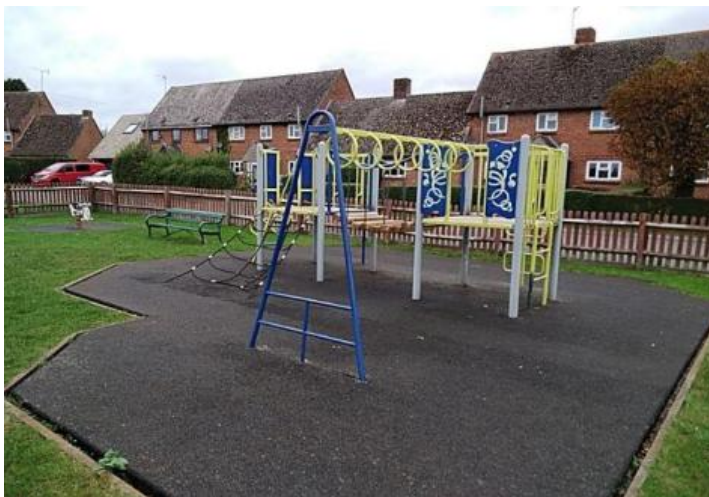
Finding: There is some damage to the concrete edging

Action: Replace all affected areas
