the play inspection company

Annual Inspection

Adderbury Parish Council

The Rise

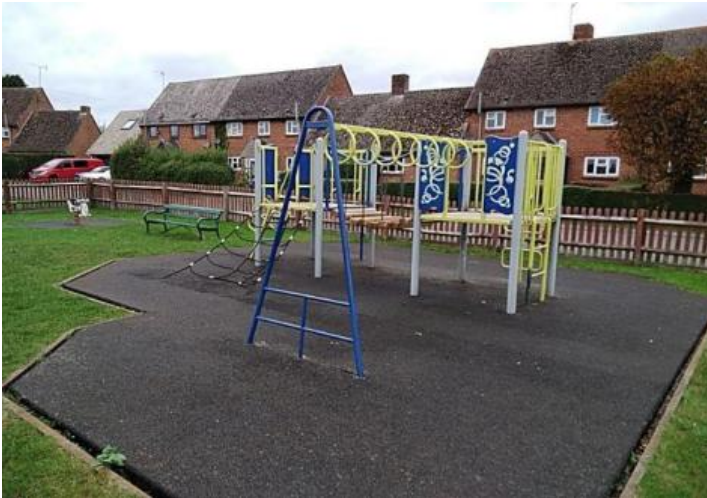
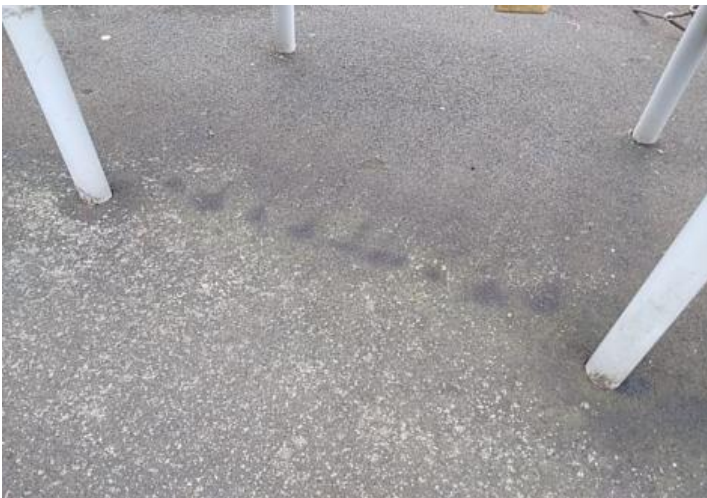
Finding: There is algae or moss growth on the surface resulting in slippery conditions

Action: Clean and treat appropriately

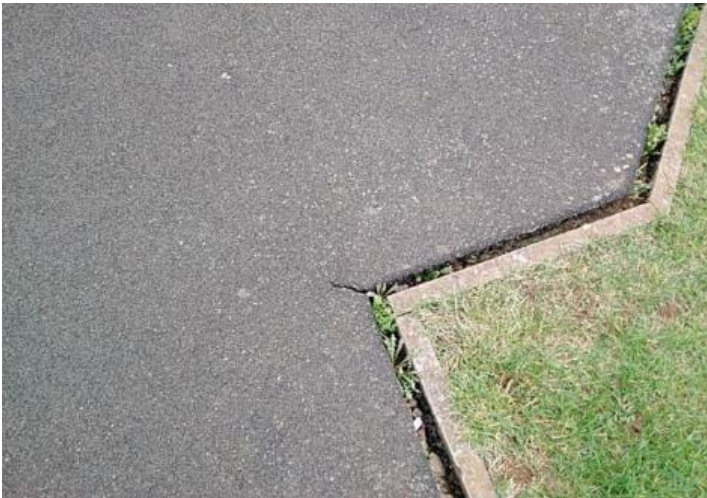
Finding: There is some minor damage to the surface

Action: Monitor for any further deterioration and repair as required

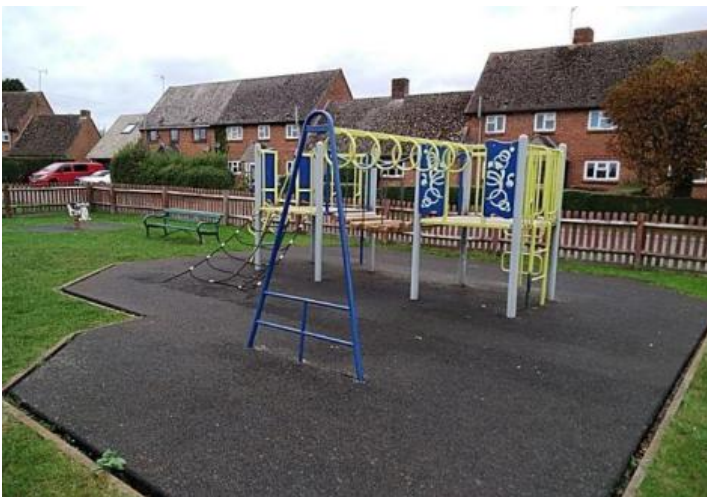
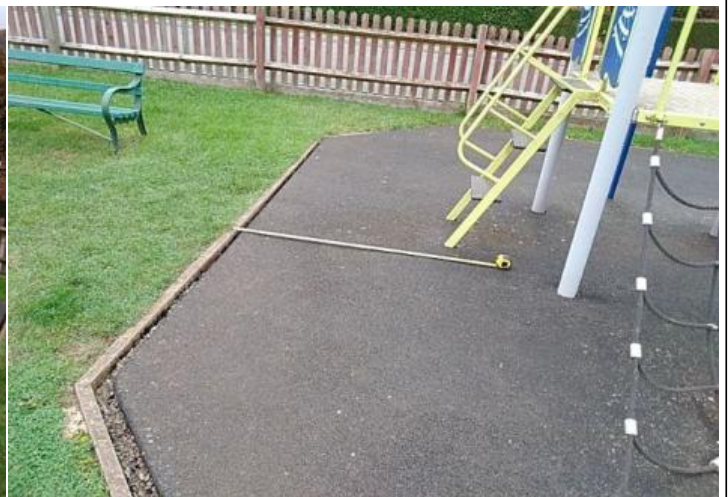
Finding: The concrete edging forms a hard object within the impact area of the equipment in contravention of the requirements of BS EN 1176 Part 1
Action: Monitor - No remedial work recommended

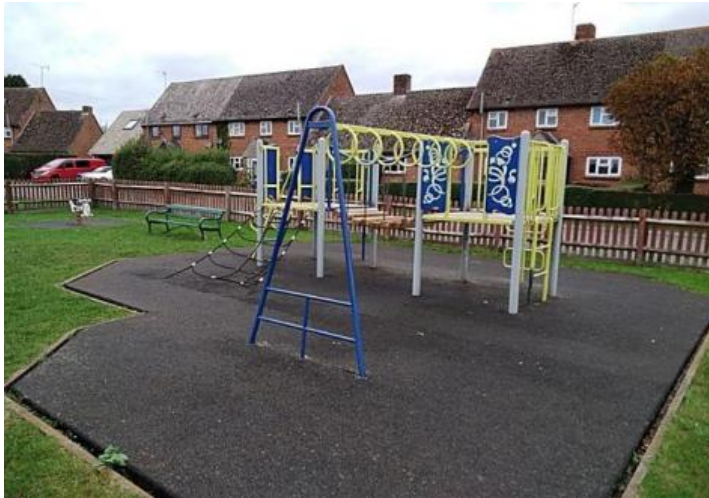
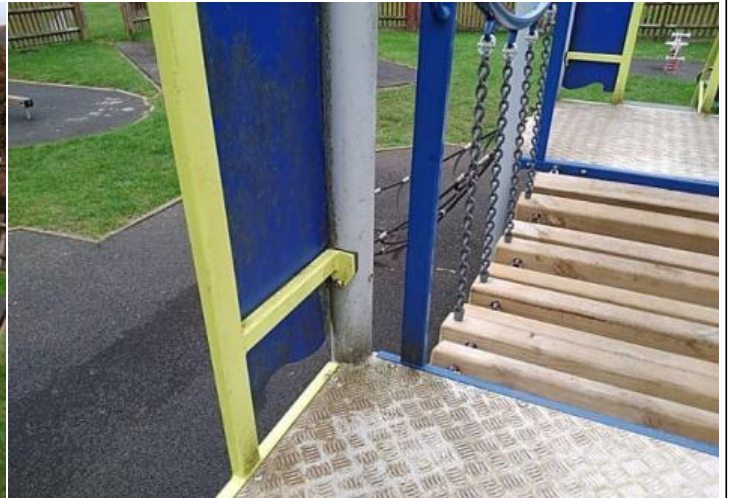
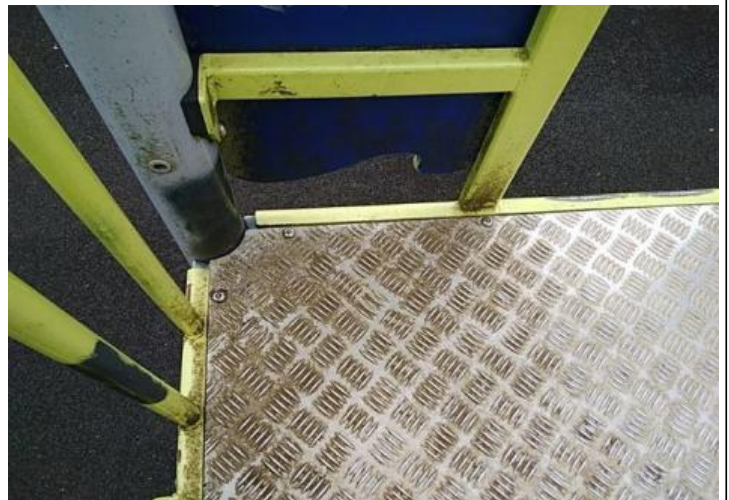
Finding: There is algae or moss on the surface of the equipment

Action: Clean and treat appropriately

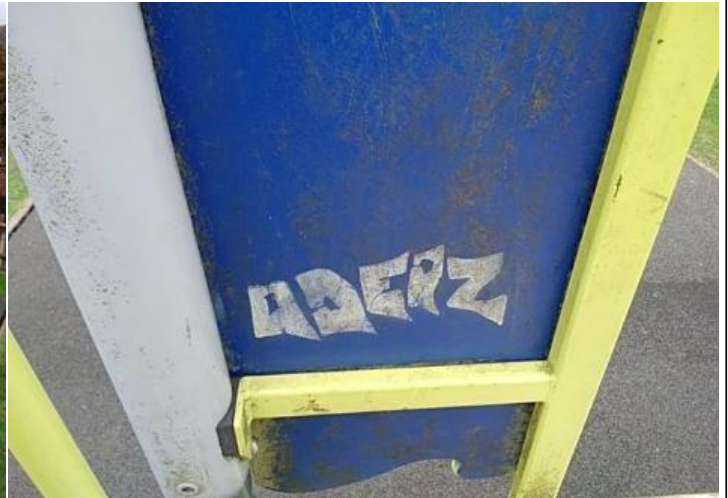
Finding: There is some graffiti present

Action: Remove the graffiti

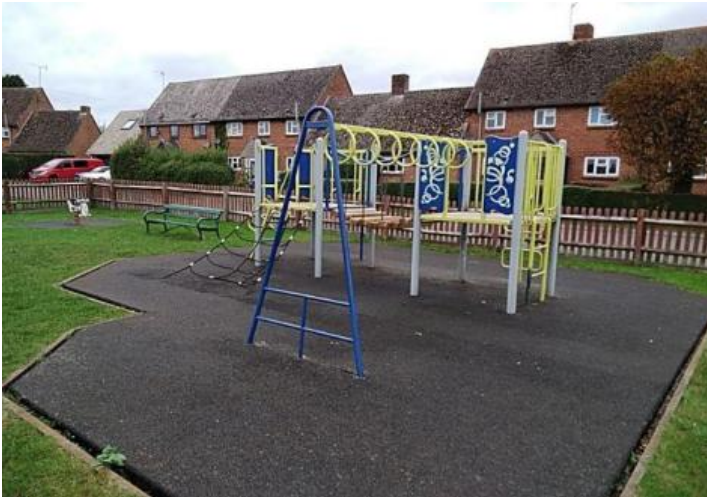
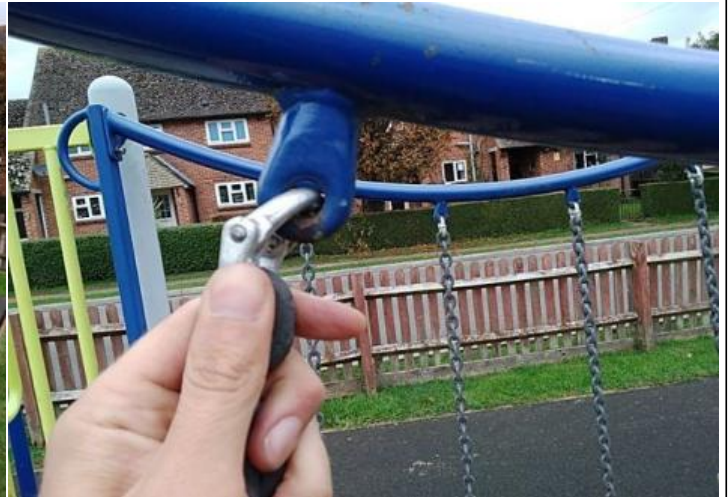
Finding: The connecting lugs are showing signs of wear

Action: Monitor for any further deterioration and repair as required

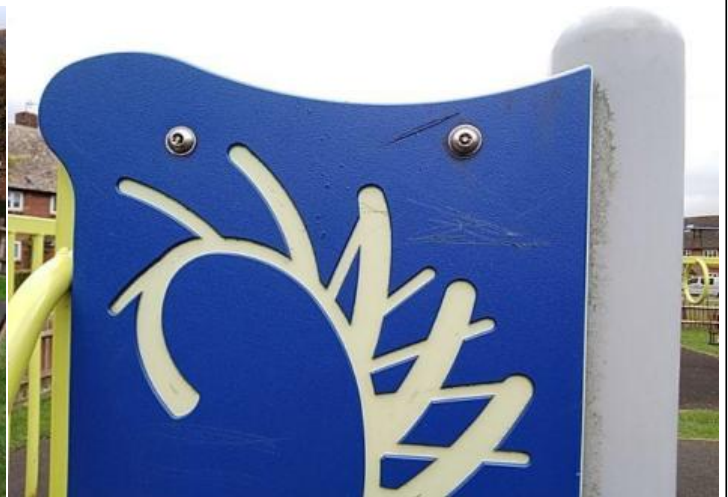
Finding: There is some damage to the barrier

Action: Monitor for any further deterioration and repair as required

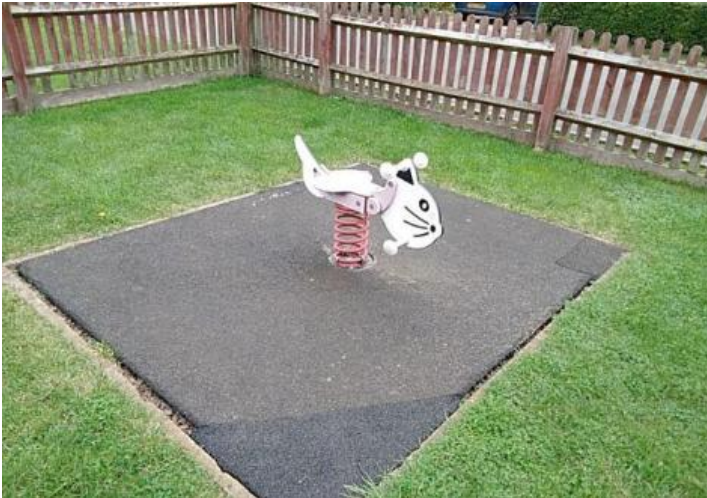
Finding: The concrete edging forms a hard object within the impact area of the equipment in contravention of the requirements of BS EN 1176 Part 1
Action: Monitor - No remedial work recommended

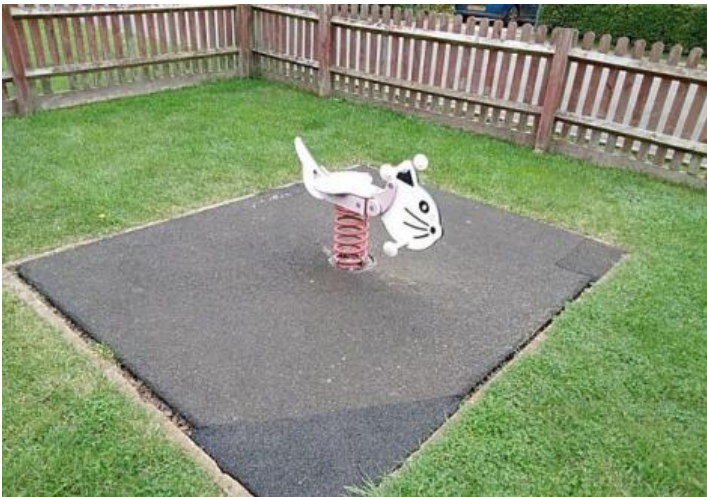
Finding: There is some damage to the seat

Action: Monitor for any further deterioration and repair as required

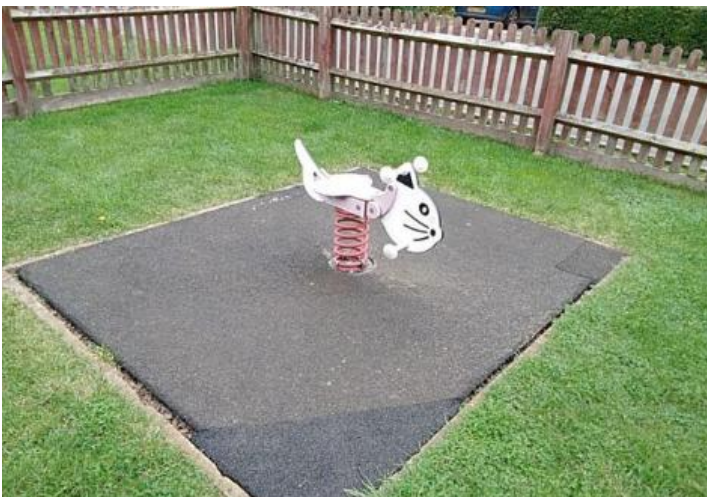
Finding: A number of fixing(s) have worked loose

Action: Secure all loose fixings

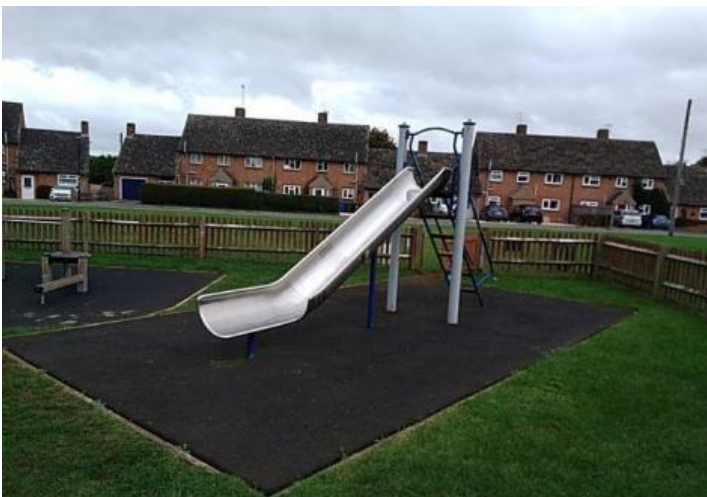
Finding: There is some minor damage to the surface

Action: Monitor for any further deterioration and repair as required

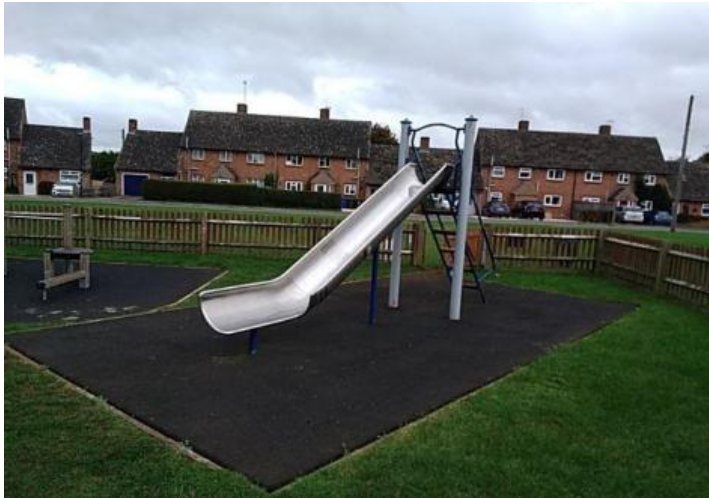
Finding: The safety surface around the area is beginning to wear
Action: Monitor for any further deterioration and repair as required

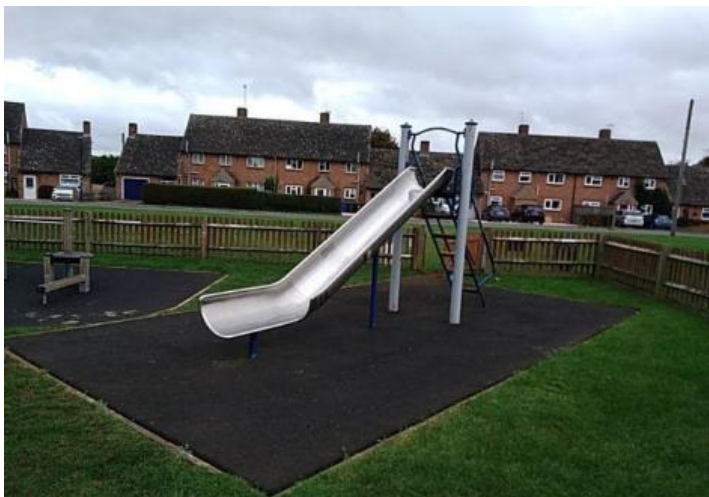
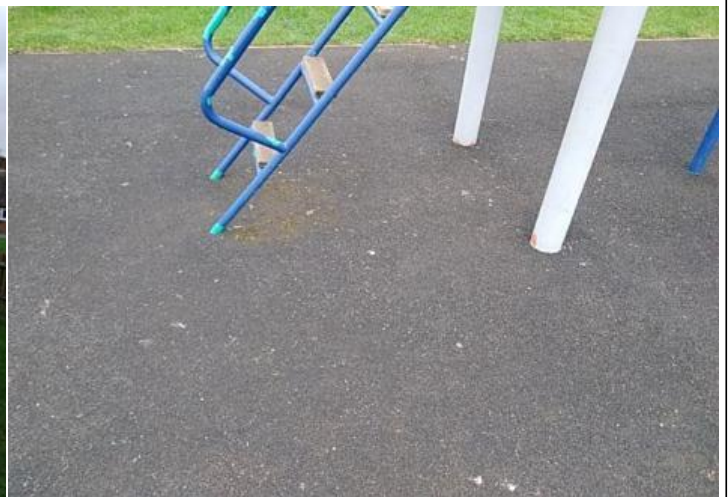
Finding: There is algae or moss growth on the surface resulting in slippery conditions
Action: Clean and treat appropriately

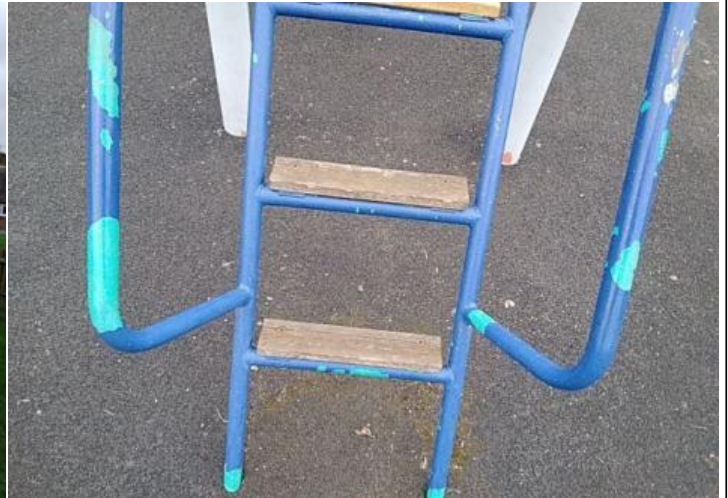
Finding: There is algae or moss on the surface of the equipment

Action: Clean and treat appropriately

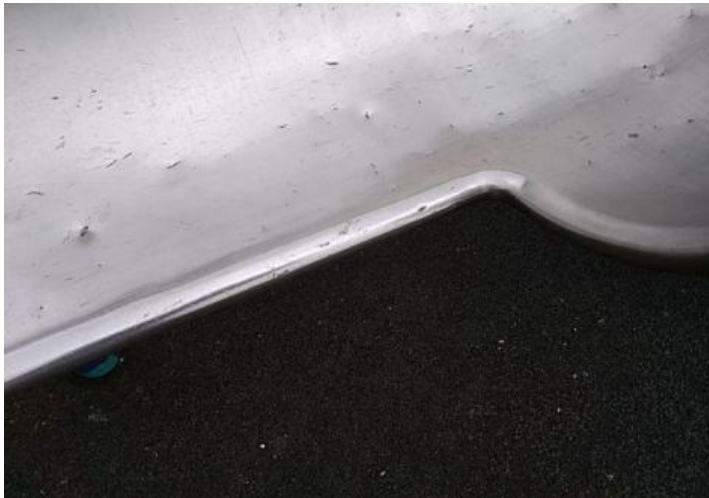
Finding: The side of the slide is damaged

Action: Monitor for any further deterioration and repair as required

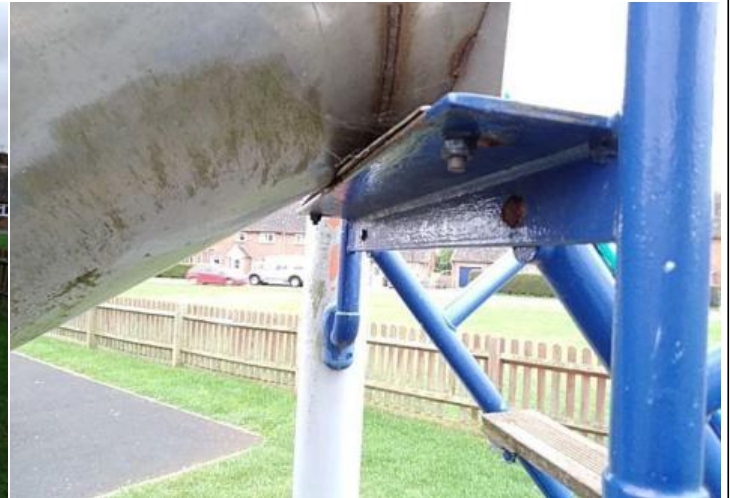
Finding: There are projecting bolt thread(s) present

Action: Remove excess thread length and deburr or provide cap

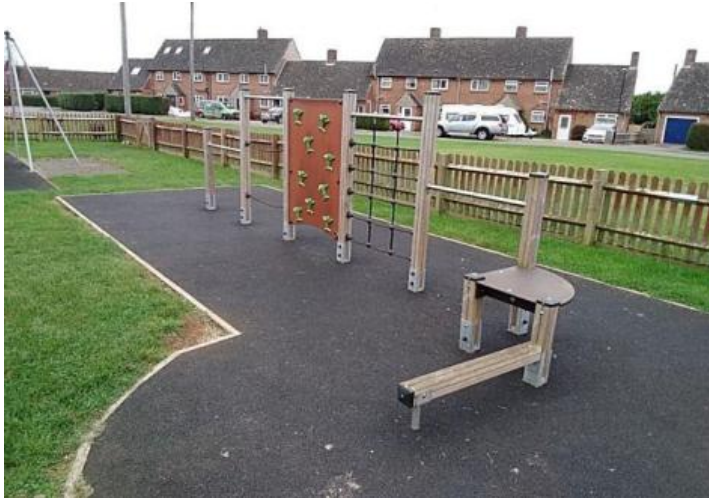
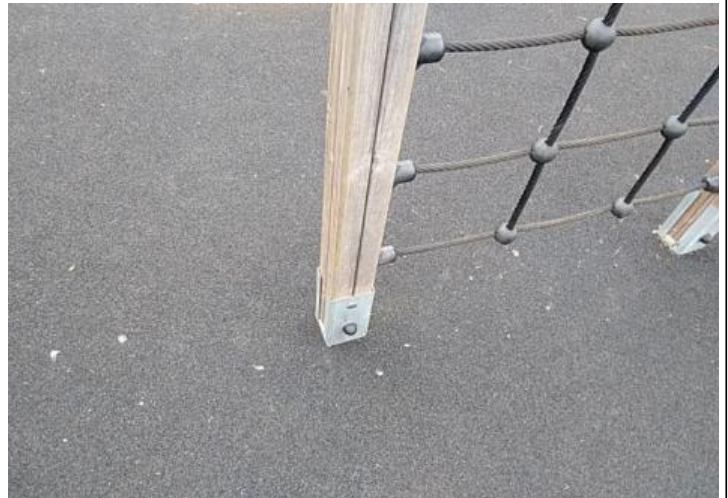
Finding: The item is slightly loose in its foundations

Action: Monitor for any further deterioration and repair as required

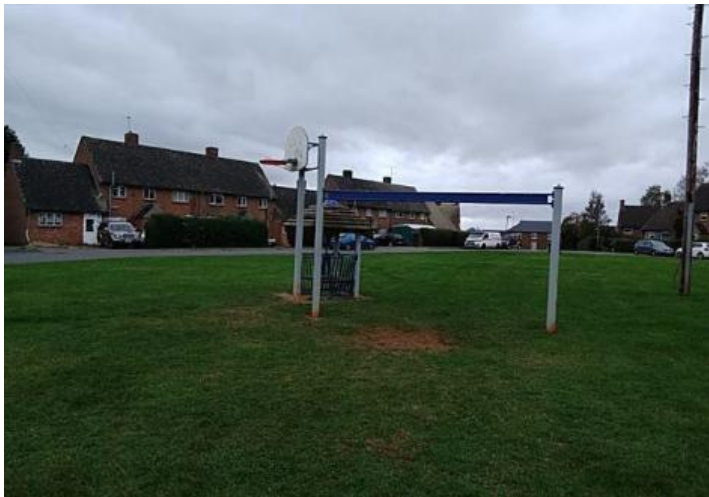
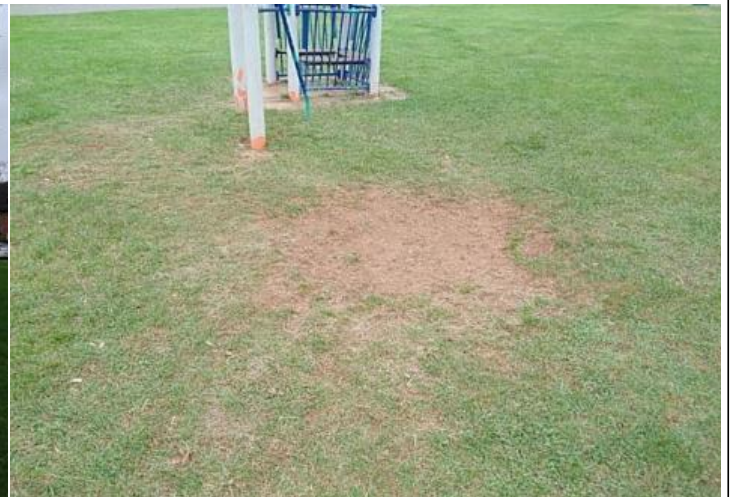
Finding: The surface has eroded in some areas

Action: Reinststate the surface

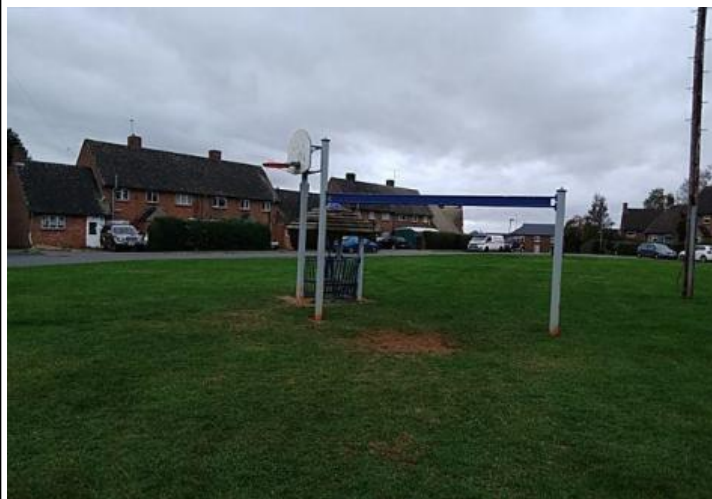
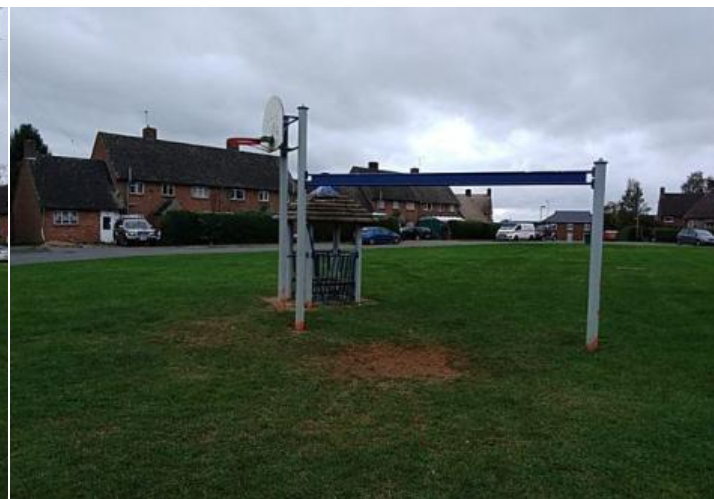
Finding: A clearly visible facility sign should be provided in a prominent position with the wording as detailed BS EN 15312- the equipment is not intended for children less than 3 years old- the warning - Do not climb on the framework or nets- the warning - Do not hang on the ring (if provided)- the warning - Do not wear rings or other jewellery- name and telephone number of the administrator- number to call in case of accident

Action: Provide signage to BS EN 15312

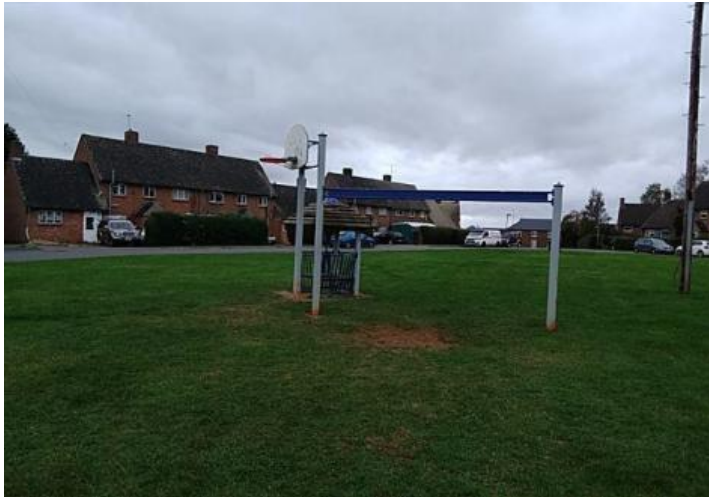
Finding: The surface has eroded and the foundations are exposed

Action: Reinstate the surrounding surfaces

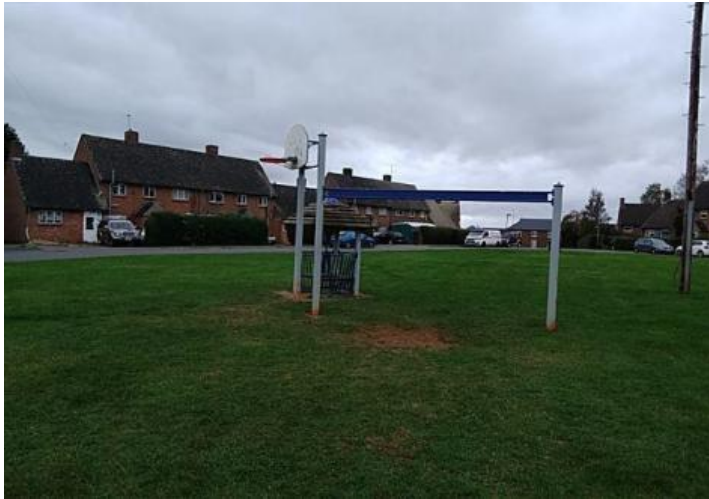
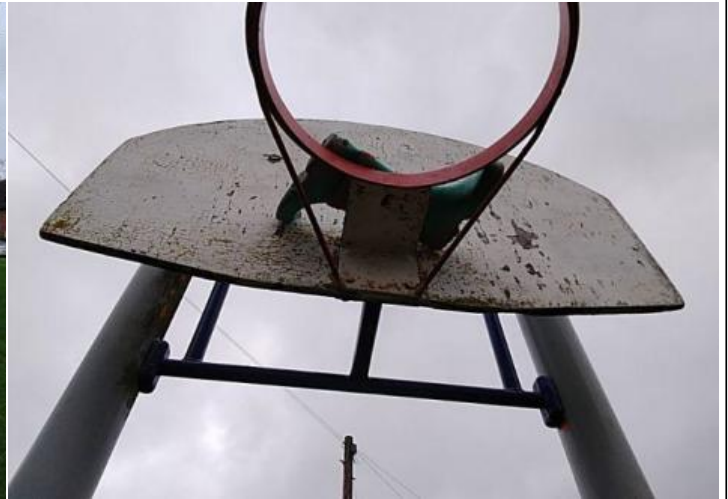
Finding: Boots have been placed on the hoop

Action: Remove the boots

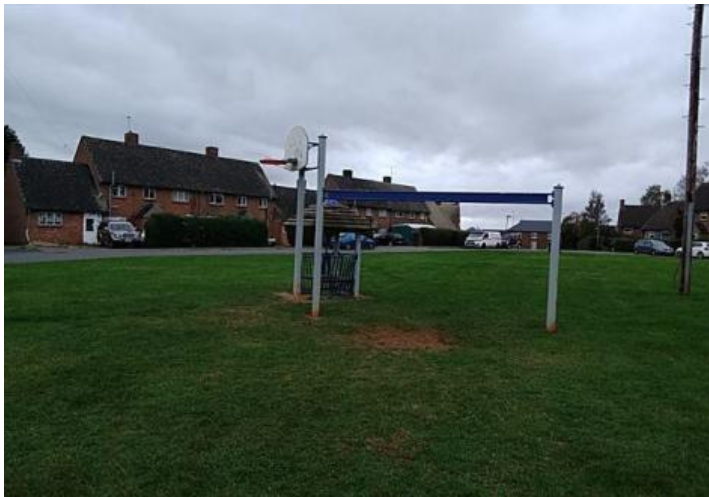
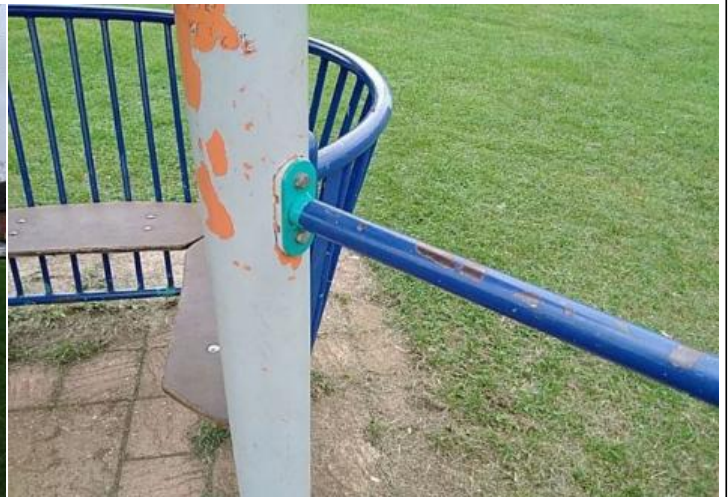
Finding: There is/are bolt cap covers missing or damaged on the item

Action: Replace missing or damaged bolt cap covers

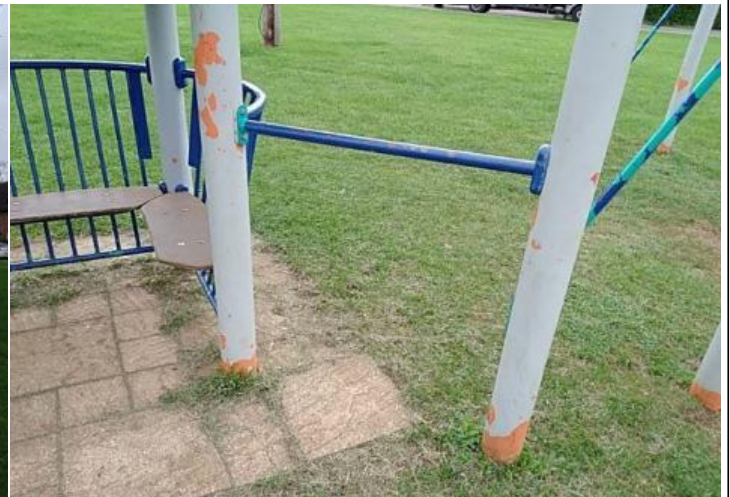
Finding: The bar may be subject to misuse with a fall height onto concrete of 1020mm

Action: Monitor use and consider providing appropriate impact attenuating surface to a distance of 1500mm from the equipment

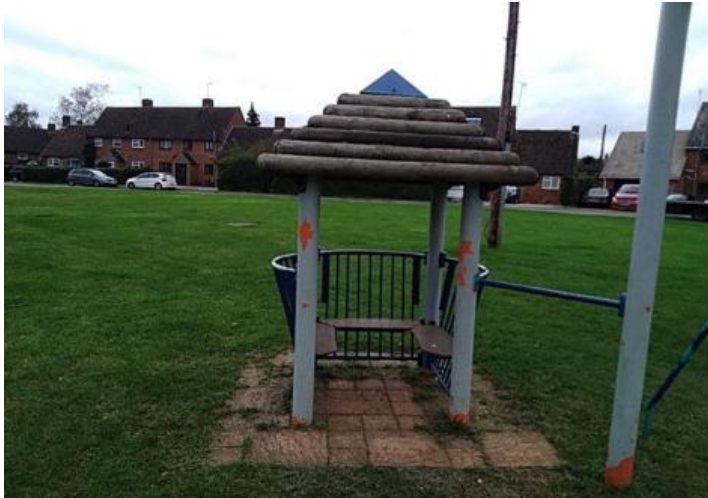
Finding: There are trip hazards at the edges of the surface

Action: Reinstate surrounding surface levels to remove the trip points

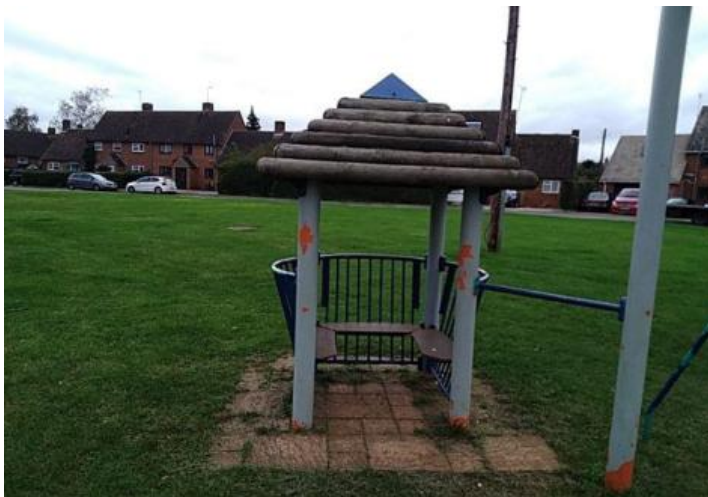
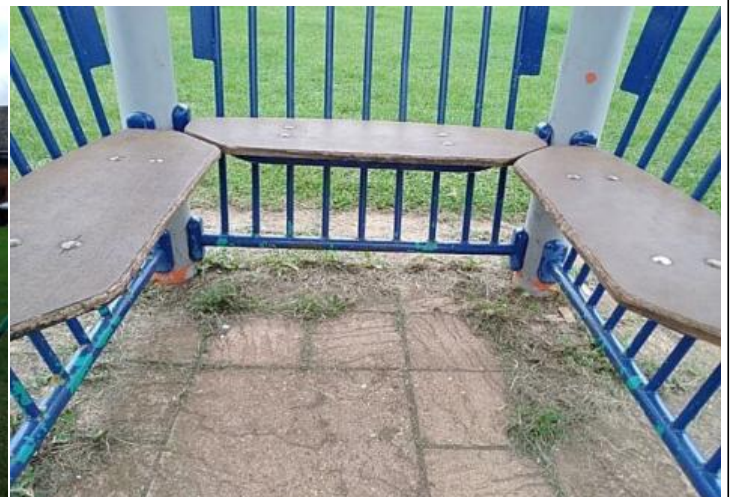
Finding: Parts of the timber are rough or splintered

Action: Remove all rough or sharp edges

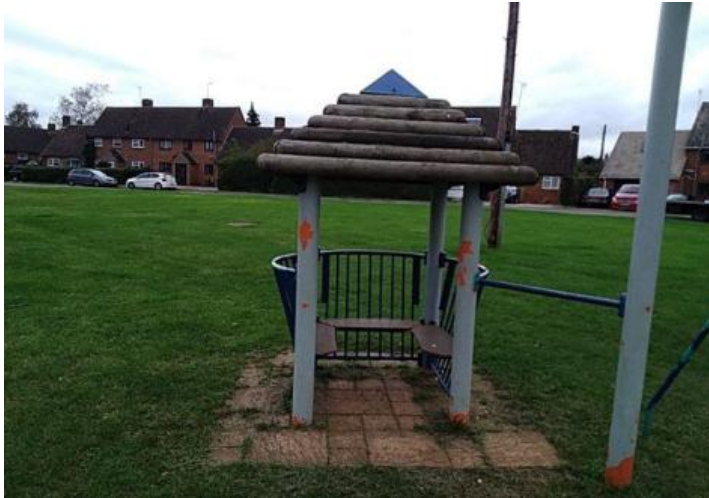
Finding: There are areas or parts of the timber roof have rotted

Action: Replace all affected timbers

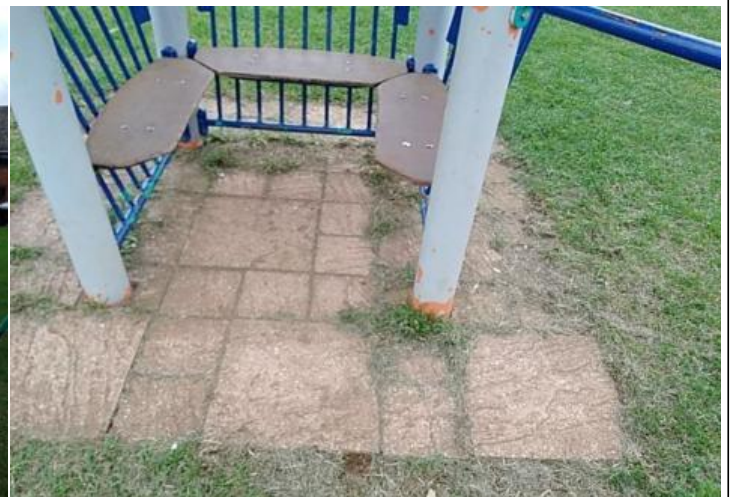
Finding: There is weed / vegetation growth on, between, or around the edges of the surfacing

Action: Remove weed / vegetation growth
