ADDERBURY – BENCHES RECORD

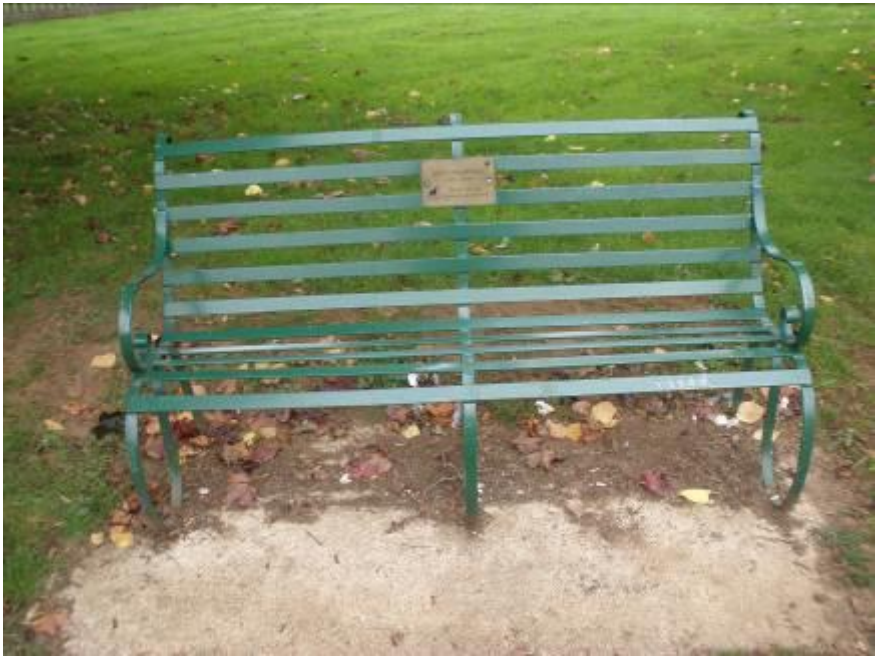
SERIAL NO:	ADD/08
LOCATION: Along the main path through the Lucy Placket playing field.	 	
DATE ERECTED:	Unknown	
FRAME CONSTRUCTION:	Six legged metal frame	
FRAME FINISH:	Painted green	
SEAT CONSTRUCTION:	Horizontal metal slats for seat and back rest	
SEAT FINISH:	Painted green	
ANY INSCRIPTIONS?	Brass plaque:	
COMMENTS ON CONDITION:	Structure is sound.	
DATE PICTURE TAKEN AND INSPECTION MADE: 12 October 2010 MAINTENANCE RECOMMENDATION: Nil.
